Case ID: 060407-01

Accident Narrative

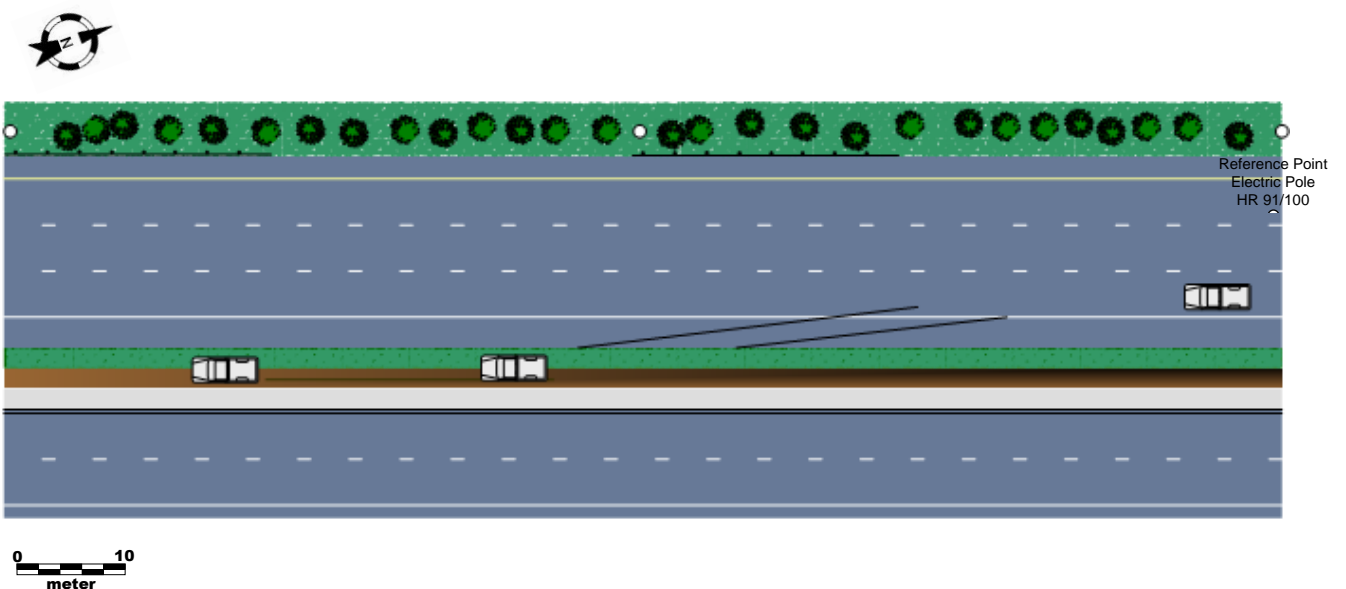
Figure 3-2: Collision Diagram

On 7 April 2006, at 9:30 A 23 years old male driver started his trip from Hi Tech Industrial Estate, Ayutthaya at about 7:00 in the morning. While he was traveling towards Bang Na on Highway No.1 at KM.41+100 (**Figure 3-1**), the front right tire suddenly blew out. He tried to slow the car by applying the brakes but the car failed to stop. It fell into a roadside concrete open ditch and moved for some distance. The pickup stopped in a roll position, the left wheels were in the canal and the right ones were along the roadside as shown in **Figure 3-2**. The driver, the only occupant, received no injury.

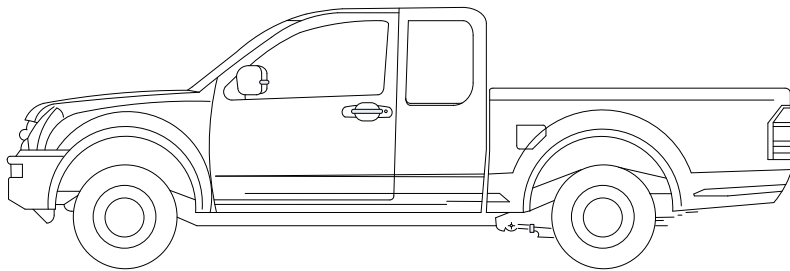
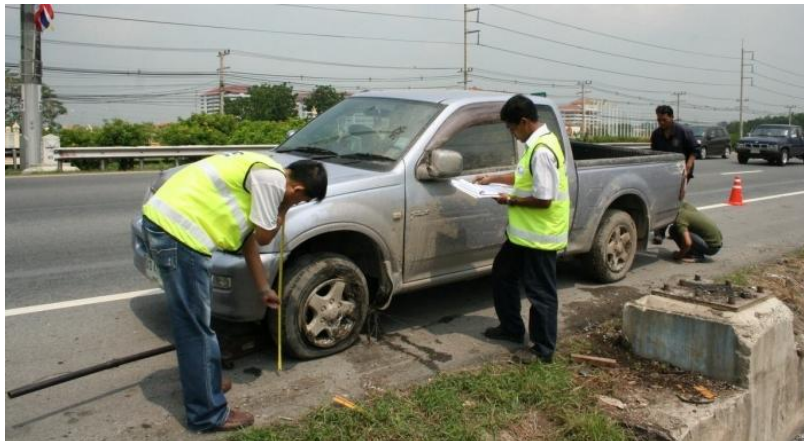
Figure 3-3: Different Levels of Scratch Marks from Ground

The left side of the vehicle came in contact with the concrete side linings of the ditch. The cover of left side mirror was pushed inward and the cover of the left rear light (at the upper corner) was broken. There were several scratch marks on the left side of the body varying from 70 cm to 110 cm from the ground. **Figure 3-3** shows the major scratch marks on the body-structure. Finally, the crashed vehicle required to be towed from the crash scene by a towing vehicle.

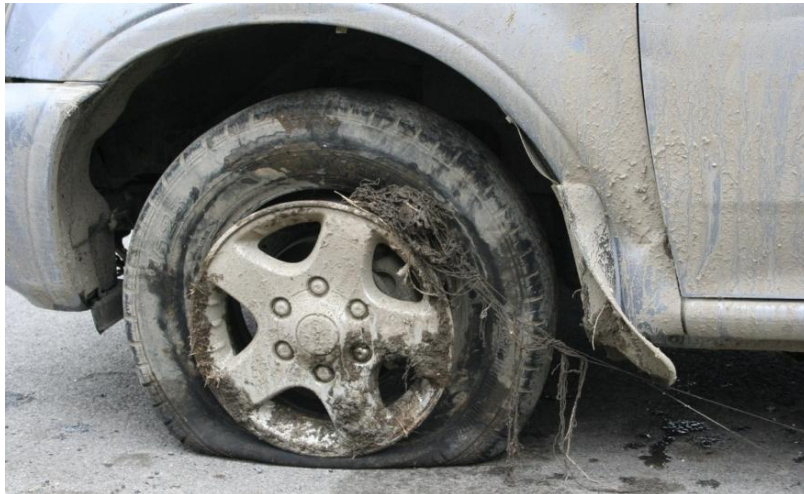
Figure 3-4: Blown out Left-Front Tire without Rapture

The left tire was found completely blown out without any visible rupture as shown in **Figure 3-4**. The mud on the alloy-wheel assembly clearly showed that the air was completely out as found at its POR. The pressure readings from the other three tires were found quite fluctuating. The right-front tire was 24 psi, left-rear 28 psi and right-rear 35 psi. The tread depth of the tire was found to be not very satisfactory for a pickup. All the tires had a 5 to 6 mm deep tread. Since the vehicle went down into the ditch's left side of the left-most lane, the front and rear wheels were marked with mud and worn-out grasses.

The zero tire pressure of the front-left wheel initially caused the driver to lose control of the vehicle and run into the ditch on the left side of the travel direction. The tire's condition, i.e. tread depth was not satisfactory, indicating poor maintenance. In addition, the tire's pressure was imbalanced, showing variable pressures at different tires.

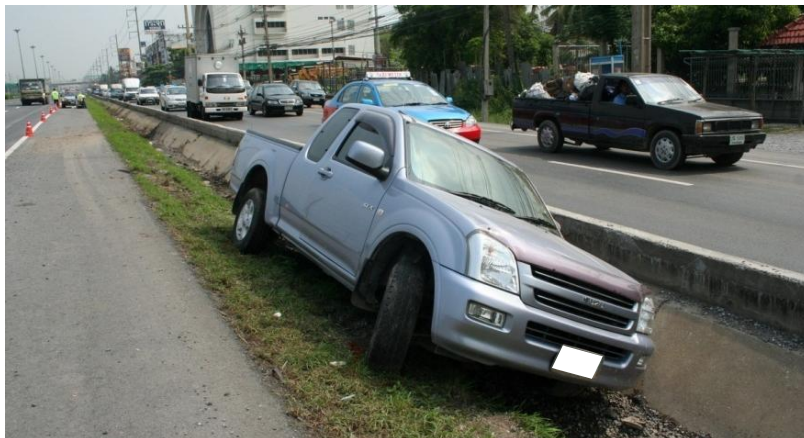
Figure 3-5: Point of Rest of the Vehicle partly in the Ditch

The vehicle was found at the rest position (i.e. POR) on the roadside embankment. Considering the roll-over, the vehicle made one-eighth of a full turn counter clock-wise from the initial condition to the POR. **Figure 3-5** shows the POR of the vehicle partially inside of ditch.

The steep roadside embankment was not safe for any errant vehicle driver to recover in case of a road run-off that could have resulted in a severe roll-over. The detailed analysis of the clear zone concept, including findings from other cases, is comprehensively discussed in topic 5.2.

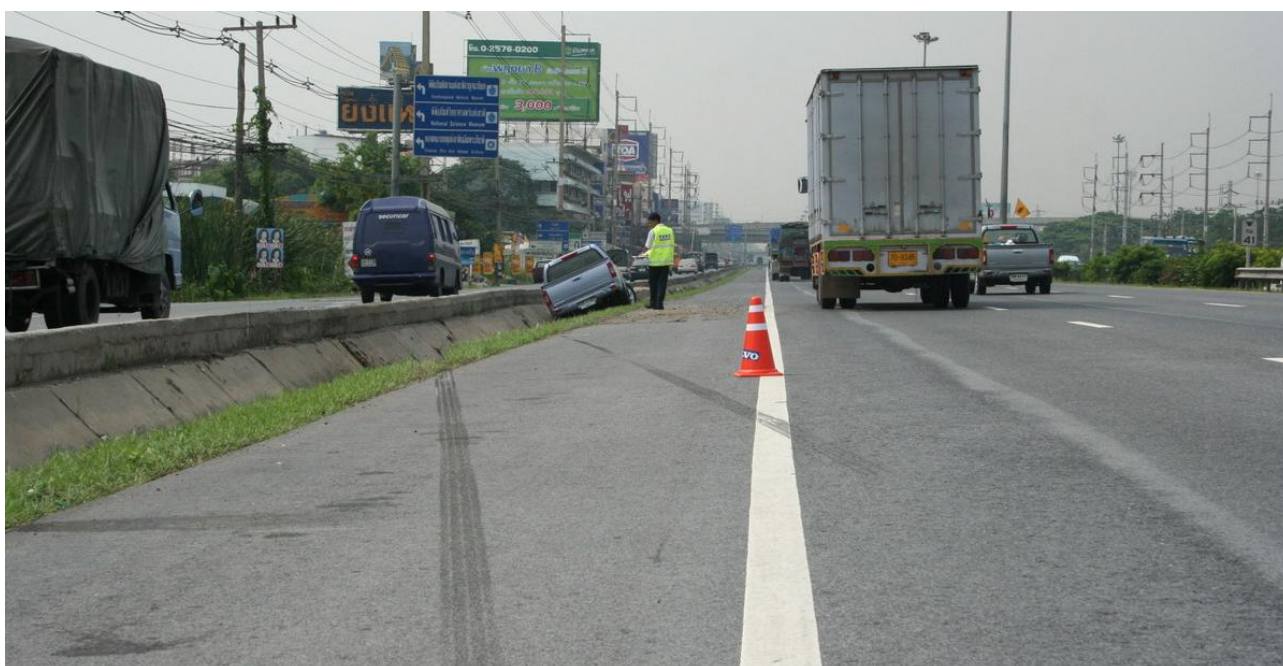
Figure 3-6: Evidences at Crash Scene

The 20.90 m. and 26.60 m. long skid marks for left and right wheels respectively were found starting from the left shoulder to the roadside embankment (**Figure 3-6**). However, the marks were also found to be continuing inside the ditch about 33.00 m. further and stopped at the point of rest. The total length of the tire marks found indicated that the distance traveled by the errant vehicle from the shoulder to the point of rest was about 57.30 m.

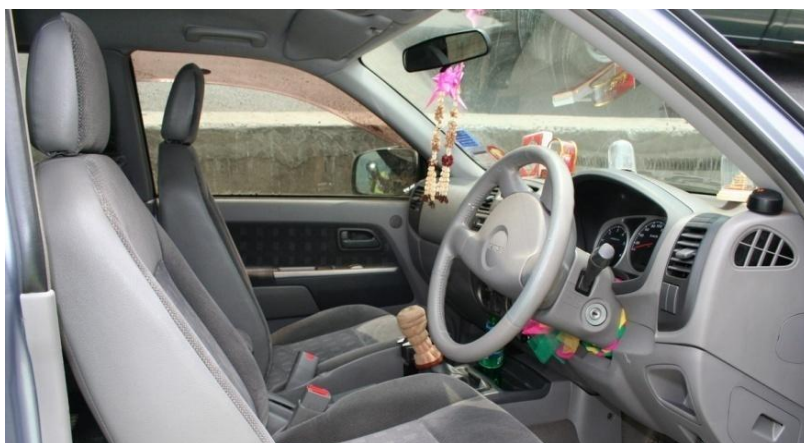
Figure 3-7: Interior of the Vehicle (Driver side)

dissipated to the vehicle was 10.47 kN during this time. No evidence of contacts between the occupant and the interior of the vehicle was found. **Figure 3-7** shows the driver's seating position.
