Case ID: 060811-01

Accident Narrative

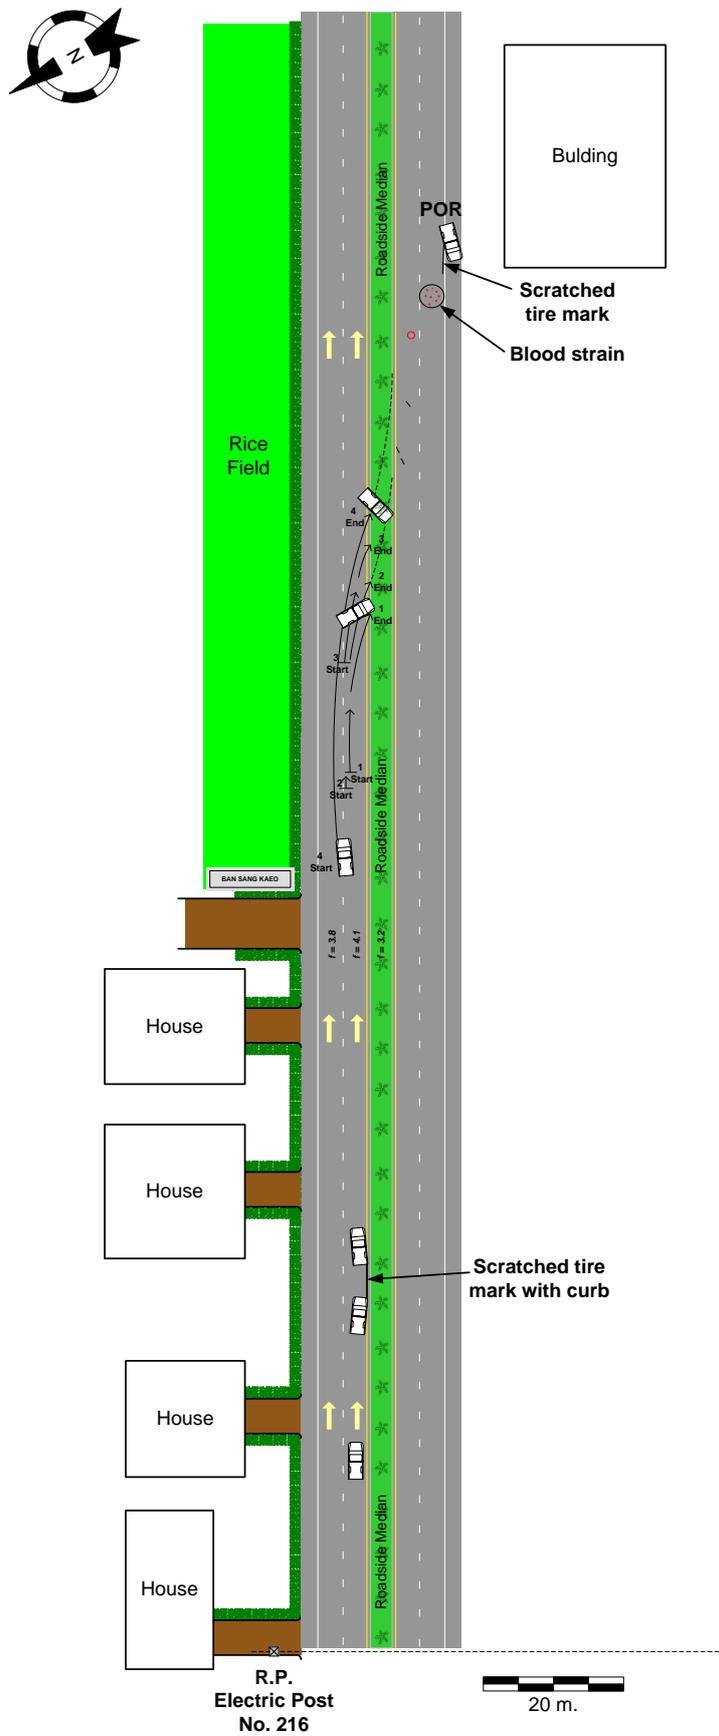
Figure 3-2: Schematic of Accident Scene

At about 07:00 on Thursday, 11 August 2006, a family left Ayutthaya province, planning to join their relative's funeral at Chiang Yeun in Mahasarakham. At about 06:30 on Friday, 11 August 2006, 11.5 hours later, the pickup that was traveling eastbound on Highway no. 209, a four-lane divided highway, near Chiang Yeun, Mahasarakham (**Figure 3-1**), lost control and rolled over by crossing the median into the westbound lane. The vehicle finally stopped on wheel position, facing westbound. **Figure 3-2** shows the major events of the crash.

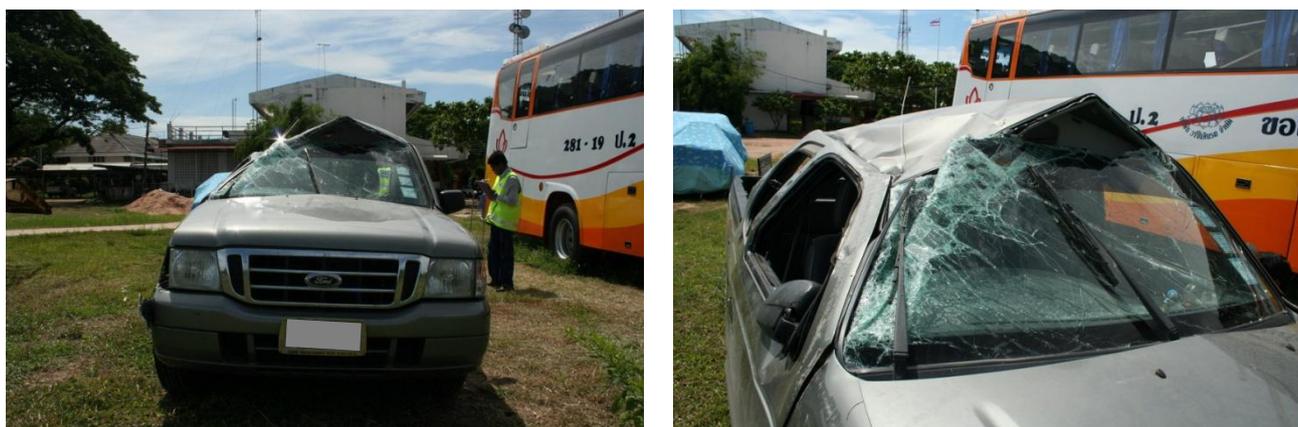
Figure 3-3: The Damage to the Pickup

The exterior damage of V1 shows mostly on the top-right of the vehicle (**Figure 3-3**). The roof particularly the top connecting right A-pillar on the driver's position was indented. The A, B, and C pillars were bent inwardly, which also caused the broken windshield originating diagonally from the top of right A-pillar. Several scratch marks were found on the front-right part of vehicle's body. The front-right signal light loosened from its original position, hanging by the electrical wires. The rear window at the cab was also damaged. The front-left wheel showed damages on the rim. It was partly broken, see **Figure 3-3**. TARC evaluated the Collision Deformation Code (CDC) for the pickup as **02TY1HO5**. **Figure 3-4** shows the extent of damage of V1.

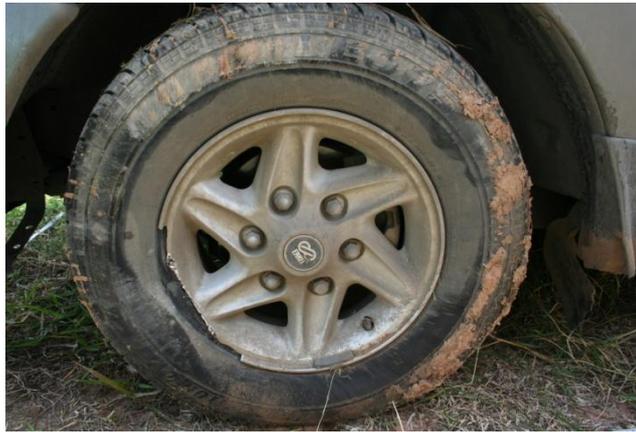
Figure 3-4: The damage on Front-Left Wheel

The vehicle ended up in a roll-over in the median leaving four long yaw marks on the road surface. It was in high speed during the rollover situation and went into the opposite direction of the road, making one-full turn (360°). The orientation of the tire marks as well as the damage of the rim on the front-left wheel supported that the vehicle had been rolled over by its left. The final rest position of the pickup was on its four wheels near the shoulder of the opposite direction road, facing the opposite of its initial travel direction. **Figure 3-13** shows the path of the vehicle during the rollover occurrence.

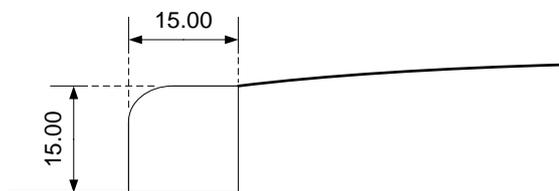
Figure 3-6: Raised Median at Crash Scene

The raised median was constructed as a concrete curb at the middle of two opposing traffic along the roadway. It is located about 30 cm. apart from the yellow-inner lane line, with 4.1 m. in total width. The height of the curb was 15 cm., as shown in **Figure 3-6**, from the road surface. It was filled with soil and covered by grass. The coefficient of friction shows 0.64.

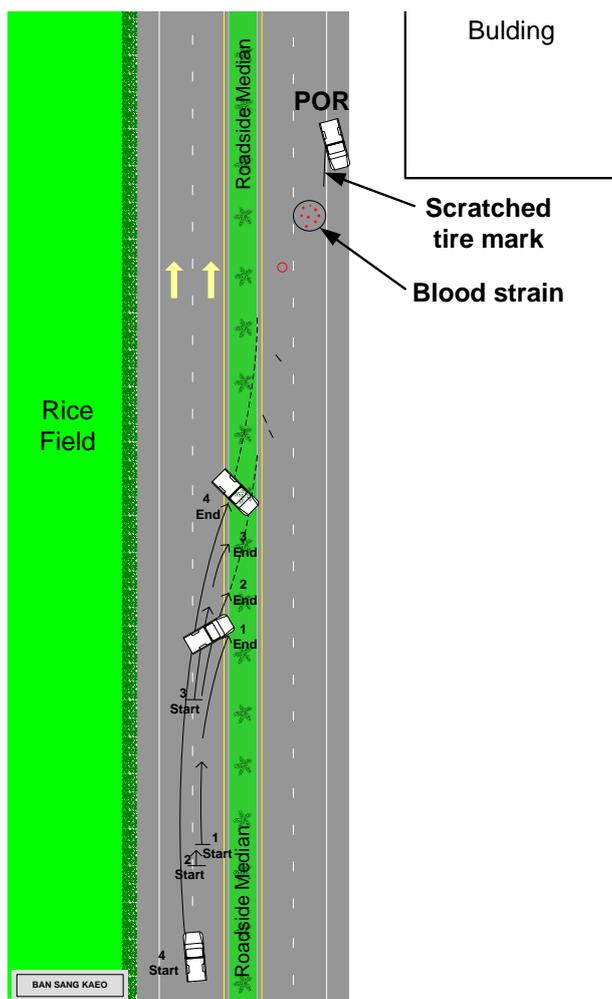
Figure 3-7: Evidences Found at the Crash Scene

The four clear tire marks were documented during the investigation, both on the pavement and median. All evidences were measured and documented as shown in **Figure 3-7**.

The electric pole number 216 was selected as a reference point. The first mark showed on the median curve. The black mark, scratch from vehicle-right tire, was about 6.1 m. in

length, 50.5 m. from the reference point. The four-tire marks, yaw marks, continued 56.2 m. further.

After a close investigation of the yaw marks, each mark was identified as corresponding to the vehicle's wheels. Considering the characteristics of the vehicle rotation about its vertical axis, it rotated clockwise in this crash. The left-most mark, started from the second lane (outer lane) as shown as the rear-left wheel (mark number 4) in the **Figure 3-7**. Next, the mark printed parallel to the rear-left tire would be rear-right tire since they were on the same axle. The same for the other two marks (mark number 3 and 1) were the front-left and front-right, respectively. To use these parameters of tire mark geometry in the mathematical calculation, the chord lengths and middle ordinates were required. **Table 3-2** shows the information about the yaw marks on each wheel.

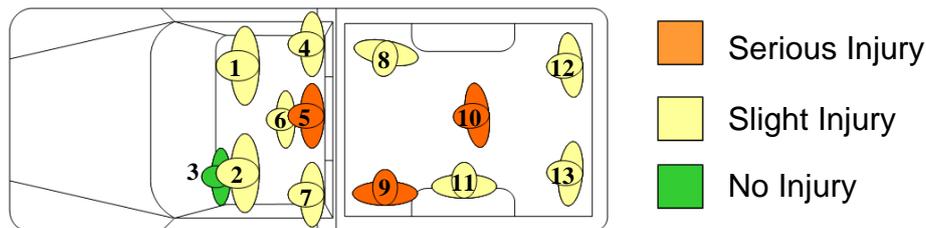
Figure 3-8: Occupants' Seating Position

The other seats, including the extended cab had no restraint system. **Table 3-3** and **Figure 3-8** show the occupants' injuries and restraint system on his/her seats. The injuries were coded in ICD10 standard.

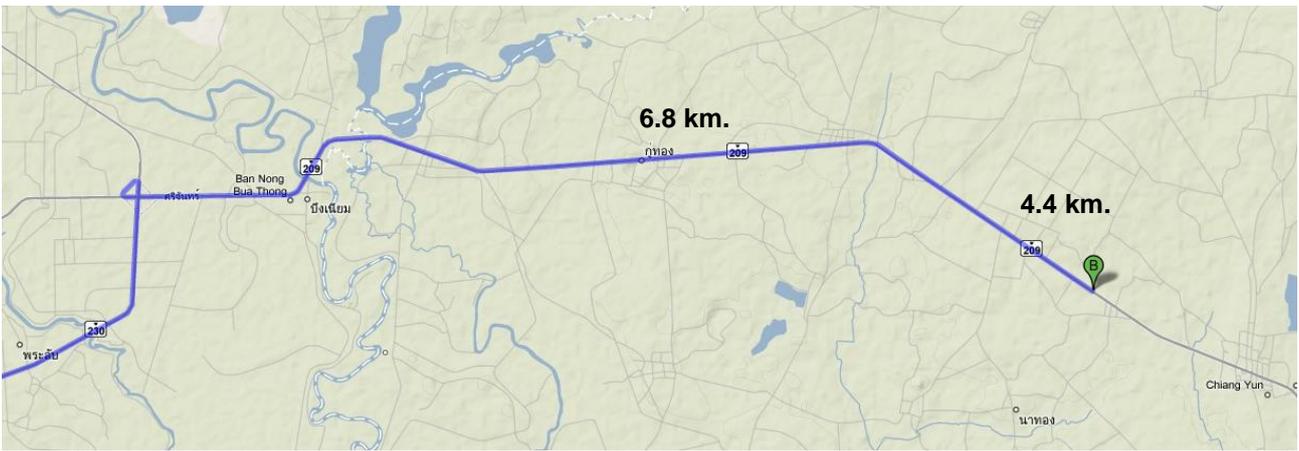
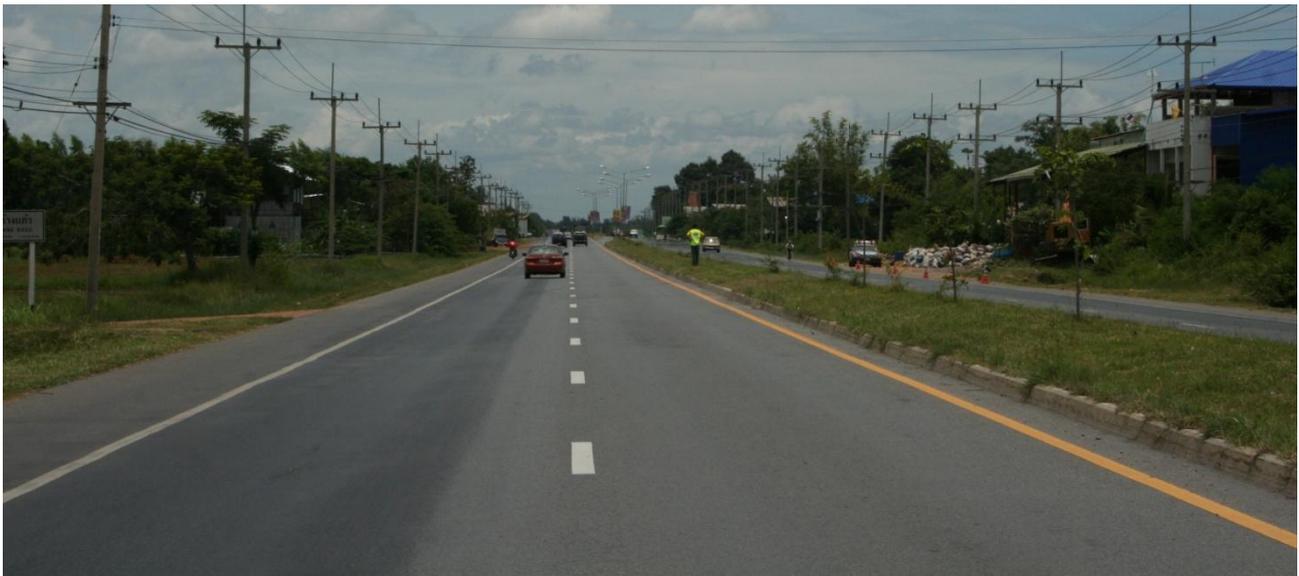
Figure 3-11: Long Straight Section of Highway Number 209

The driver lost the control of regular driving on the straight section of the road. As shown in **Figure 3-11**, the last ten kilometers has only one regular curve, 4.4 km. upstream from the accident scene. The road surface was asphalt and found dry with a friction coefficient 0.82 and 0.76 for the inner and outer lane respectively. The straight section was level grade with a cross slope of 3%.

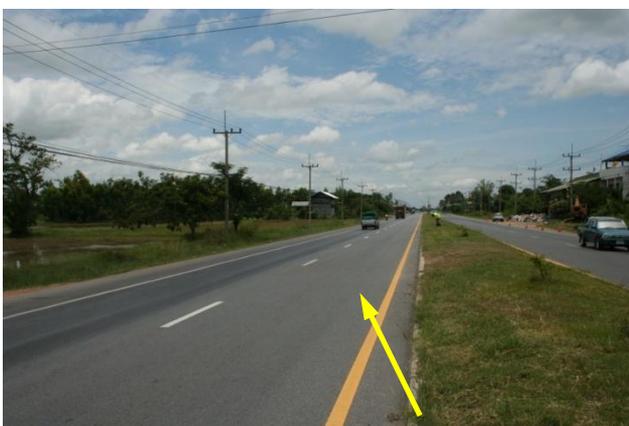
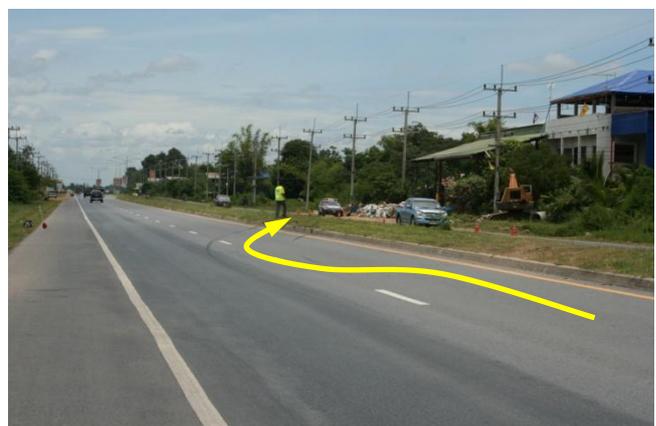
Figure 3-12: Evidence of Driving Behavior from Road Surface

After hitting the median curb at first, the pickup came left inside the road and traveled a short distance on the inner lane. Again losing control, the pick went into the raised median. The inattentive driving behavior could be illustrated in **Figure 3-12**, evidence gathered from the road surface and hit marks with the curb. However, the driver could have other alternatives to control the vehicle (e.g. decelerating by braking) to maintain its regular driving again.

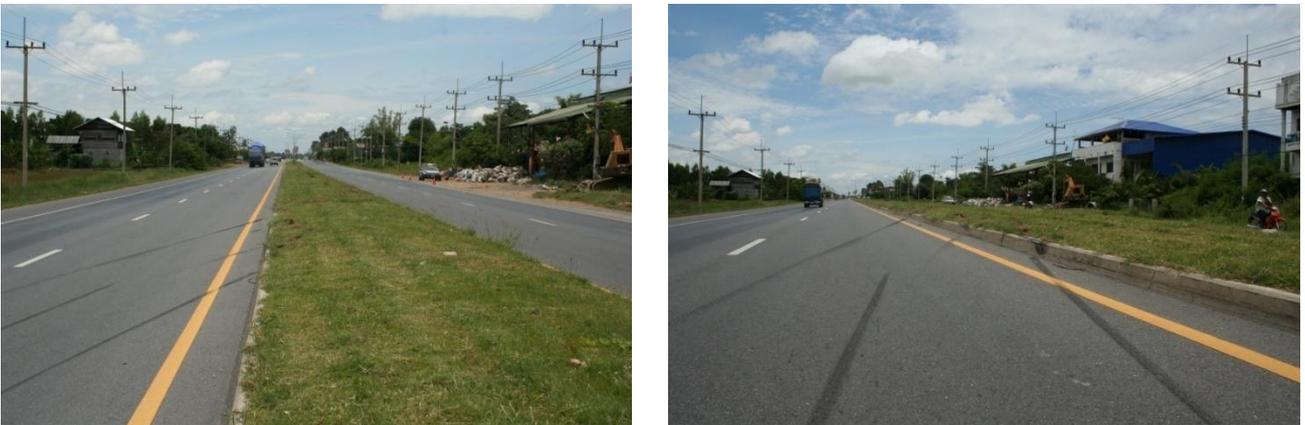
Figure 3-14: Yaw Marks Analysis Considering its Geometry

There were four yaw marks found during the investigation left by the four tires of the pickup. The yaw marks analysis considering the geometry of marks (i.e. chord length, middle ordinate, and radius) and the road surface conditions (i.e. friction, cross-slope) was conducted to determine the maximum cornering speed of the vehicle at the yaw.

Tire	Middle Ordinate (m)	Chord Length (m)	Friction, f	Radius of Curvature, R (m)	Yaw in Positive Grade: Critical Speed (km/hr)
Front Left	1.0	24.3	0.82	74.31	91.00
Front Right	0.4	27.4	0.82	94.81	102.78
Rear Left	2.7	51.8	0.81	198.15	147.51
Rear Right	0.9	31.1	0.82	134.78	122.55
