# Case ID: 081017-01

## Accident Narrative

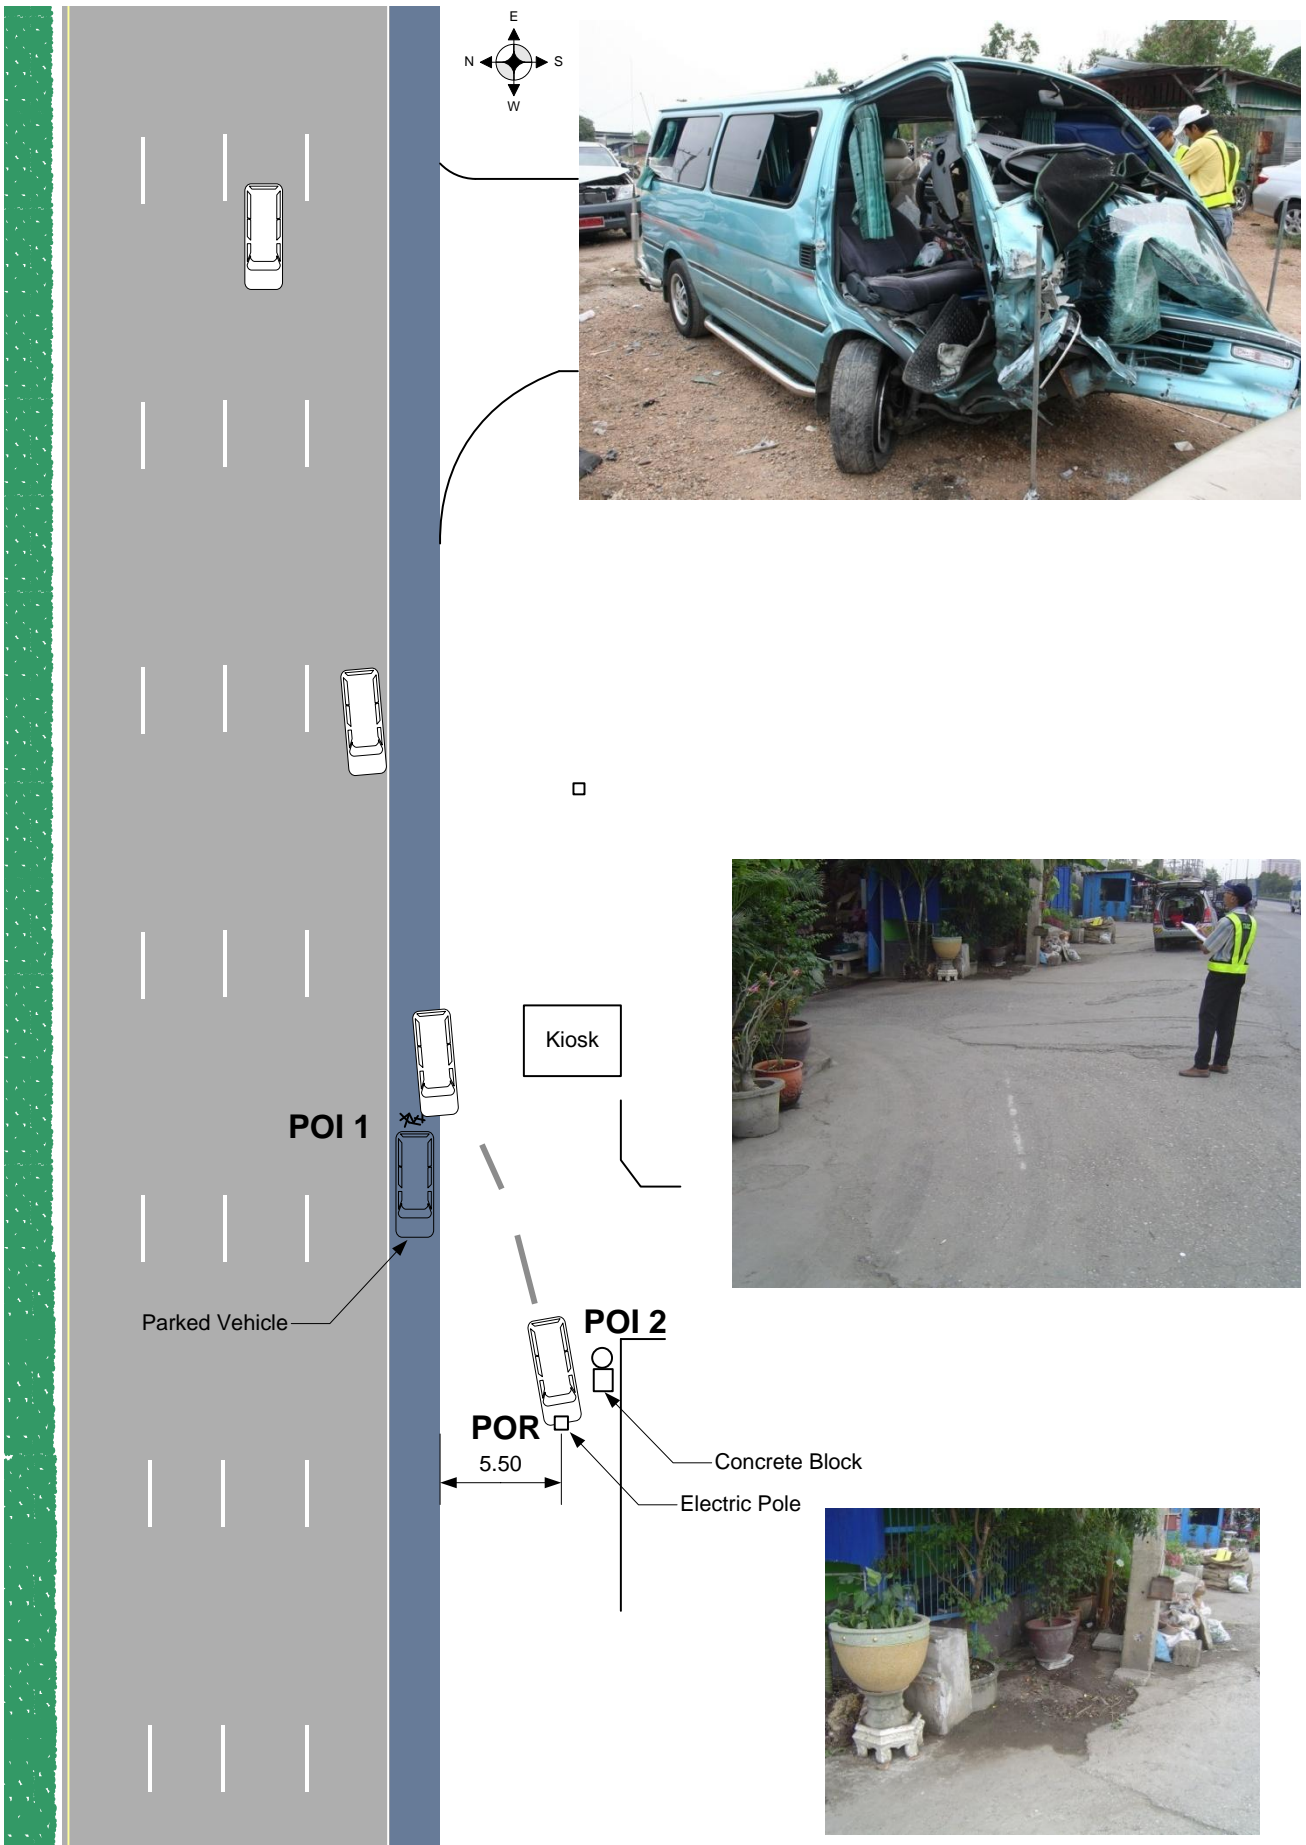
**Figure 3-2: The Damaged Van and its Two POIs and POR**

According to the witness, there was another van parked along the shoulder in front of the garbage workshop. The van traveled from the interchange, ran off the roadway and hit the rear of the parked van. It then swayed to the left. At this stage, the van left a 7.8 m. scratch mark on the ground, probably resulting from the solid part underneath. The van continued towards the gate of the shop and hit the concrete tree pot, 38 cm. in radius and a concrete sculpture causing damage to the left sliding door. The van then rebounded into the 30x30 cm. electric concrete post considered as Point of Rest (POR) causing massive damage to the front. It got stuck at this POR and required a rescue team to evacuate the driver to the hospital.

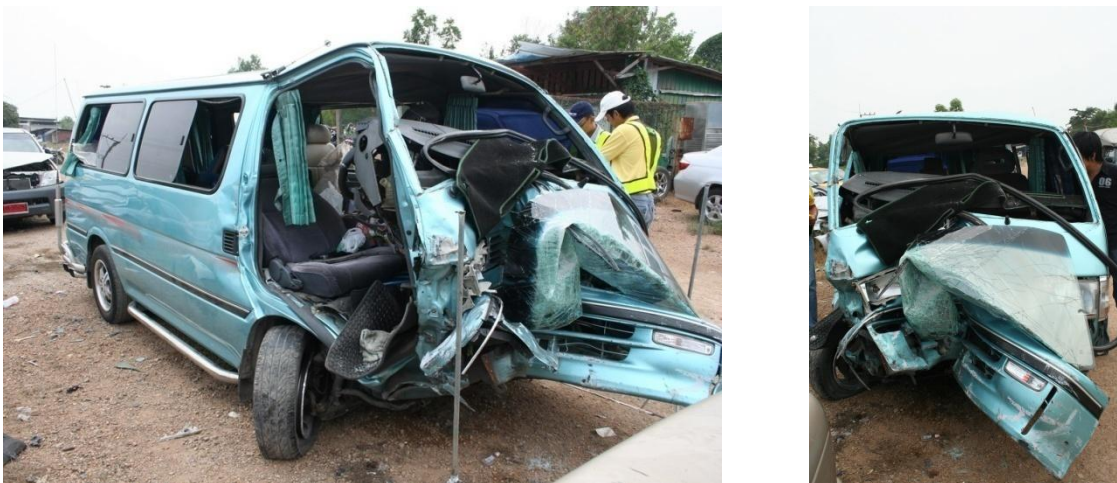
The exterior damage from the crash shows particularly on the front right of the van (**Figure 3-4**). The front bumper was imprinted by the concrete column at the middle of the car. The front beam and axle was bended by the frontal intrusion. The windshield was shattered and dislodged from its position. The A-pillar and roof on the driver side was slightly bent while the driver's door was separated during the rescue. The detail of the frontal deformation is presented in **Table 3-2**. Another damage occurred on the left sliding door. There were scratch marks and a light deformation made by the impact with concrete objects.

**Figure 3-4: Frontal Deformation of the Van**

Location	Width	Height	Depth Profile						Offset	CDC
			C1	C2	C3	C4	C5	C6		
Front	75	110	0	20	27	33	13	0	8	12FZ1EN6

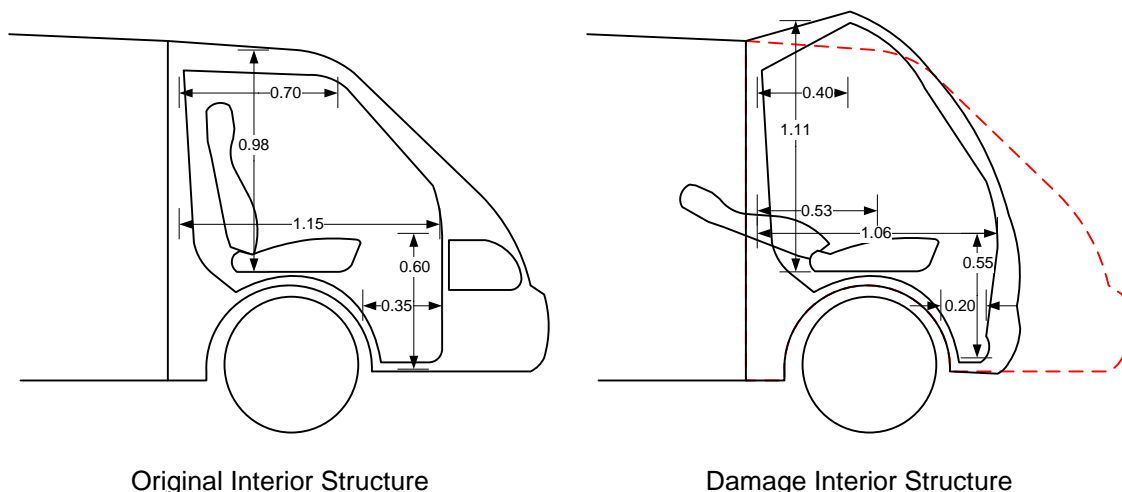
The frontal intrusion pushed the console close into the driver seat. The deformed modified steering wheel possibly collided with the driver. All the control gauges were missing through the impact with the steering wheel. The lower part, including the pedals was almost displaced into the driver’s seat, only a small space was left underneath. Blood stains were found on the steering wheel, the console (near the music player and gear box) and the driver’s seat. There was no other damage to the other seats. **Figure 3-5** compares the interior dimension between original and crashed vehicle.

**Figure 3-5: Interior Damage**

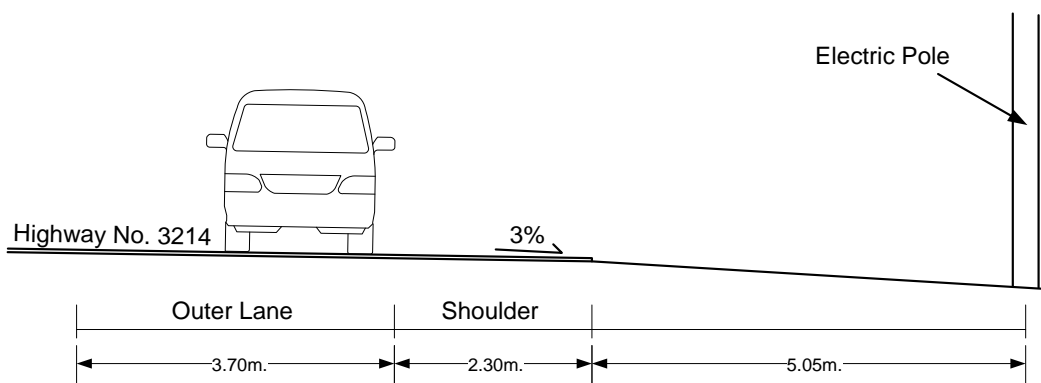
## Figure 3-6: Cross Section of Highway No.3214

Highway No.3214, 15 km. long, connects the East-West corridor between Highway No. 347 and Highway No.3010 in Klong Luang, Pathumthani. The crash occurred in the area of the Klong Luang Interchange. It was an 8-lane divided road, 3.7 m. lane width concrete pavement and 2.3 m. shoulder asphaltic concrete. There was a 3% crown slope with a 0.6 coefficient of friction. **Figure 3-6** shows the cross section of Highway No.3214 at the area of crash.

On the left of the road, the garbage workshop is located about 8 m. from the shoulder edge. The space between the shoulder and the shop was paved with asphaltic concrete material. There were concrete sculptures and tree pots close to the gate while an electric pole was installed 5.05 m from the shoulder edge.
