Crash ID: 150221-01

Accident Narration

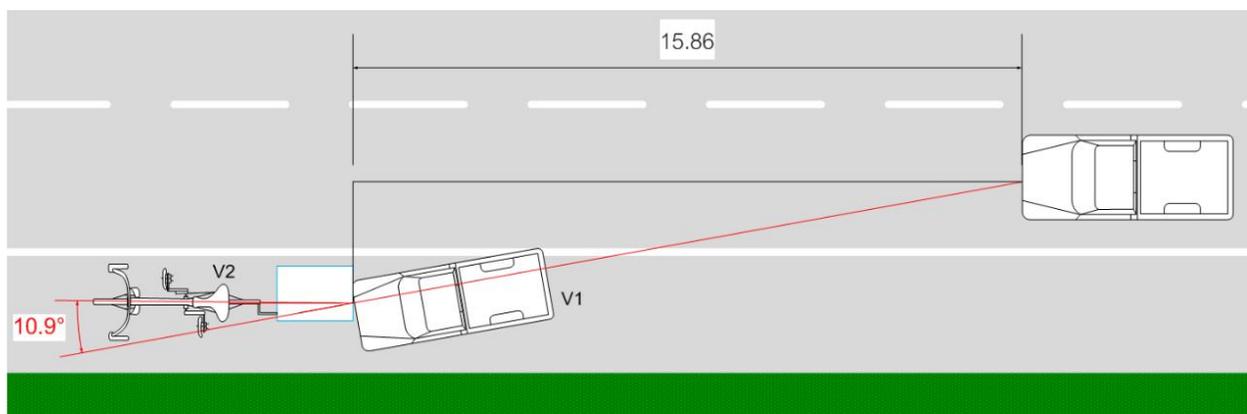
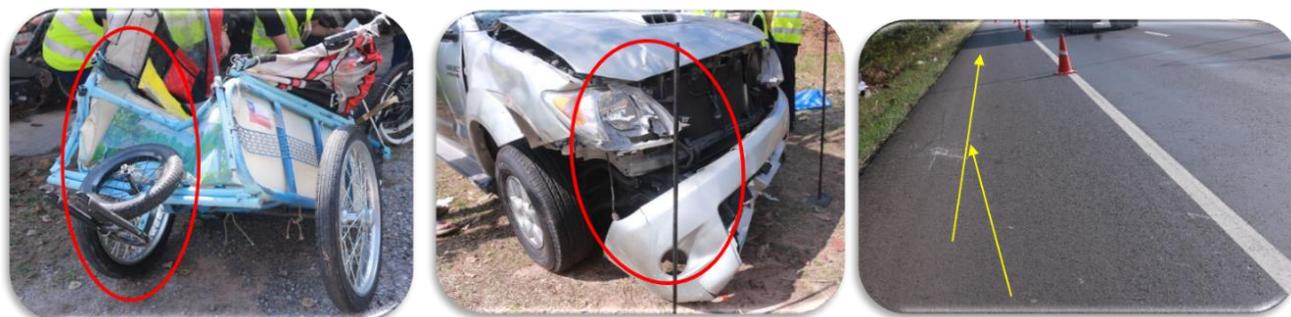
Figure 6 Heading angle of the crash

The heading angle was calculated by looking at the evidences like contact point between pickup and carriage during the crash as shown in **Figure 6**. It was observed that the right front part of pickup hit the left rear part of bicycle with the heading angle of 10.9 degree. This indicates that the pickup took 15.8 m distance at the onset of overtaking to collision.

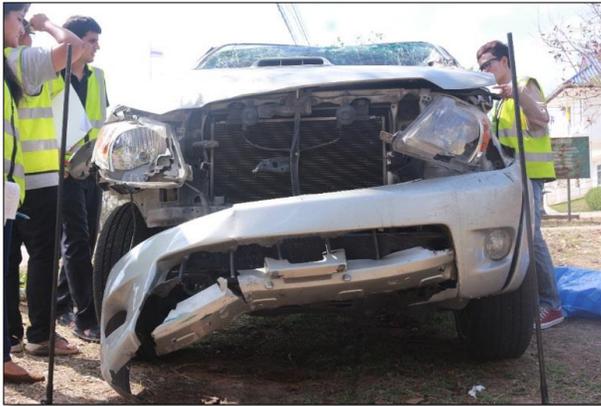
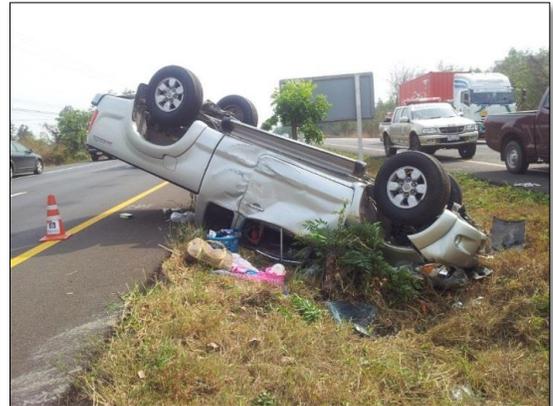
Figure 11 Damages of the pickup (V1)

The pickup had a massive damage on its front part as shown in **Figure 11 & Figure 12**. Front bumper was damaged due to impact. Bumper on right side was hanging, while on the left side was intact. The roof was deformed due to overturning and the supporting pillar were deformed from original position. In addition, the front windshield was broken and hood was panned up. There were several scratches on the left side of the pickup (**Figure 14**), which was due to sliding of pickup before overturning. **Figure 13** shows the damage condition of the pickup in all directions.

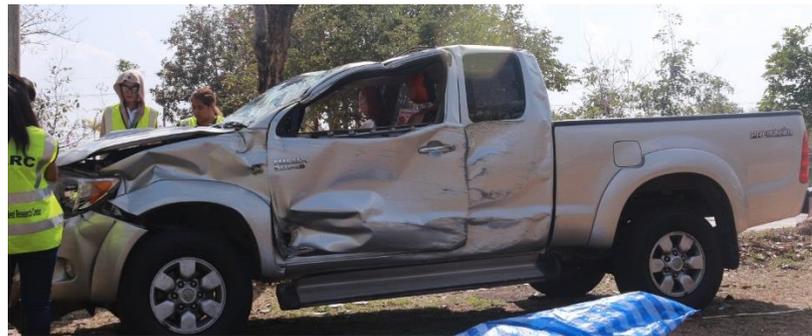
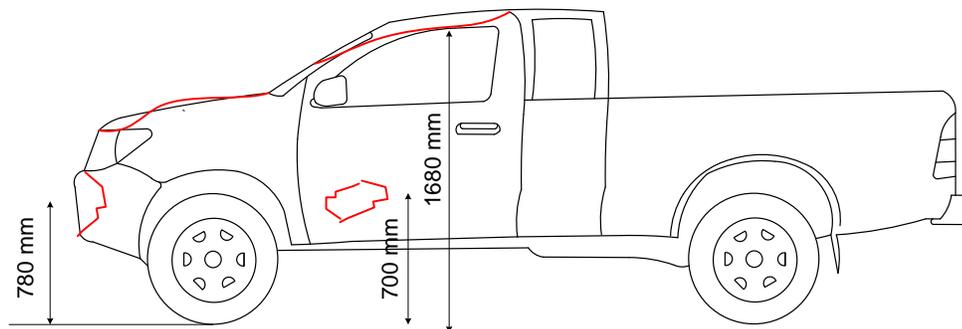
Figure 14 Critical damage and their height from ground level

The critical damage in the pickup was on the frontal and left side as can be seen in **Figure 14**. Deformation of 600 mm was observed on the front frame at a height of 780 mm from ground level and at a distance of 700 mm from the right front corner of the pickup. Furthermore, there was a dent on the left side, below the door at a height of 700 mm from the ground level. **Figure 14 & Figure 15** show the damages and deformation of the pickup with dimensions.

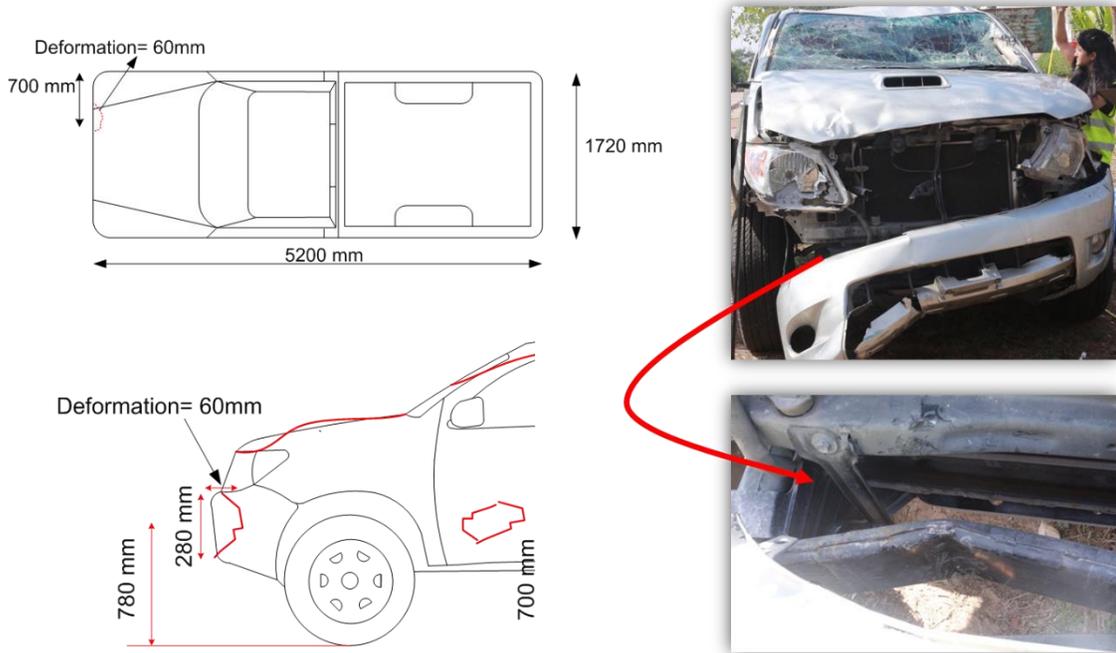
Figure 15 Deformation of the front frame of the pickup

The 60 mm deformation on the frontal frame of pickup indicates that some energy might have dissipated during the collision. Hence, the pre-crash speed of the pickup can be estimated as: 81 to 85 km/hr.

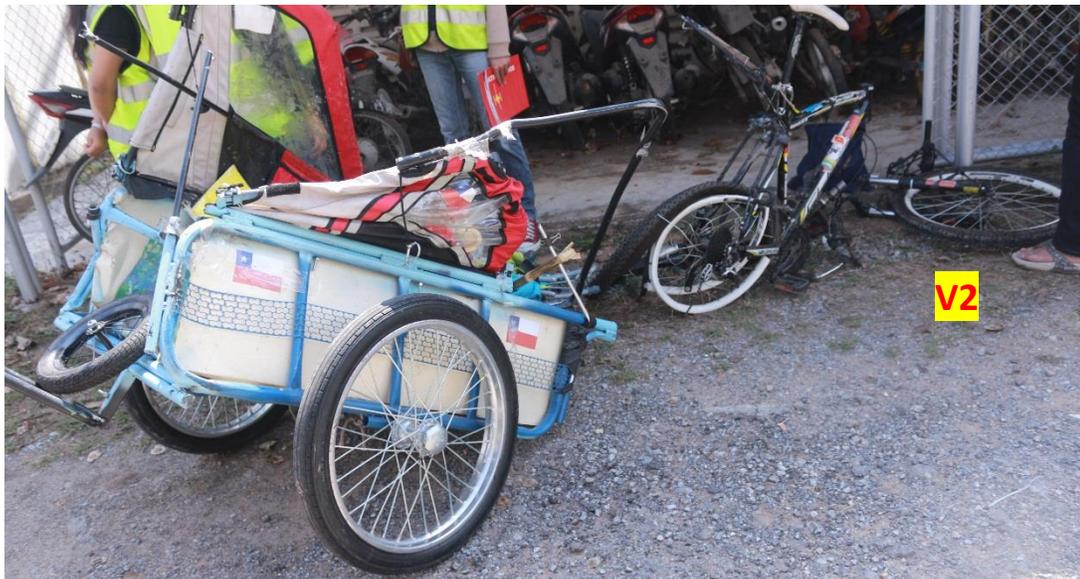
Figure 16 Damage of carriage

The bicycle with carriage (V2) sustained heavy damages in frame and rear wheel as shown in **Figure 16 & Figure 17**. There was a deformation of 240 mm on left rear side of the carriage. Also, the metal rod connecting the bicycle and carriage was broken by the impact. The handle of the bicycle was broken and the rear wheel was massively damaged (**Figure 18**).

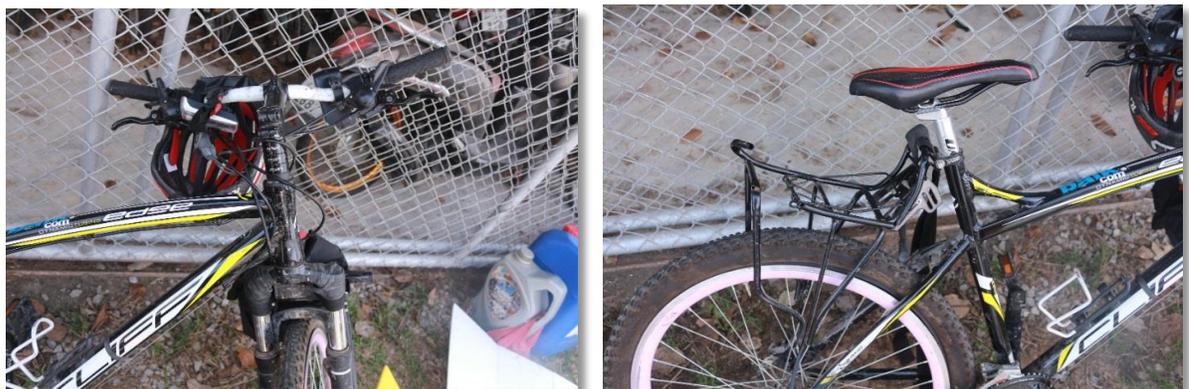
Figure 19 Damages of V3

Another bicycle (V3), which was ridden by female had comparatively less damage than V2. The handlebar of the bicycle was broken and both tires were flat. Also, pillion seat bar was deformed by the impact as shown in **Figure 19**.

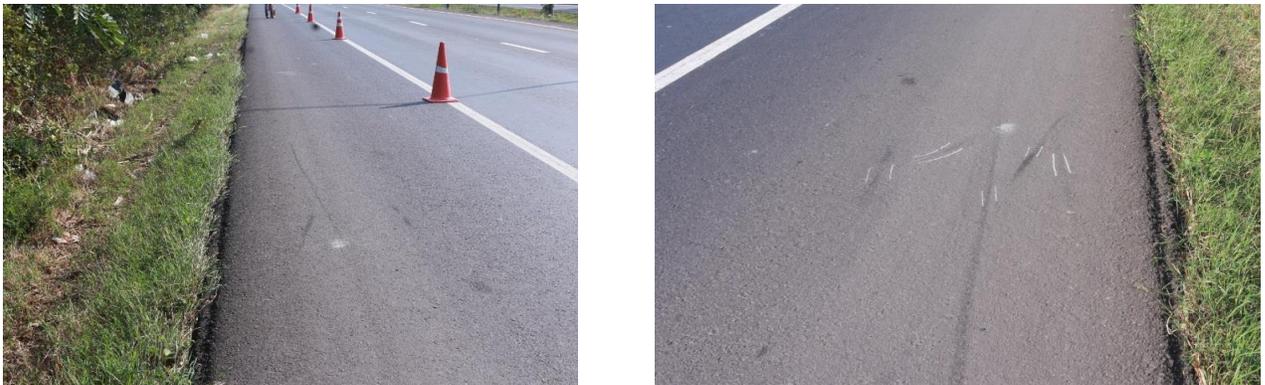
Figure 24 Evidences showing POI

- i. There were several scratches, skid marks of bicycle & carriage, and markings by police present in the crash scene indicating the point of Impact (POI) as shown in **Figure 24**.

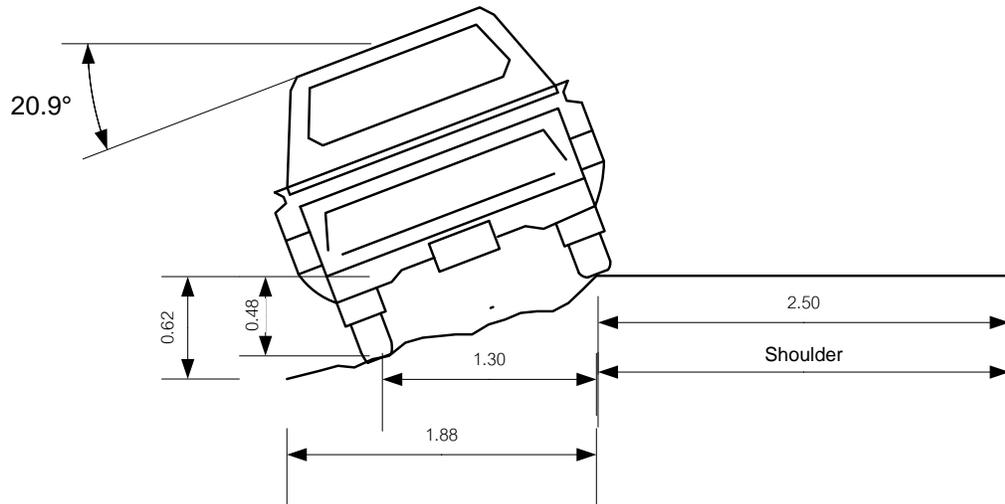
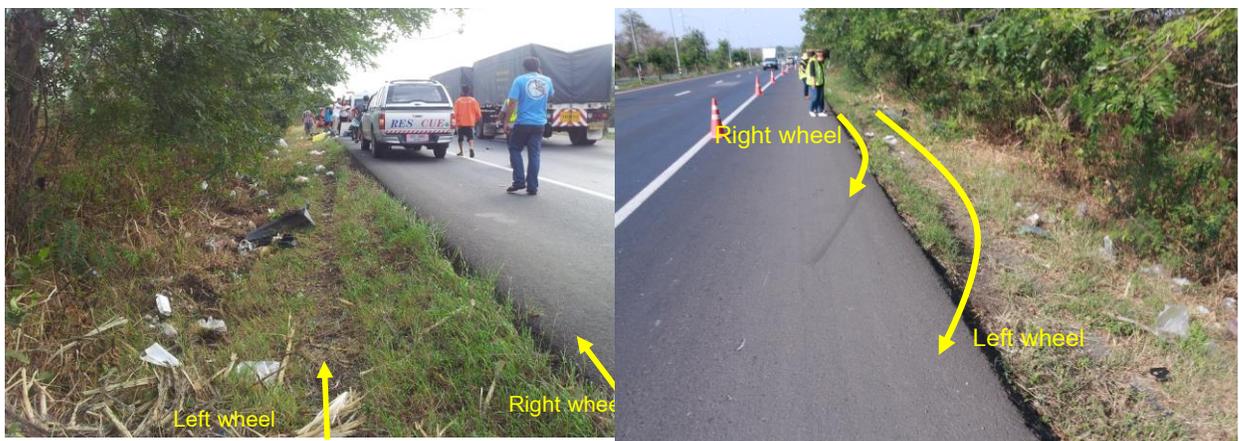
Figure 25 Tire marks (22 m) leading to skid and yaw marks

- ii. After the Point of Impact, there was a 22 m long tire marks on the road side slope that leads to yaw marks on the road pavement as shown in **Figure 25**.

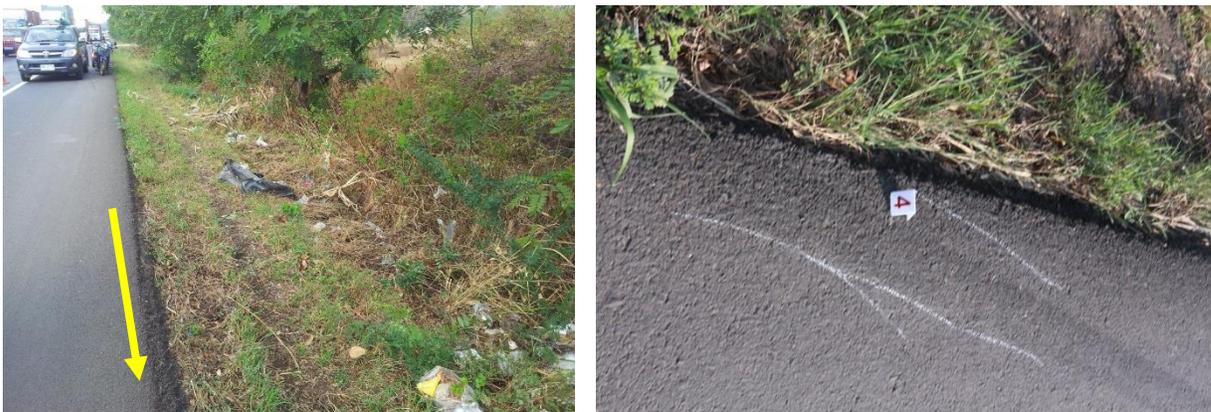
Figure 26 7 m long skid marks on the edge of shoulder

- iii. Following the tire marks, there was a 7 m long skid marks on the edge of shoulder indicating that while running off road, the pickup applied brake before swerving to right as seen in **Figure 26**.

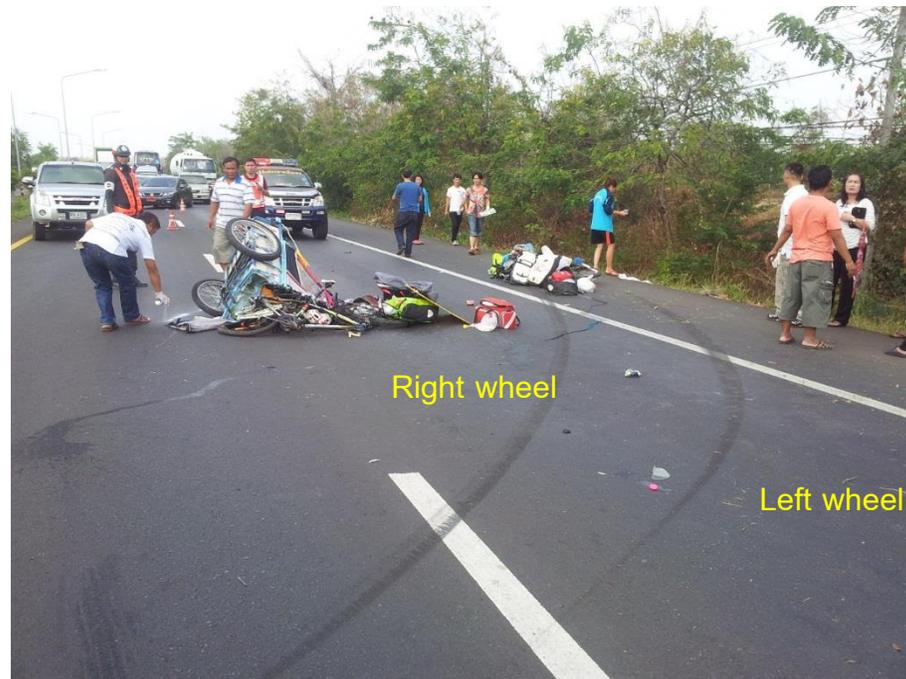
Figure 27 Yaw marks starting from edge of shoulder

- iv. Preceding to skid marks, there was a 21 m long yaw marks on the pavement surface (**Figure 27**), which indicates that, after the pickup lost control and run off into the shoulder, the pickup applied brake and swerved to the right in order to recover, and then overturned to the other edge.

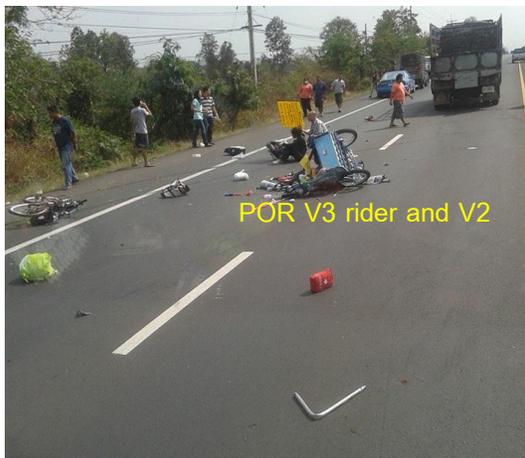
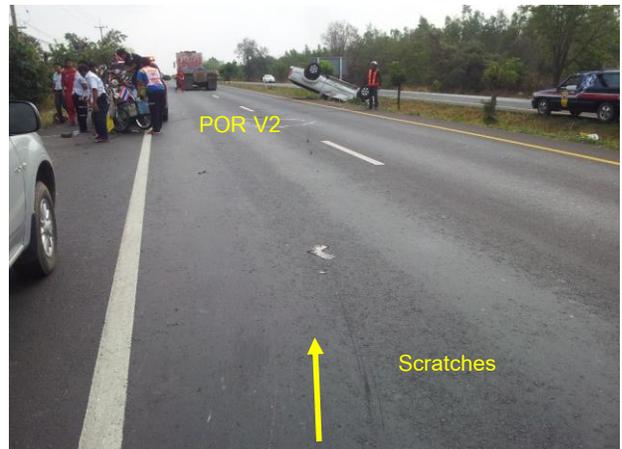
Figure 30 Broken metal rod (left) and scratches on road surface (right)

Similarly, **Figure 30** shows the broken metal rod after the impact, POR of V3's rider and the scratches leading to the POR of V2. These evidences indicate that after the impact, the carriage disconnected from the bicycle and slide towards the middle of the road. **Figure 31** demonstrates the summary of physical evidences that were collected in the crash scene after the accident.
