Case ID: 060815-01

Accident Narrative

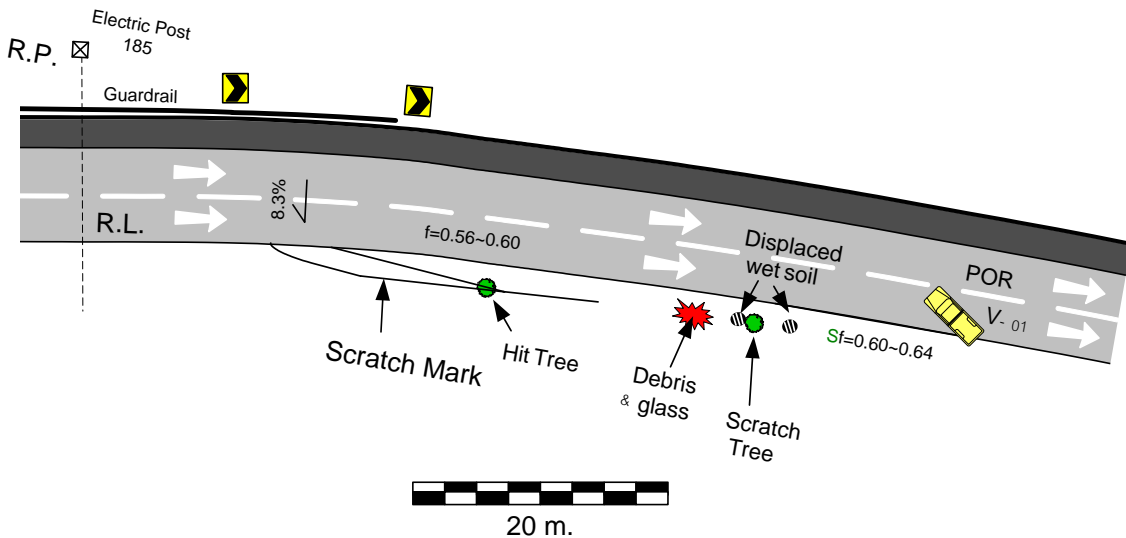
Figure 3-2: Schematic of Accident Scene

On the rainy day of Tuesday, 15 August 2006, at about 14:25 the pickup, traveling eastbound on highway no. 209, a four-lane divided highway, near Chiang Yeun, Mahasarakham (**Figure 3-1**), lost the control and rolled over into median. The vehicle, finally stopped in on-wheel position, heading backward to the oncoming direction. The schematic of the accident scene is shown in **Figure 3-2**.

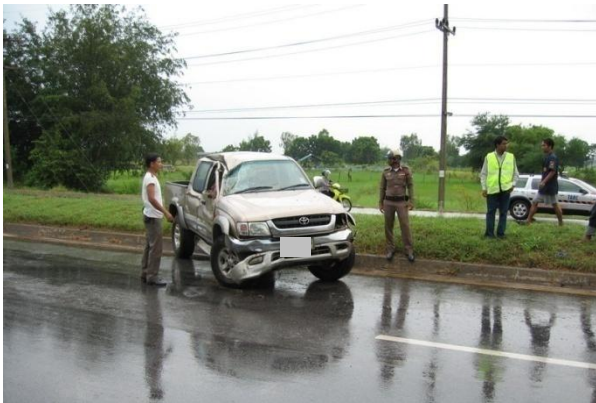
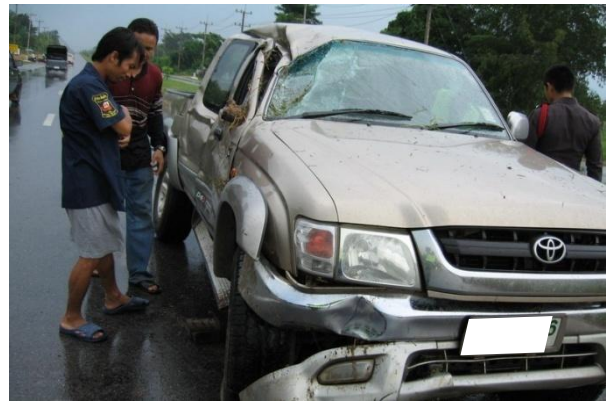
Figure 3-3: Vehicle Position and Its Damage

The post crash vehicle showed substantial damage on the right side, especially around the driver's compartment area, as shown in **Figure 3-3**. The roof was deflected downward at the driver's seating position. The right A-pillar was deformed inwardly into the driver, causing the windshield to be damaged. The intrusion started from the right door and extended to the cab compartment. The front bumper was displaced at the front right corner. The right rear view mirror was also missing. On the left side, the head lamp and left turning signal were missing. TARC evaluated the Collision Deformation Code (CDC) for the pickup as **02RY1AO3**.

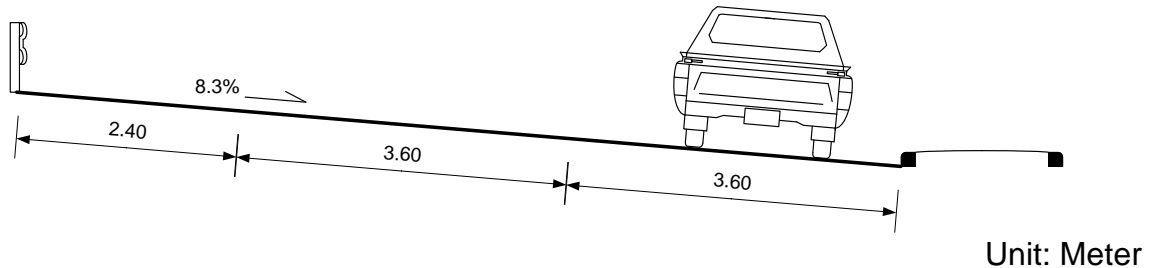
Figure 3-5: Highway Number 209 Cross Section at the Crash Scene

The accident occurred on the westbound lane of Highway No. 209 in Chiang Yeun, running from Khon Kaen to Kalasin. The right curve section of the two lanes eastbound and the two lanes westbound are divided by a 4.1 m. raised median. All lanes are 3.6 m. width, with a 2.4 m. outside shoulder. The asphalt pavement, during the investigation, had a coefficient of friction of 0.56 with an 8.3% super-elevation, as shown in **Figure 3-5**.

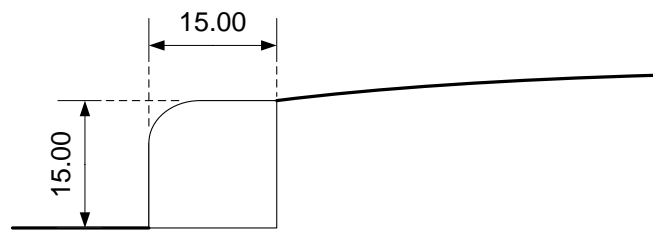
Figure 3-6: Raised Median at Crash Scene

The raised median was constructed as a concrete curb, in the middle along the roadway. It was located about 30 cm. apart from the yellow-inner lane line, with 4.1 m. in total width. The height of the curb was 15 cm., as illustrated in **Figure 3-6**, from the road surface. It was filled with soil and covered by grass. The coefficient of friction showed 0.64.

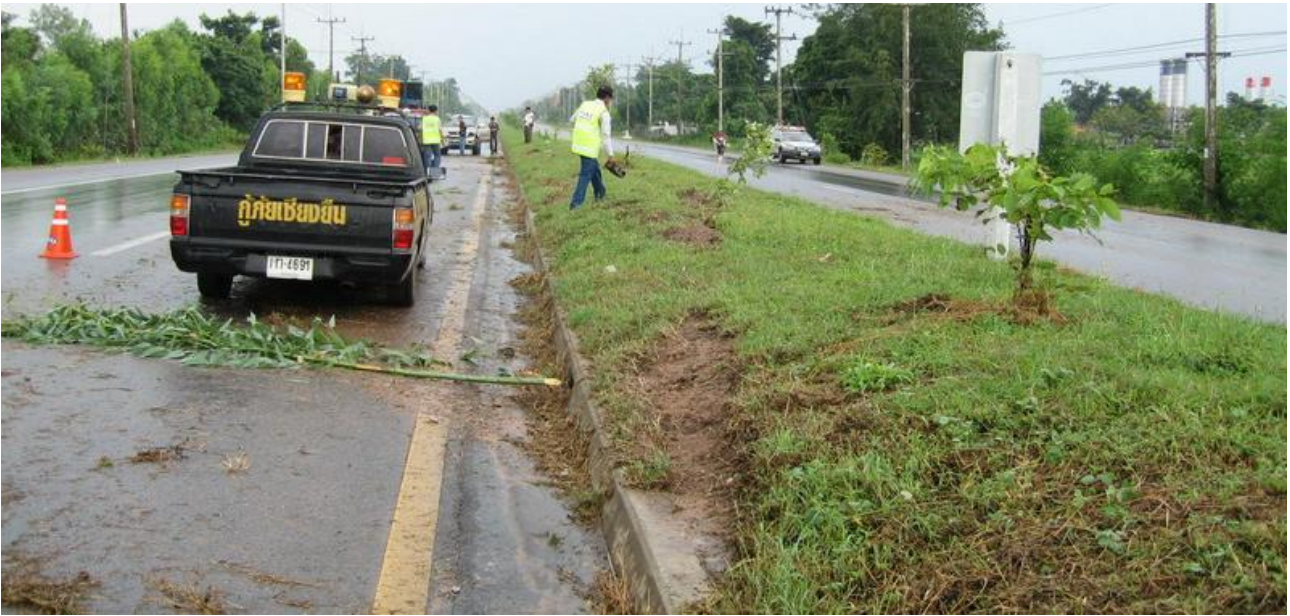
Figure 3-7: Evidence on the road

An electric pole no. 185 was selected as a reference point. No tire marks were found around the crash scene. Several gouge marks were found on the grassy median, as a path of vehicle roll over. It started 14.7 m. from the reference point. From the beginning of the mark until the point of rest of the vehicle the total distance was 66.8 m. One small tree on the median was damaged due to vehicle's impact. **Figure 3-7** shows the traveling path at the crash scene.

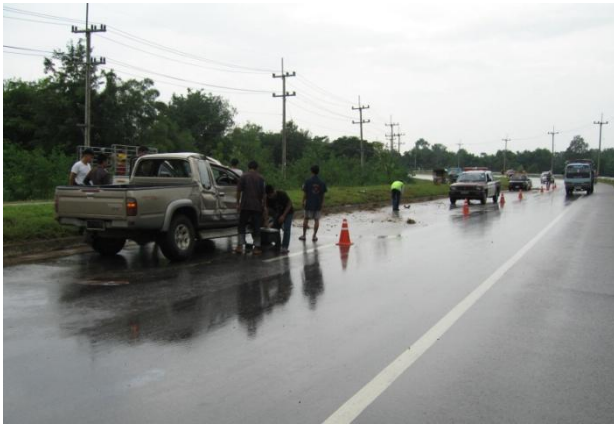
Wet Surface

The road surface was found to be wet during the crash. The coefficient of friction was measured along the direction of travel of pickup to be 0.56-0.60. The road was a horizontal curve of 377.5 m. in length with a super-elevation of 8.3%. The 2-lane 2-way raised median divided highway had a 226.5 m. guard rail along the curve as shown in **Figure 3-8**.

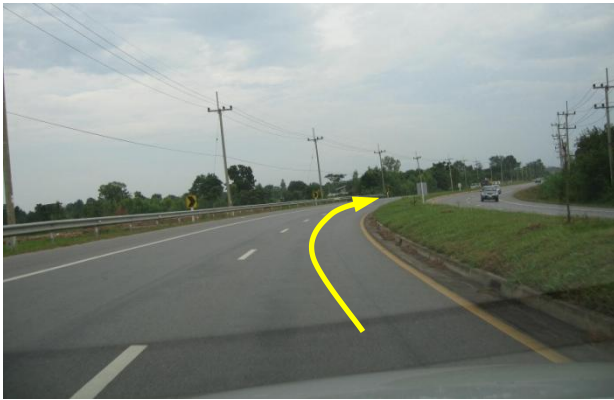
Vehicle Movement into Median

The traveling path of the pickup showed over steering while negotiating the curve, showing that the radius of the travelling path was less that the radius of the traveling lane. Over steer is a phenomenon that can occur in an automobile which is attempting to turn, when the rear wheels do not track behind the front wheels but instead slide out towards the outside of the turn. It can throw the car spinning over the traveling direction.

To overcome an improper steering maneuver, recently, EURONCAP has introduced Stability Control, the electronic sensors, when a driver is about to lose control by detecting the differences between a car's course and the driver's intended direction. The system has been developed from other technologies such as ABS brakes and traction control. By selectively applying the brakes to individual wheels, Stability Control helps the driver to maintain control of the car and to steer safely. This can make the difference between an accident and a near-miss (Euroncap.com).

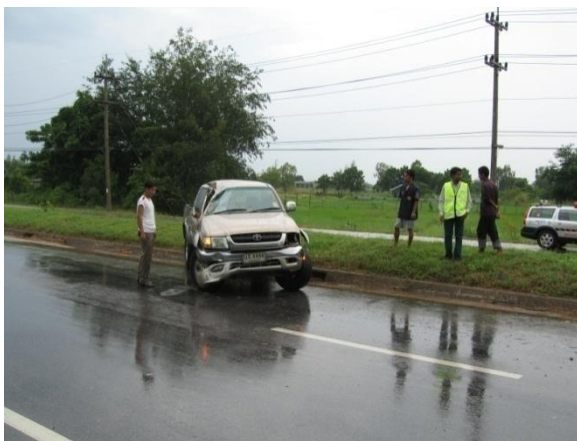
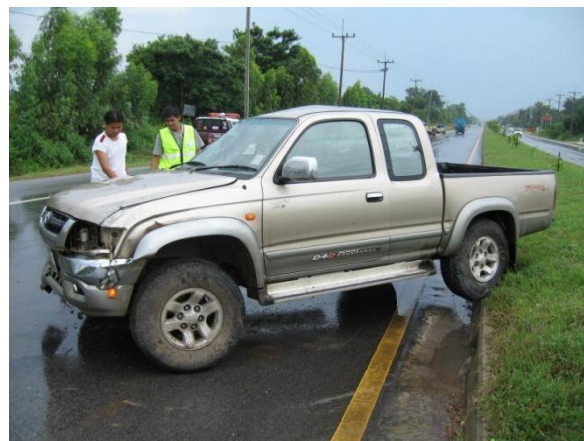
Figure 3-10: Final rest Position of Pickup after Rollover

The pickup went inside of the raised median and made a right turn full rollover (360°). From **Figure 3-10**, the final rest position of the pickup was on the four wheels partially inside of the median and inner lane of the highway. The vehicle showed most damages on the right side.

Thailand Accident Research Center determined that the contributing factor of the 060815-01 crash was the improper driving maneuver while negotiating the curve in wet surface conditions. The contributing factor to the crash severity was the vehicle roll over which occurred after hitting the median curb. All these factors combined as a chain of events.
