Case ID: 060829-01

Accident Narrative

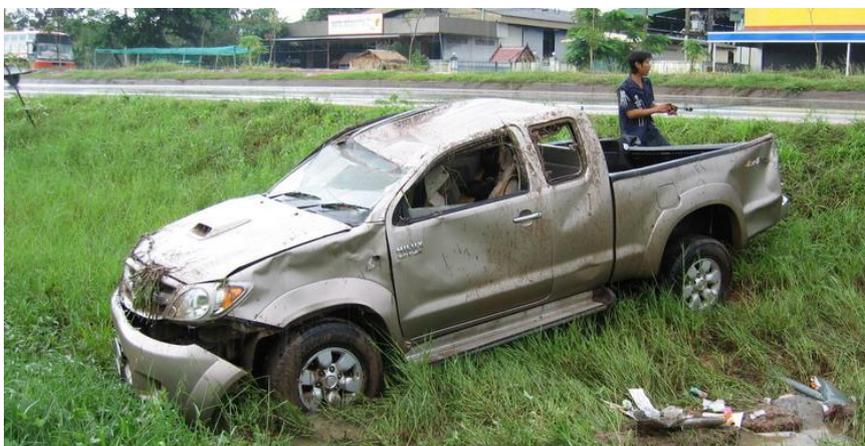
Figure 3-3: Damage on the Vehicle Roof

The post crash vehicle showed substantial damage on its roof (**Figure 3-3**). The roof of the pickup was entirely deflected downwards, damaging the A-pillar that supported the roof. Several intrusions were found also on the left side of the vehicle's body, including the part above the front-left wheel, left door, and cab compartment. The front bumper was deformed directly on the left.

TARC evaluated the Collision Deformation Code (CDC) for the pickup as **12TY1GO2** for roof deformation and **06BD0EN2** for rear deformation.

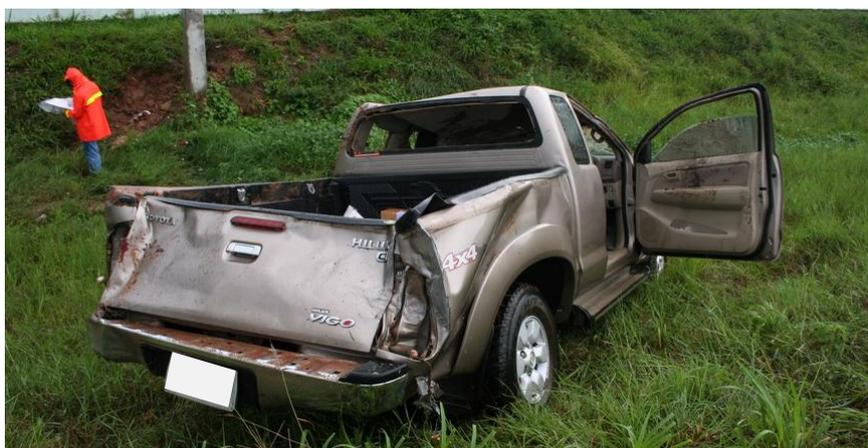
Figure 3-4: Damage to the Rear of the Pickup

However, there was also massive damage at the rear part of the vehicle (**Figure 3-4**). The rear-right corner was crushed inwardly. The vehicle's body between the occupant's compartment and the pickup was displaced, it moved rightward, deflected from its original position. **Figure 3-5** shows the alignment of the vehicle on the right side. After closely measuring the crush on the rear-right corner, examining the crash scene, and discussing with the driver, it was found that the vehicle had hit the concrete electric pole before stopping at the rest position.

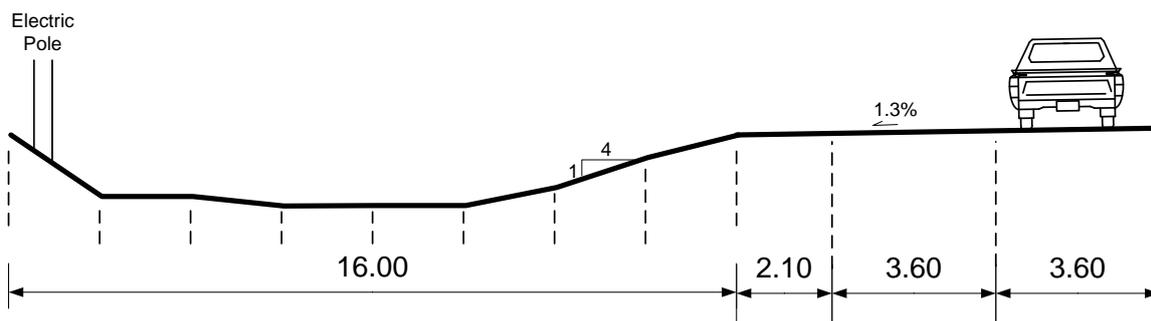
Figure 3-7: Roadside Embankment at Crash Scene

The grassy soft clay roadside embankment had a slope of 4:1. It had 16 m of total width. The embankment profile is shown in **Figure 3-7**.

The pickup was found to have made a 1-full turn and a 0.25-turn with its rest position on its left side, showing that it rotated and spun over three-axis, supported by the marks on the ditch and at the electric pole. The roadside slope, 4:1, was not “errant-friendly” for the loss of control of the vehicle. In addition, due to rain and low lying ditch the water accumulation made the soil softer than usual in the dry season. This soft soil might have caused imbalance of the errant vehicle resulting in roll-over. **Figure 3-14** shows the location of the vehicle rollover after leaving the roadway.

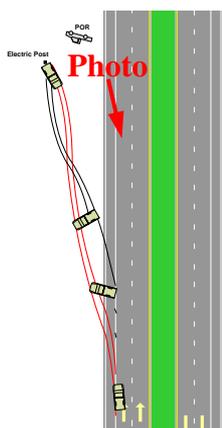
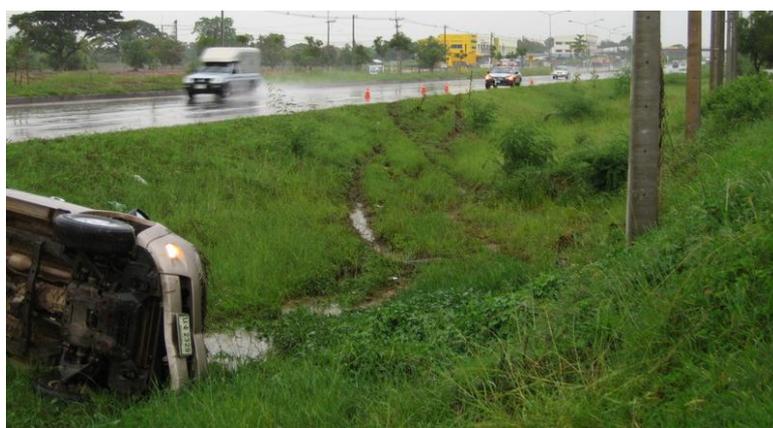
Figure 3-8: Rollover Orientation

The vehicle's traveling path was clearly shown on the wet road surface. The pickup left the roadside 4.8 m. after the reference point, from its right. It started rolling over near the cross-over of the tire mark between the front and rear axles. The path showed that the pickup continued to move towards an electric pole.

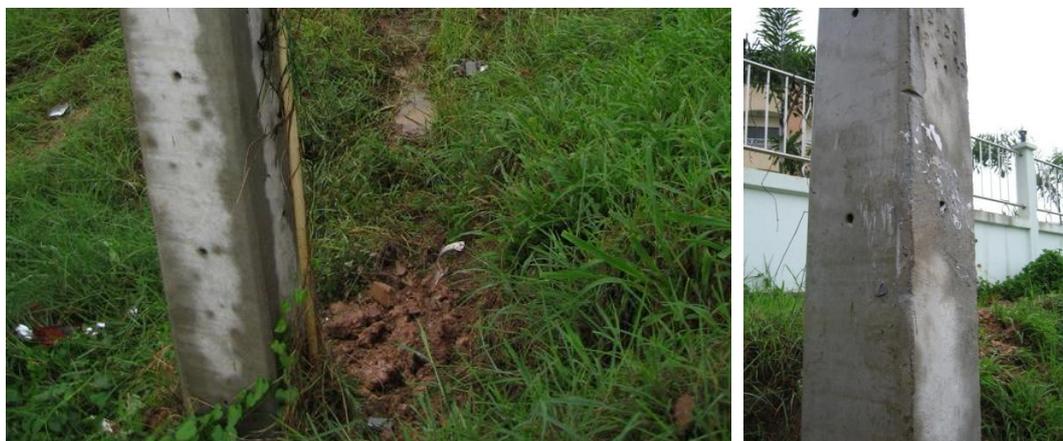
Figure 3-9: Evidence found at the Electric Pole

By closely examining the electric pole, some damaged parts from the vehicle were found, including the right turning signal, braking light, and turning signal. The mark on the electric pole printed by the vehicle's paint was found at a 1.50 m. height from the ground, as shown in **Figure 3-9**.

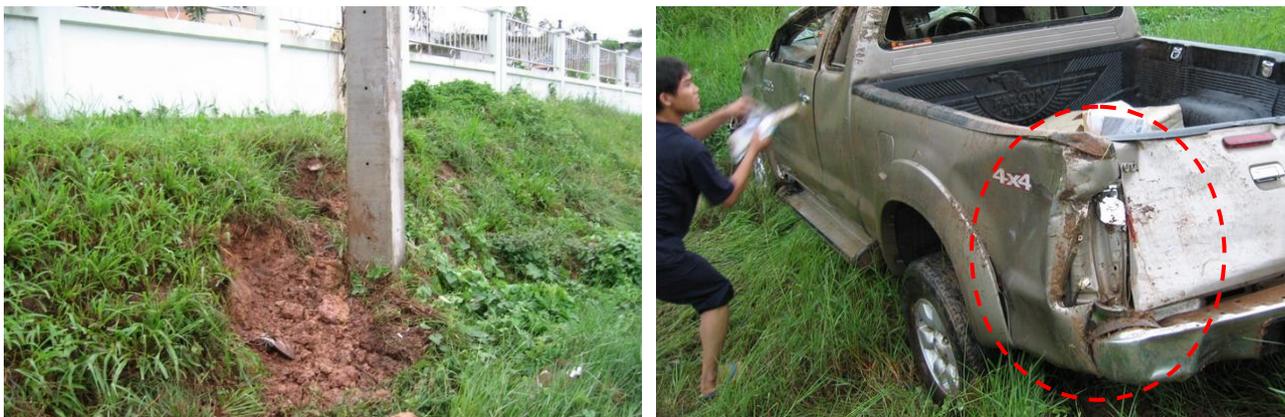
Figure 3-10: Crash Position with the Electric Pole

Figure 3-10 shows that the excavated gouge at the bottom of the electric pole matched with the gouge soil stuck around the rear-left corner of the car.

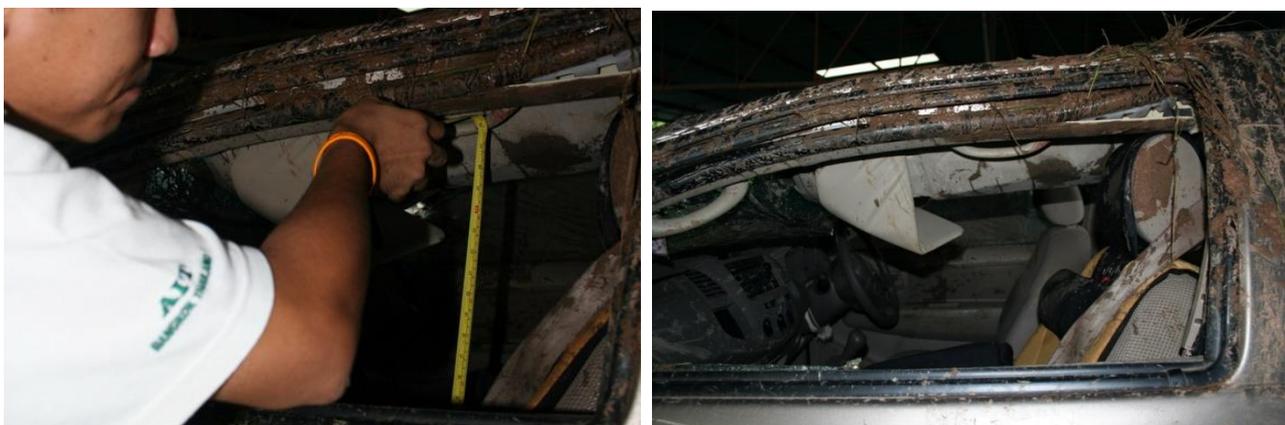
Figure 3-11: Marks showed on the front passenger's seat

The interior damage at the front showed blood stains on the front passenger hand-hold fitted on the roof near the passenger door, at a height of 70 cm from the seat after the crash (Figure 3-11). Blood was also spread into the bent passenger sun visor. The deformed roof remained 62 cm. high, measured from the seat (Figure 3-12). The detail of victims' injuries is shown in Table 3-2.

The belted driver did not receive any injury. The front belted passenger however, was reported to be seriously injured to the head. The contact point between her head and the vehicle’s interior was indicated by blood stains on the passenger’s hand-hold and sun visor.

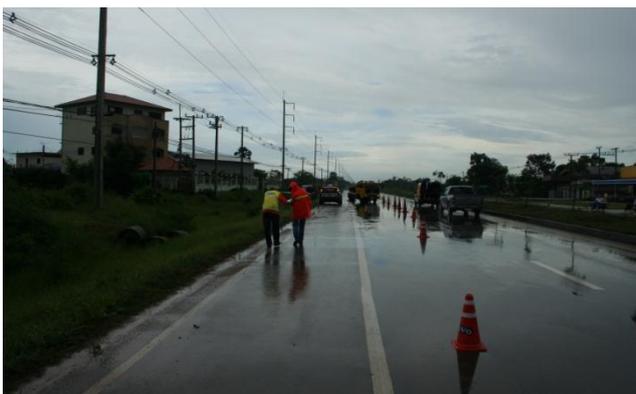
There was a small film of rain-water (i.e. slash) on the surface, as presented in **Figure 3-13**. The slash was found accumulated on the undulated surface near the shoulder of the outer lane. The coefficient of friction was measured as being 0.52-0.60 on the wet surface.

Rain-water Accumulation on Undulated Surface

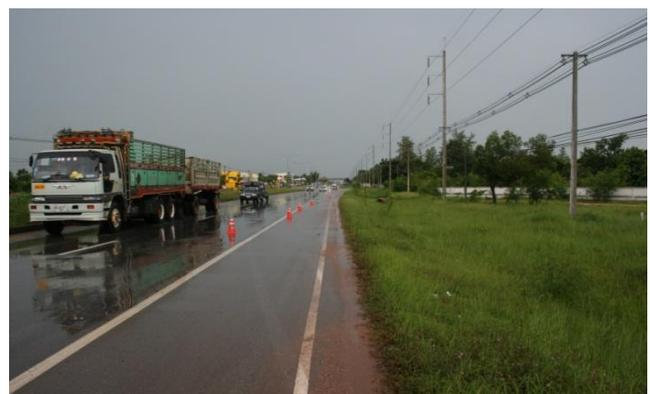
Thin Water Film on Road Surface

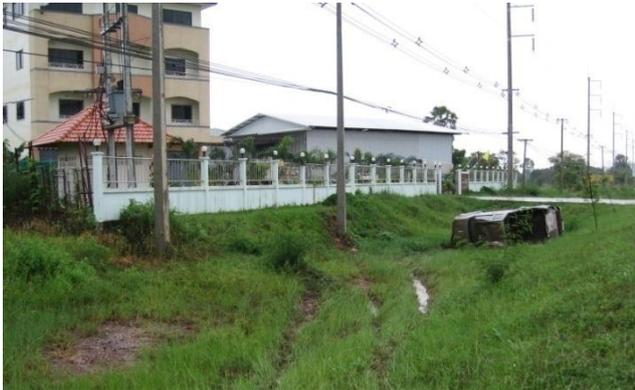
Soft Soil and Water leading to POR

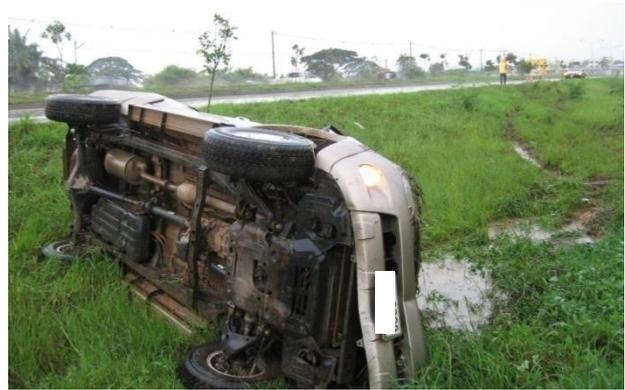
Presence of Water in the Ditch
