Case ID: 080126-01

Accident Narrative

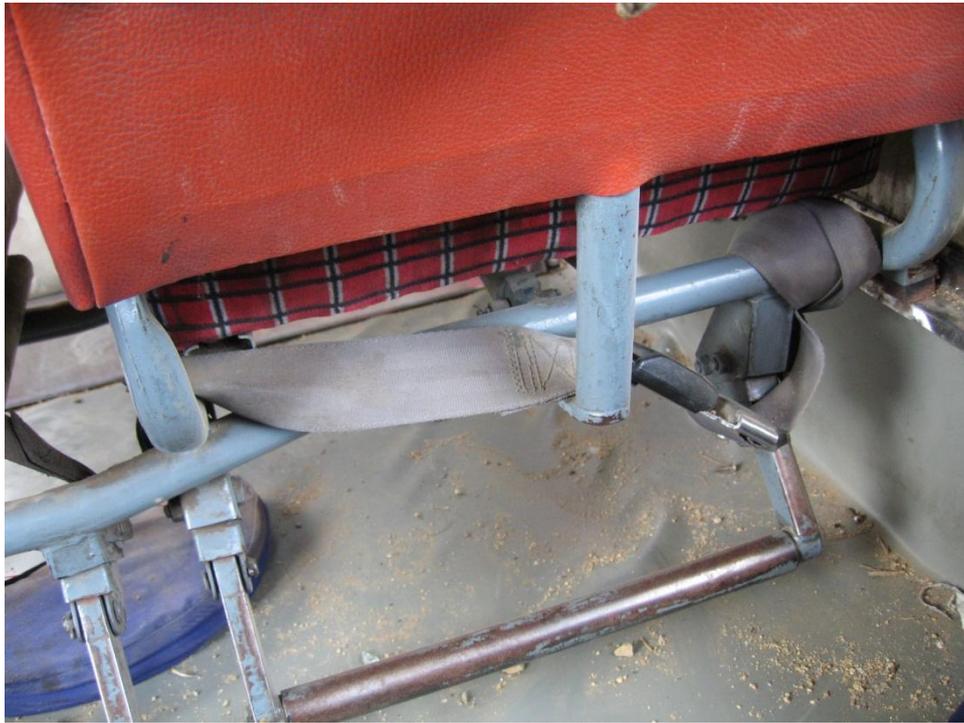
Figure 3-8: Seatbelts

In total, there are 45 seats available on this bus. The seating configuration consists of 10 rows with 19 set of passenger seats. The eleventh rows comprises of five seats connected to each other. The seating pad was measured 0.46 m high from the walkway. The entire seats equipped to the bus body by a set of 4 bolts (**Figure 3-7**). There are seatbelts installed at the first row but they were fastened behind the seats (**Figure 3-8**).

Four passengers were reported ejecting from the bus and found dead underneath the wreckage bus. All passengers revealed not use the seatbelt. However, there is only 4 seatbelts available on the front row but there were fasten behind the seats

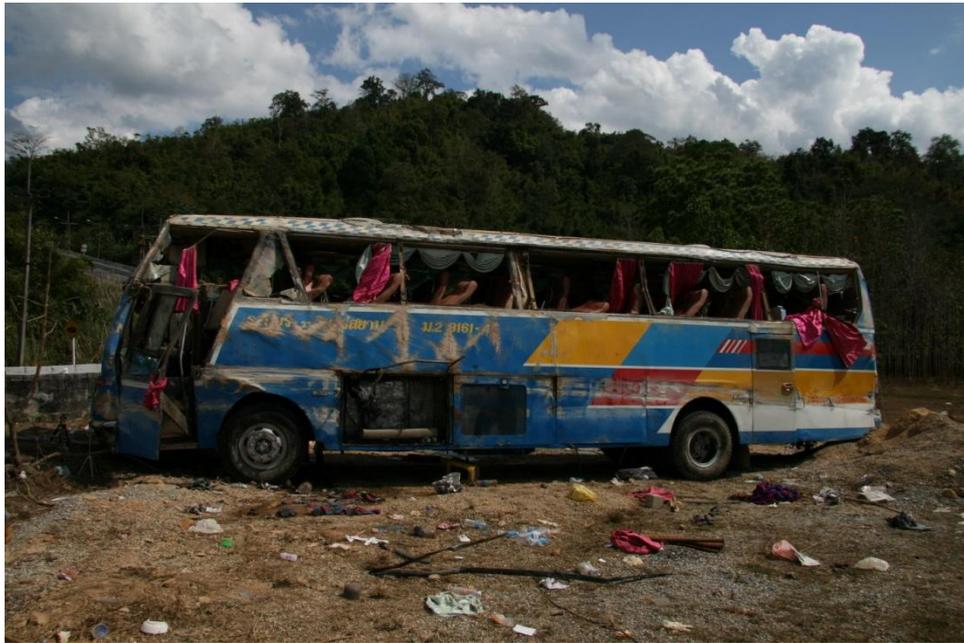
Figure 3-9: Damage Pattern

The mark printed by the concrete barrier is located about 1.30 – 1.40 m high (**Figure 3-9**). The bus was damaged on its left by the scratch marks during landing, located about 1.60 – 2.00 m high. The moving angle was measured 23 degree (**Figure 3-10**).

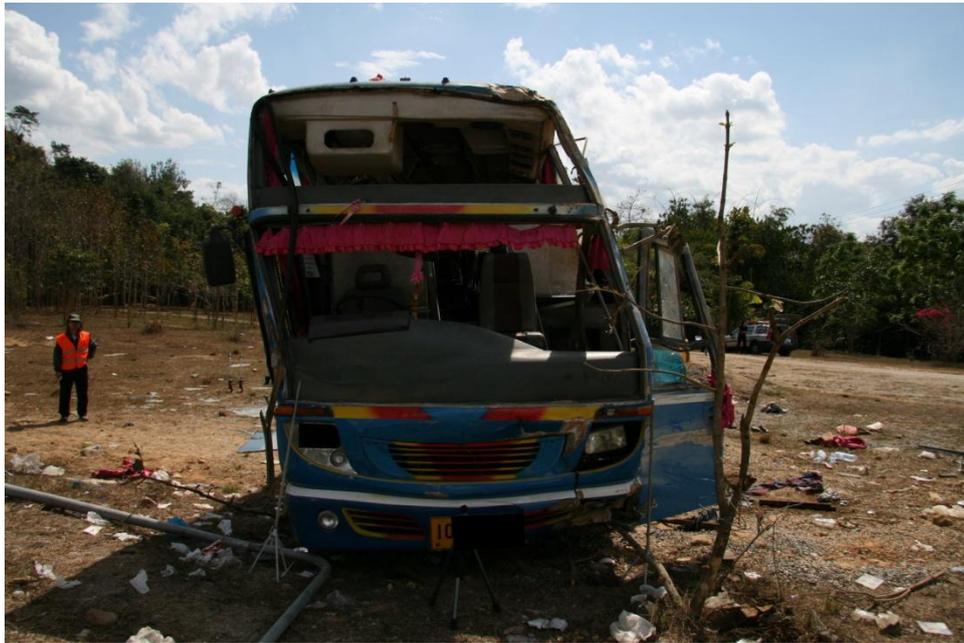
Figure 3-11: The Front of the Bus

The windshield was separated from original position. At the height of 0.30 in the front, there is an intrusion made by the impact force with the concrete barrier (**Figure 3-11 and Figure 3-12**). However, it is lower than the barrier height because the bus was lifting during the time of impact.

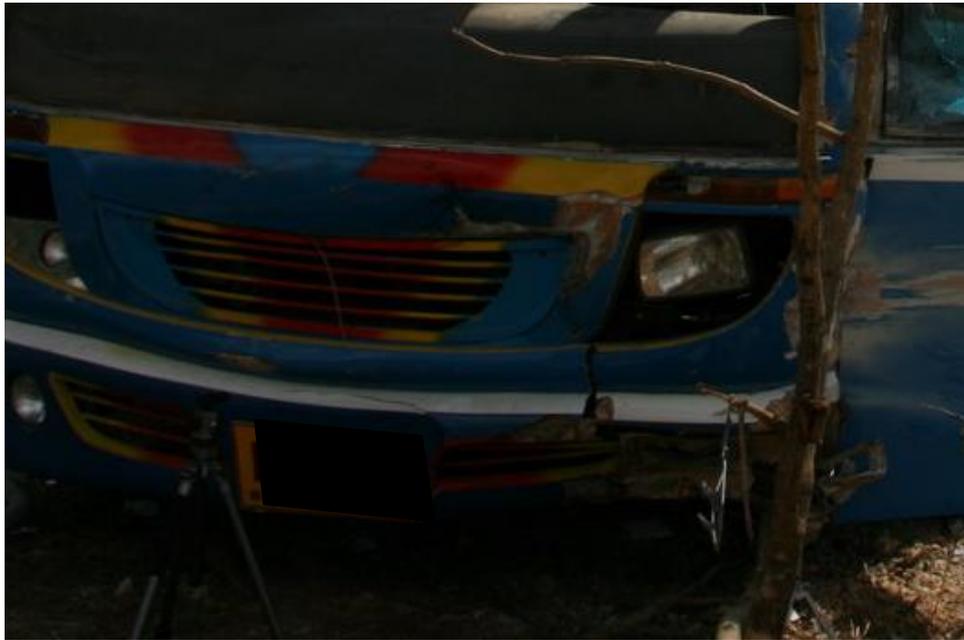
Figure 3-13: Damage near the Headlamp

Damage occurred when hitting the truck was located 1.40 m high from the ground, near the headlamp (**Figure 3-13**).

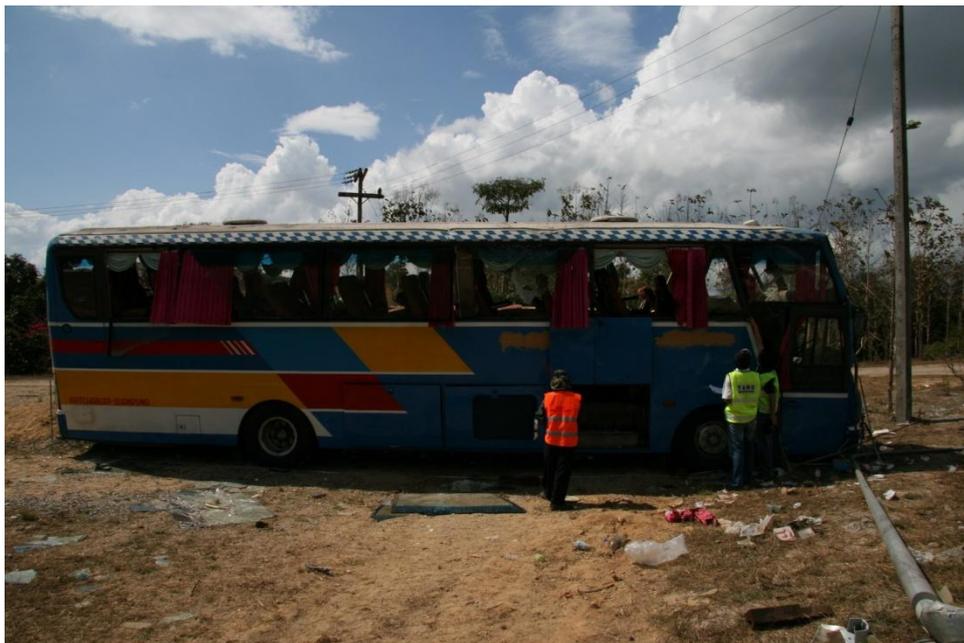
Figure 3-14: Bus Body on the Right

There is no major damage on the right and rear of the bus. All of windows were separated from original position (**Figure 3-14** and **Figure 3-15**).

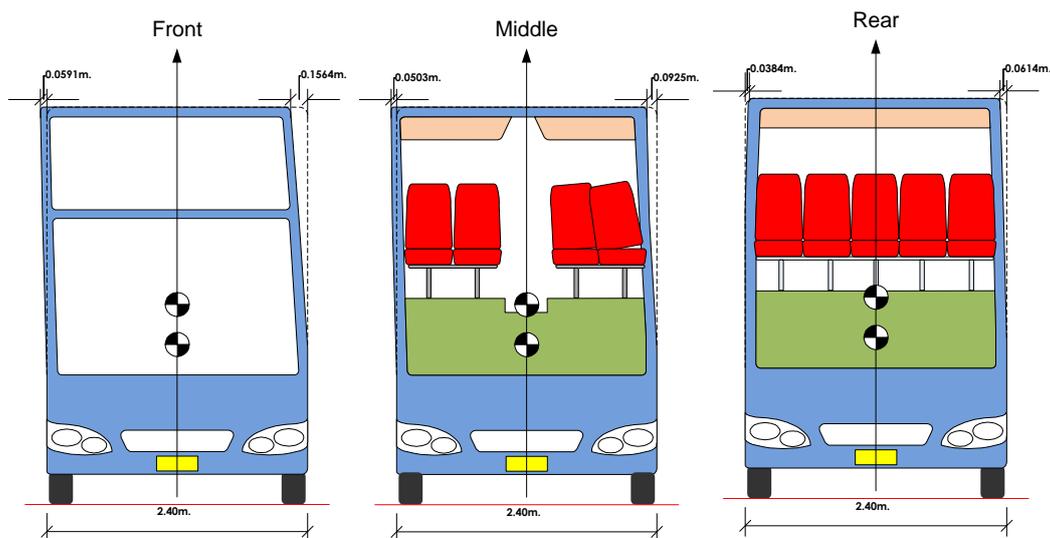
Figure 3-16: The Deformed Structure

The bus was pushed from the left side during landing. Therefore, the body structure was bended to the right as shown in **Figure 3-16**.

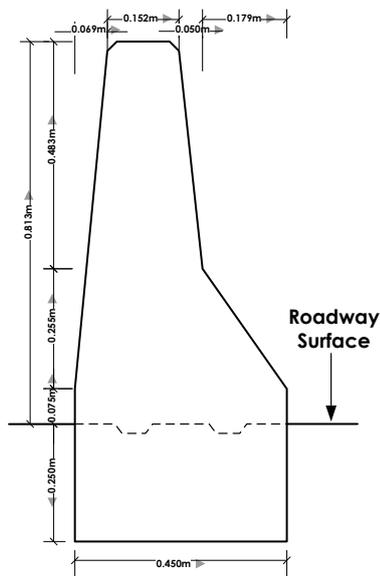
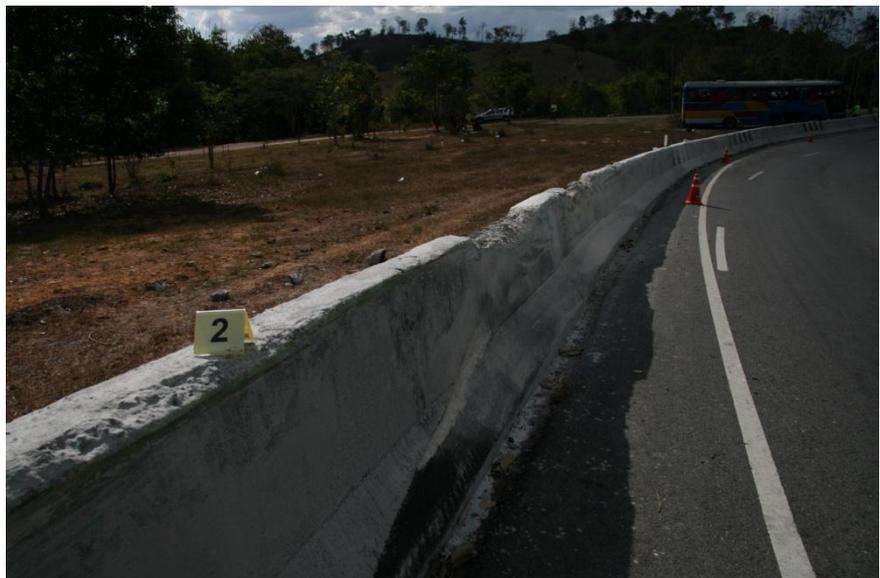
Figure 3-20: Concrete Barrier

A grade of carriage way between km 66+000 and 66+330 was measured 14% downhill, connected with a sharp curve with 57 m curve radius. A superelevation rate is 0.05 m/m and increase to 6.5% uphill grade after leaving the curve. The concrete barrier type I with 0.81 m high is installed along the curve (**Figure 3-20**).

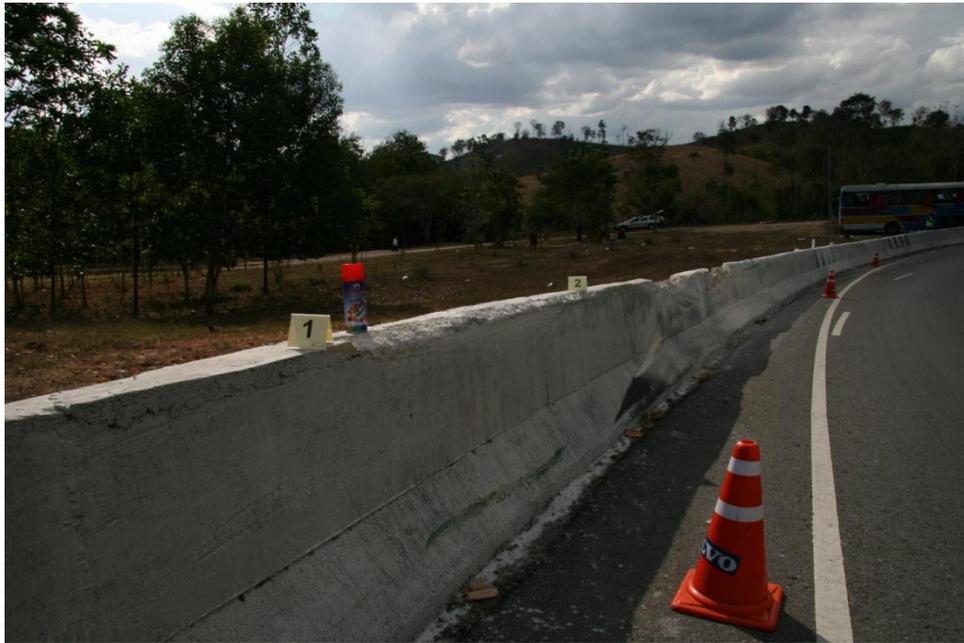
Figure 3-24: Point of Impact

- POI is located 10.3 m further from the kilometer post 66+300. The bus's body color printed on the concrete barrier, making damages on its top. There was a tire mark printed on the barrier at the next 2.4 m. (Figure 3-24)
- The bus started lost control and left the scratch marks 21.7 m from Point of Impact. The chevron warning sign and electric post were damages. (Figure 3-25)
- The bus starting rollover and falling from the barrier 44.5 m measured from the POI. It hit another electric post and slide on the ground 52.2 m. (Figure 3-26)
- The bus stopped near the sandy mound, measure 23.5 m from the landing point. (Figure 3-27)

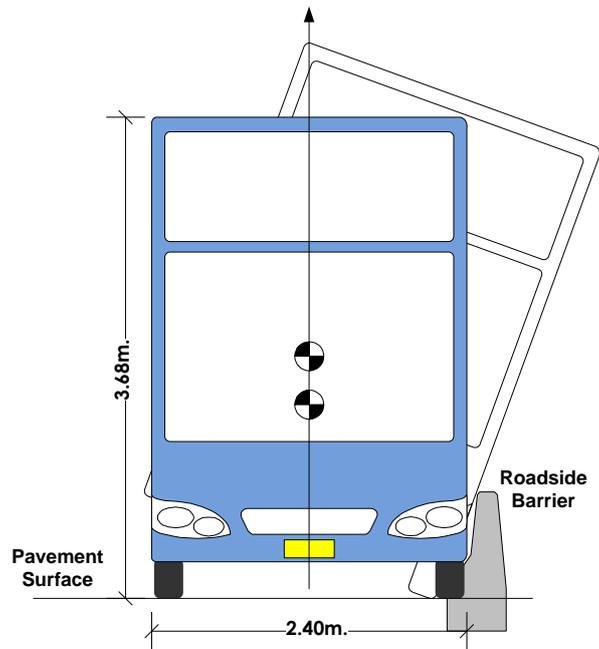
Figure 3-30: Incompatibility between Bus and Concrete Barrier

The impact speed of the bus was calculated to be 73 km/hr with a marginal impact angle. It was reduced to 55 km/hr at the landing point. This impact speed is below the threshold of barrier crash test mentioned in NCHRP Report 350. However, the different between the bus dimension and barrier height is not compatible causing the bus rolling over the barrier.
