# Case ID: 080825-01

## Accident Narrative

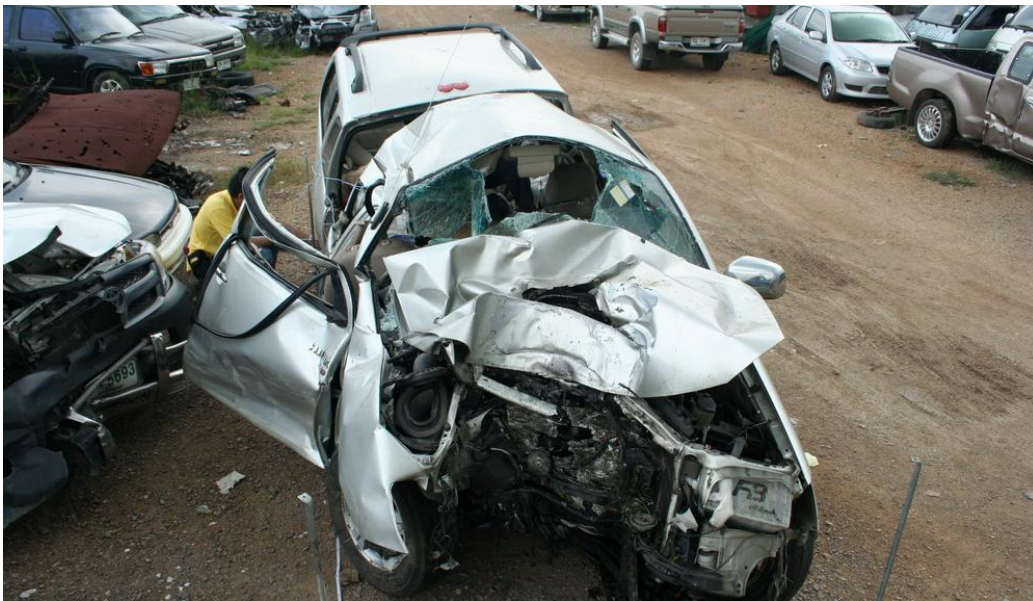
**Figure 3-3: The Damage of the Pickup**

The pickup sustained a massive frontal crush deformation (**Figure 3-3**). The front beam, boiler, engine, and hood were totally damaged. The A pillar was bent and the windshield was shattered. The crush extended into the front axle and the occupant's compartment, where the roof and driver's door were deformed. The driver's airbag was activated. However, the damage close to the extended cab on the right side occurred during an evacuation by the emergency team. TARC evaluated the Collision Deformation Coded (CDC) for the pickup as 12FZ0EW4. The detail of the documented deformation is presented in **Figure 3-4**.

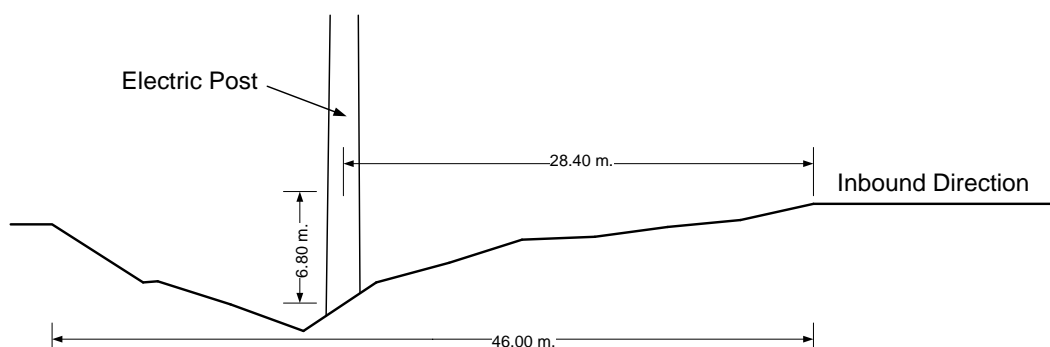
**Figure 3-5: Median Cross Section in the Area of Crash.**

A 5 m wide grassy depressed median separated the traffic between the two main roads. There was a set of pepper flower planted about 1.0 m from the road. The cross section of the median is shown in **Figure 3-5**. The deepest is 1.1 m located 3.5 m from the road edge. The side slope of the median on the south approach is 5:1.

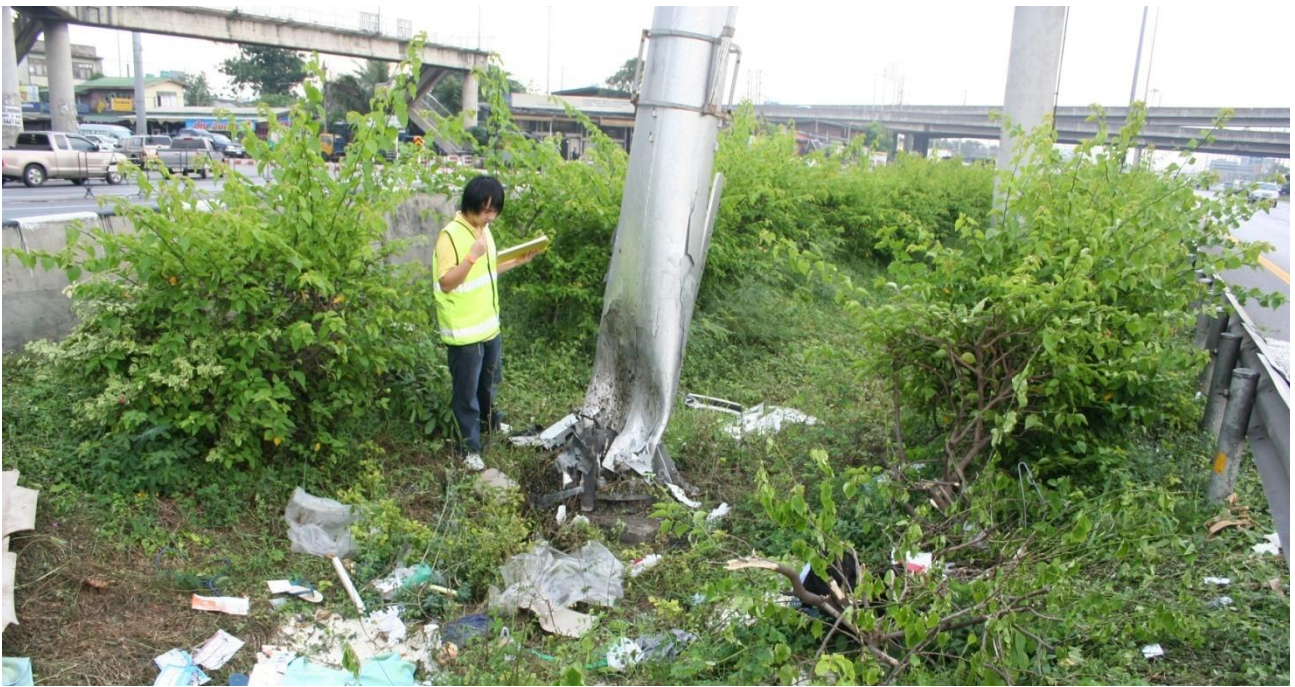
**Figure 3-6: High Mast Lighting after Crash**

25 m. tall steel high mast lightings are installed every 100 m. starting from Pratunam Pra-In. The circumference of the pole measured about 1.8 m. from the ground and was 1.47 m. or equal to 23.40 cm. in radius. The pole was still in position after the crash. However, it was massively deformed by the impact force from the pickup and needed to be uninstalled by the Pathumthani Highway sub district to prevent it from collapsing.

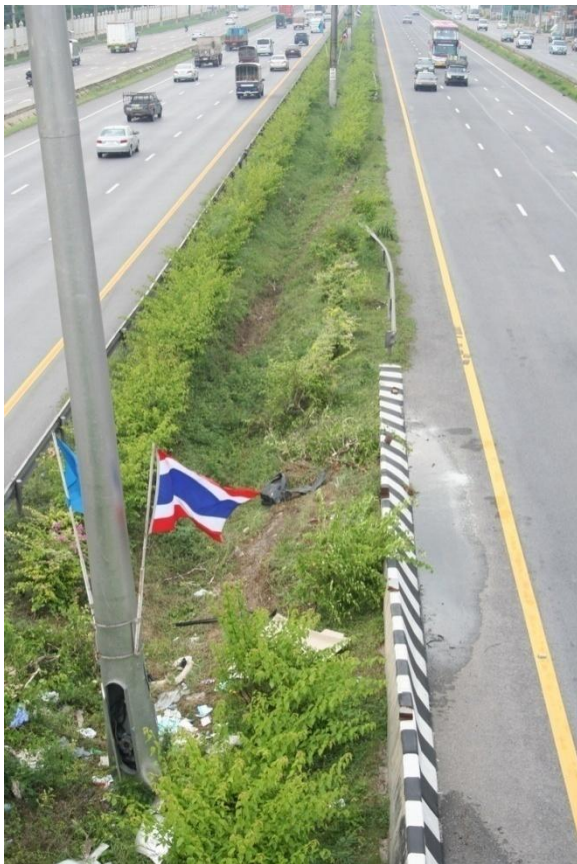
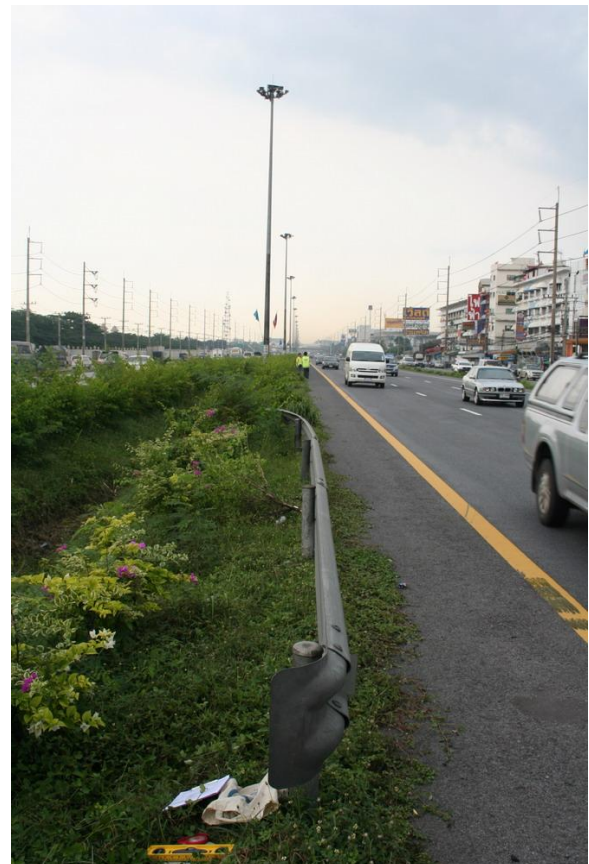
**Figure 3-7: Roadside Barrier**

In the area of the crash, the high mast was shielded by a 20 m. W-Beam guardrail approach type I (**Figure 3-7**) installed on the south approach. Especially at KM. 40+500, the approach concrete barrier type B, 20 m. in length, was also installed to protect the pedestrian bridge pole.

The pickup left the road without hitting the roadside protection. The w-beam guardrail approach was installed 20 m. from the targeted object, the high mast lighting. With the total length of 21 m., the run out length of the barrier is 41 m. In this crash however, the pickup left the roadway 81 m. before the high mast lighting, causing the frontal impact as mentioned. While the question has been raised for the length of barrier, normal w-beam guardrails are installed continuously on the opposite direction.

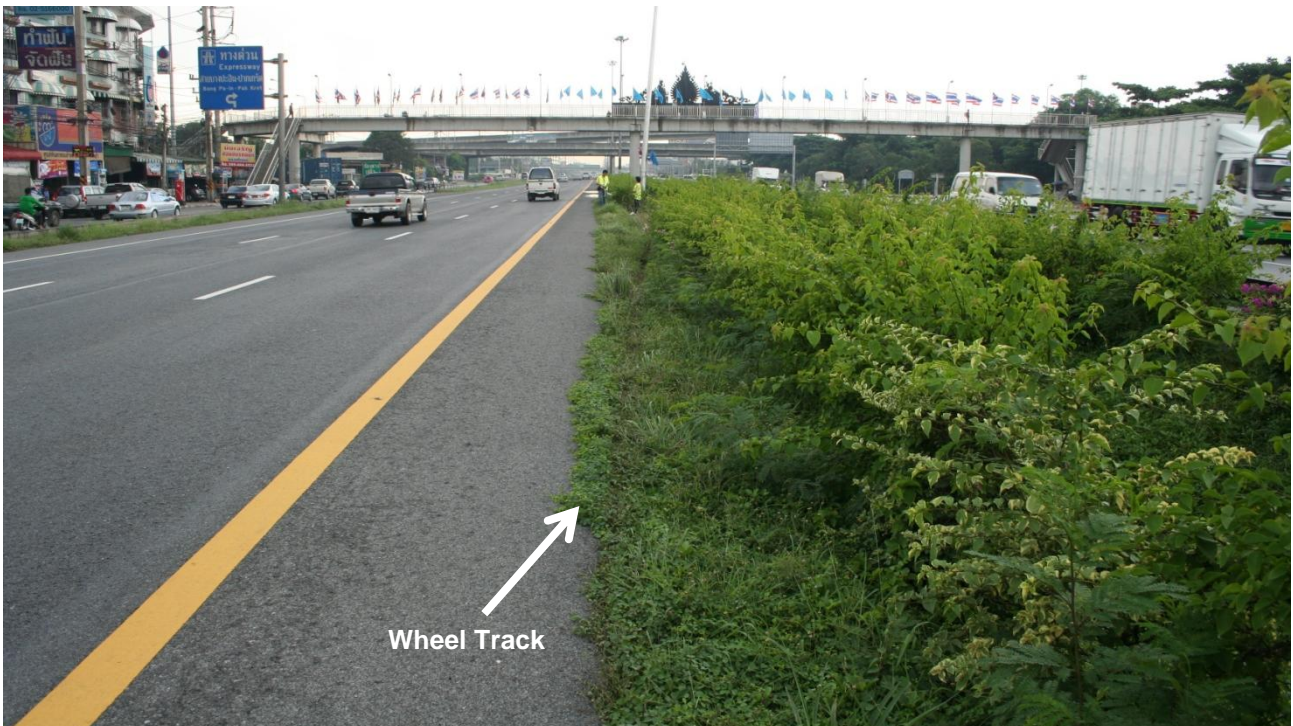
**Figure 3-8: Wheel Track**

The wheel tracks were clearly found in this crash. The starting point of the wheel tracks, measured 82 m. from the high mast, represents where the vehicle started leaving the road. Two pepper flowers were detached. The wheel tracks on the depressed median were also clearly seen until stopping at the high mast lighting. No other marks or evidences were found on the road.

After close examination, it was found that the pickup had not hit any protection equipments, i.e. guardrail or concrete barrier. Besides, the left wheel track was just less than one meter away from the beginning of the guardrail approach (**Figure 3-8**).

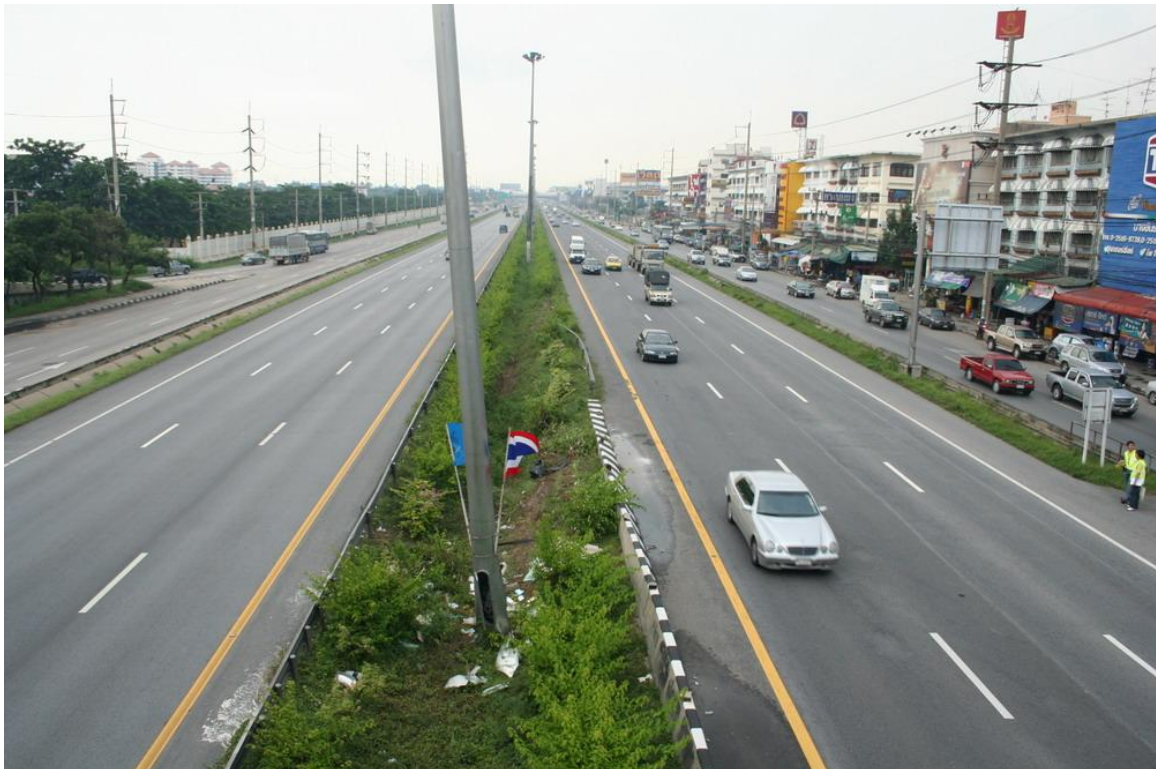
**Figure 3-11: Long Straight Road Section on Highway No.1**

Starting from Wang Noi interchange at KM. 66+000, there is only one long radius curve on the Bang Pa-In interchange at KM. 52+000. Meaning that this widen road section is more than 12 km. in length without being interrupted by any geometric changes. Likewise, according to scene documentation, there were no marks or evidences on the pavement showing the movement of the vehicle prior to leaving the roadway. According to victims, there was influence from other vehicles involved in the crash.

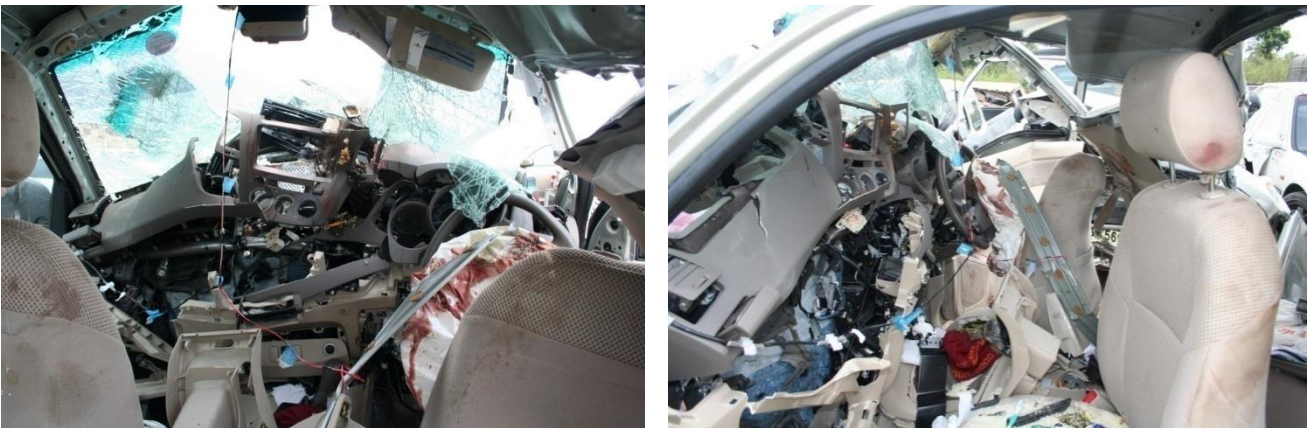
**Figure 3-12: Damaged Console**

Another four occupants suffered serious injuries, including the driver and front passenger. The driver suffered superficial injuries to the neck and fracture of the forearm while the front passenger suffered superficial injuries to the finger, open wound on the thigh, a fracture of the upper arm and dislocation of neck. It is clearly seen that the deployed driver's airbag was bloody and bunched hair was fasten near the music player. **Figure 3-12** presents the intruded damages of pickup console.
