# Case ID: 080909-01

## Accident Narrative

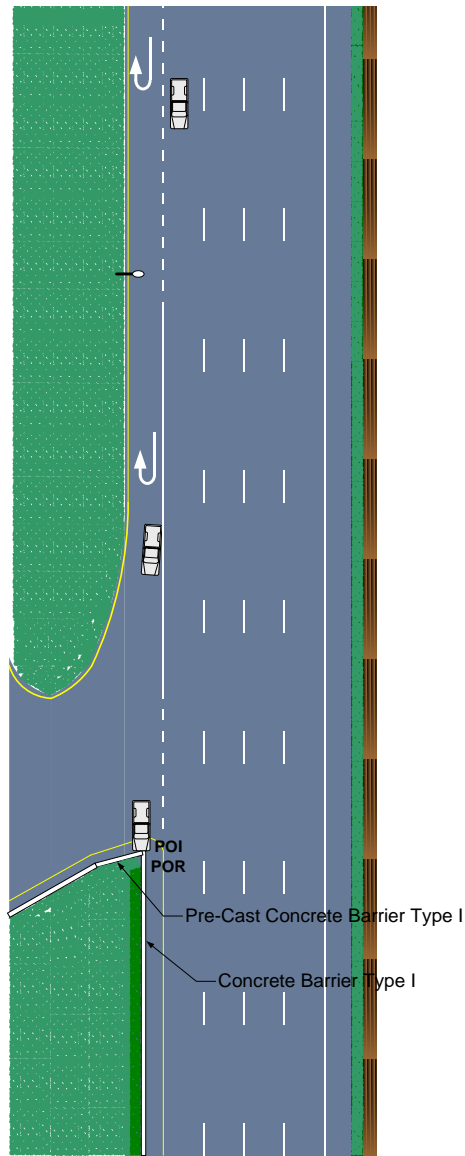
Figure 3-2: Schematic of Accident Scene

The accident scene was at a median opening area. Originally, the opening was supposed to facilitate u-turning traffic for both directions. At present, the authority installed a set of temporary concrete barriers in order to close the access to the southbound traffic, allowing only the northbound traffic to u-turn. The point of impact (POI) was the connecting section between the longitudinal and perpendicular barrier, at the adjacent to the fast traffic lane (**Figure 3-2**).

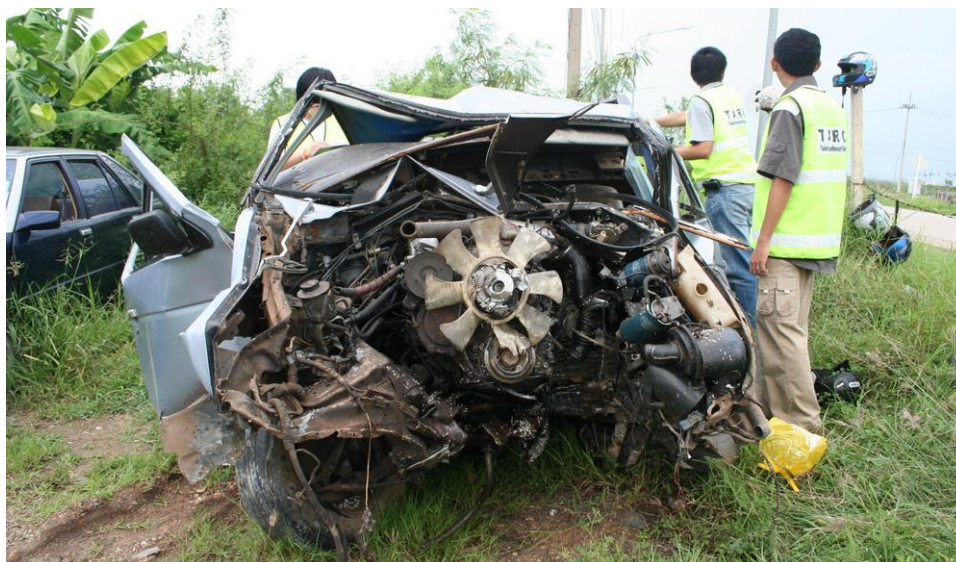
**Figure 3-4: The Damage of the Pickup**

The exterior conditions of V1 show massive damages of its front. The front bumper was separated and structure bars were bent from their original position. A-pillars were bent and the engine including coolant radiator and fan intruded into the occupants' compartment. The windshield was shattered. In addition, the rear axle was separated from its original position. The front left and front right tires had zero air pressure because the rim was bent due to impact. TARC evaluated the Collision Deformation Code (CDC) for the pickup as **12FD0EW5**.

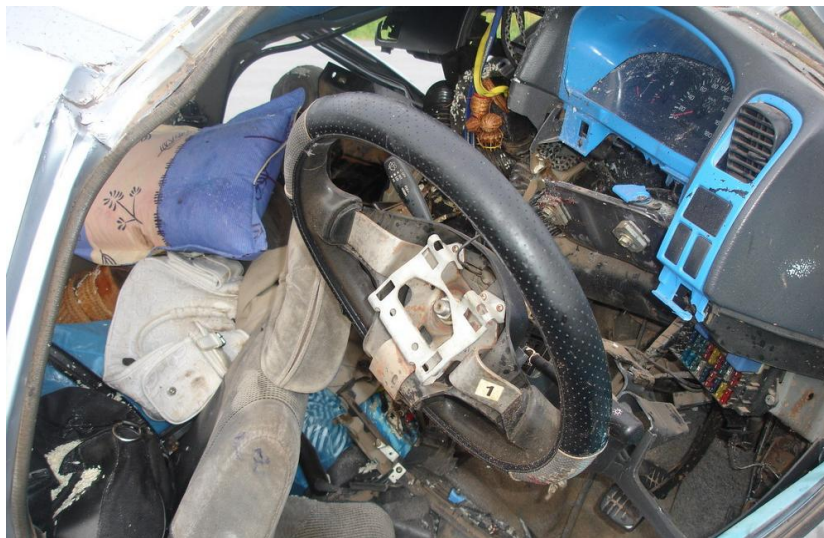
**Figure 3-5: Compressed Steering Wheel**

The interior intrusion was extremely severe. The damaged steering wheel was displaced rearward, measured to be about 25 cm from the deformed driver's seat (**Figure 3-5**). The console was destroyed by the intrusion of the engine and other frontal components. The distance from the driver's seat to the radio player was measured to be about 50 cm. Blood marks were printed on the steering wheel and B-pillar. The comparison between the original and crashed interior is shown in **Figure 3-6**.

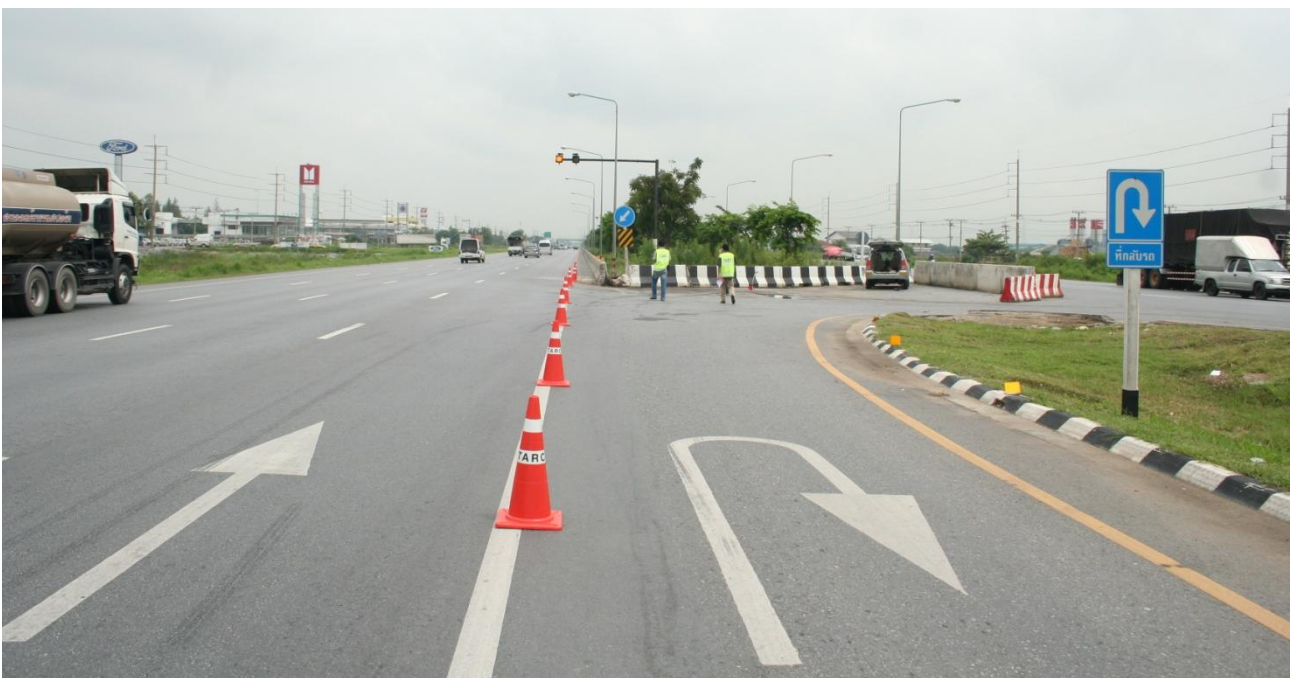
**Figure 3-8: Median Opening U-Turn**

The accident scene was considered as a median opening u-turn area. Originally, it was supposed to serve the u-turn traffic for both directions. The authority then installed a set of temporary concrete barriers in order to close the southbound traffic, allowing only the northbound traffic to u-turn as shown in **Figure 3-8**.

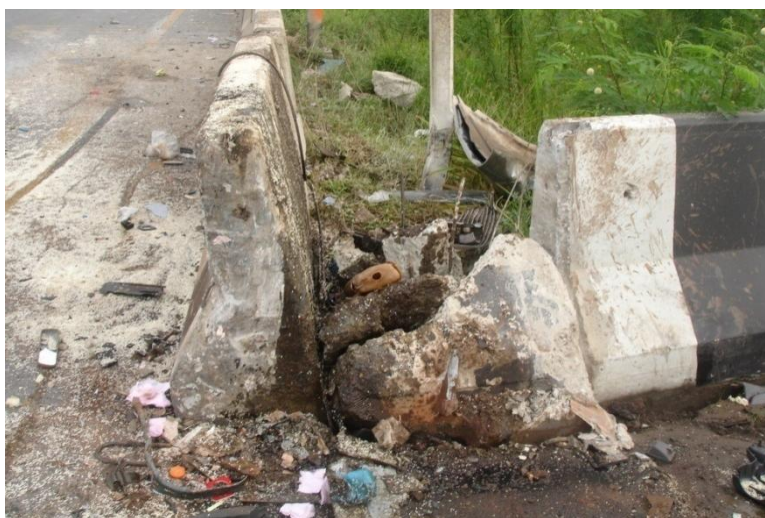
**Figure 3-9: Damaged Concrete Barrier**

At the end of the median opening u-turn, a set of concrete barriers type I was installed to protect errant vehicles out of the roadway. However, TARC found 7 concrete barriers set perpendicularly to the traffic direction. The point of impact (POI) was the connector between the longitudinal and perpendicular barriers, closest to the traffic lane, as shown in **Figure 3-9**. It broke into two parts; the top of the barrier flew into the median about 5 m. further away while the bottom of the barrier was still in position.

Unlike other median u-turns, a set of temporally concrete barriers were installed in the area of u-turn not allowing the south approach to u-turn. However, the barriers were arranged perpendicularly to the traffic without providing an end-treatment. The pickup ran directly into a corner, causing a severe crush to the front of pickup. Only a particular part of the barrier sustained damages.

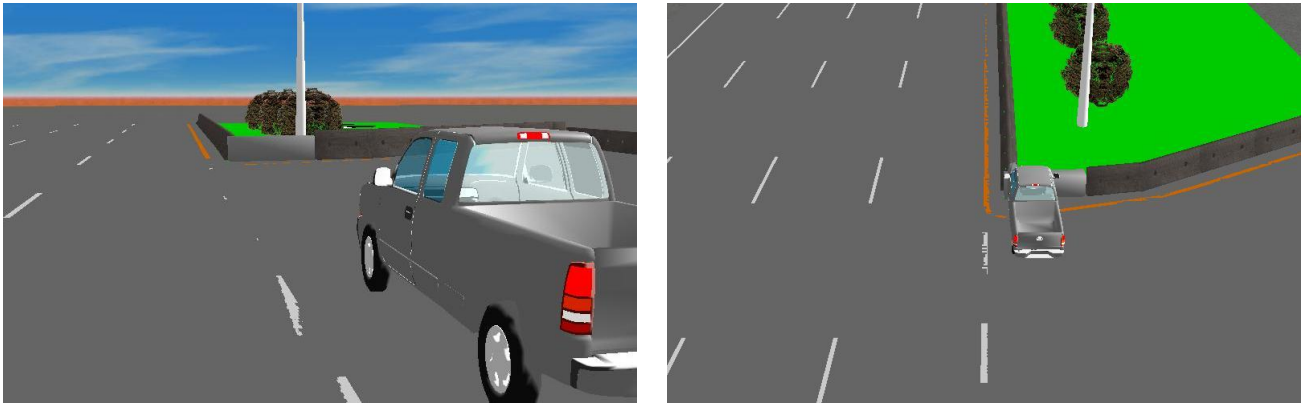
**Figure 3-11: Simulation of Positions of the Vehicle Prior To and At Impact**

Crush energy analysis was used to determine the pickup's speed of this crash. The frontal impact crash test for the Nissan pickup was selected. The stiffness coefficients A and B equal 31,101 N/m and 1,014 kN/m<sup>2</sup>, respectively. Considering the crash as a full frontal impact, finally, the equivalent barrier speed of the pickup was found to be 106 km/hr.
