Accident Narrative

At about 15:00 on Sunday, 1 September 2013, there was a report of crash between a van and a semi-trailer truck. The crash occurred on two lane road, Highway No.359 (Sa Kaew-Kao Hin Son) in front of NGV station, around 59+000 km. A van sustained heavy damage on its frontal part resulting 2 occupants dead including van driver; however, truck had only minor damage on its left part. According to the information, a van was in full capacity with foreign passengers and was heading westward on a trip to Bangkok from Aranyaprathet (Figure 1), whereas the truck was heading east to the border market. According to the truck driver, there was a vehicle suddenly trying to enter to NGV station which forced him to take an evasive maneuver to another lane. However, he was unaware of the van coming in opposite direction and got collided with it. The schematic of the accident scenes are shown in Figure 2.

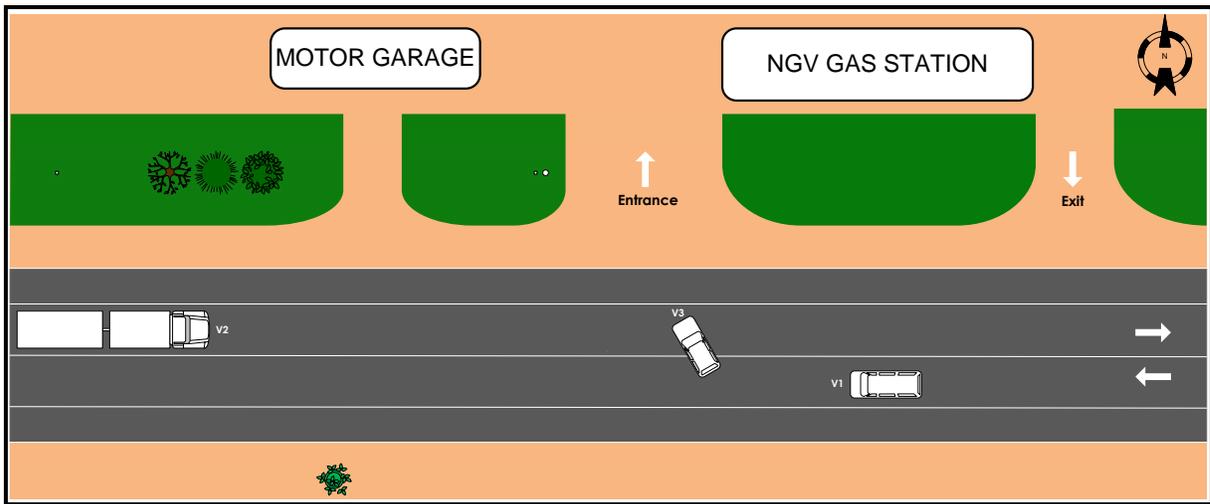
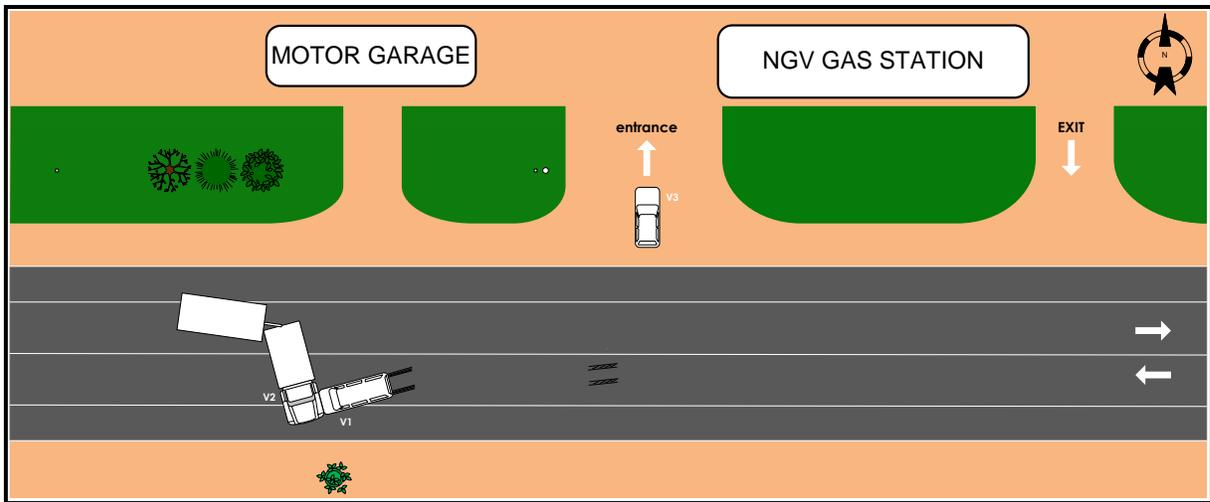
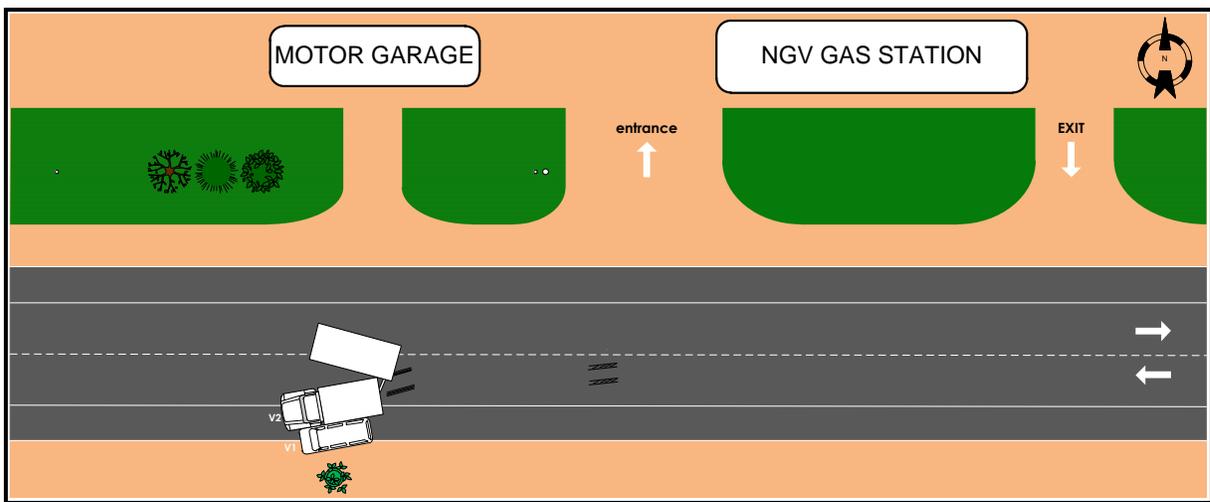
Figure 2 Schematic of Accident Scene, (a) before Collision, (b) during Collision (POI) and (c) after Collision (POR)

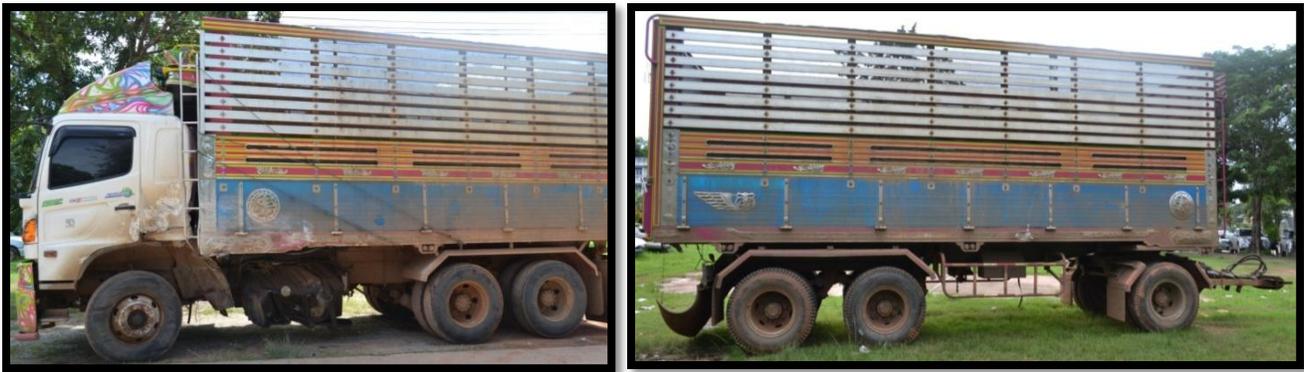
Truck had some damages on left side of its front part. The damages include minor deformation of left door, driver compartment and front left tire and its axle. The most obvious damage is the deformation of the fuel tank in the left. However, TARC observed that the truck has been driven from police station to the garage after the investigation, which clearly shows that there was no any fuel leakage in the tank. Similarly, the bed of the truck and trailer was empty and remained unharmed by the crash.

Figure 3 Damages of the Truck

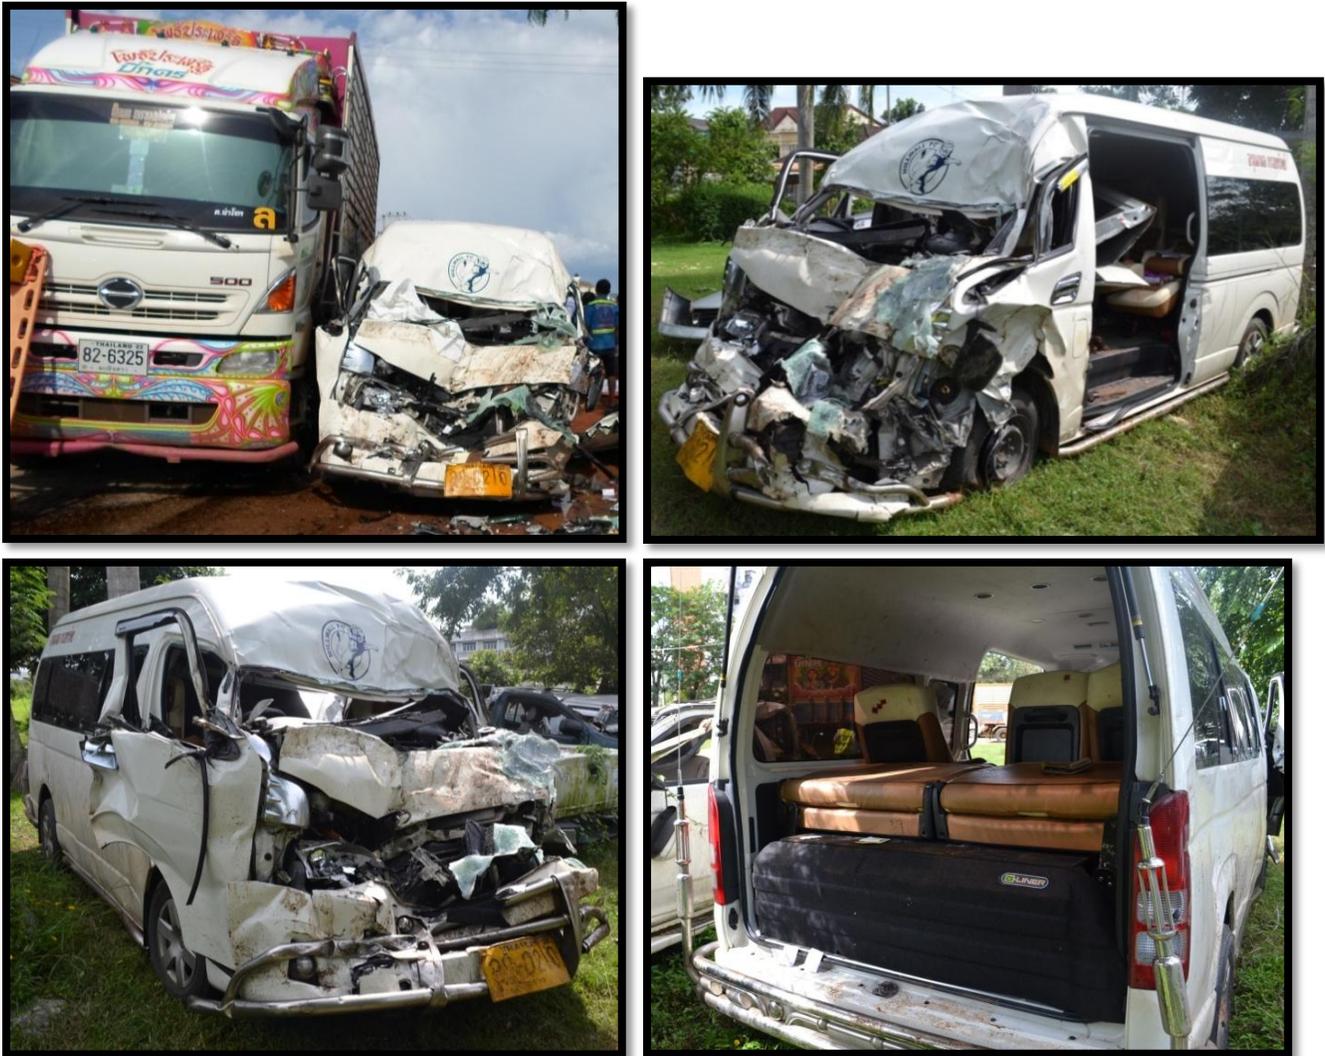
The van sustained a massive damage both on its in exterior and interior part. As shown in figure 6, the frontal part of the van was damaged heavily, with the highest deformation at the central front part. The front bumper, hood and the supporting pillars were bent from its original position. Also, there was damage to its front left wheel, with the tire flat. According to one of the survivor from the accident, sliding door on the left side of the passenger compartment was crushed by the impact and as a result, the door stops functioning and the survivors used rear door to escape sooner after the crash. Similarly, no damages were observed at the back part of the van as seen from Figure 6.

Figure 6 Damages of the van

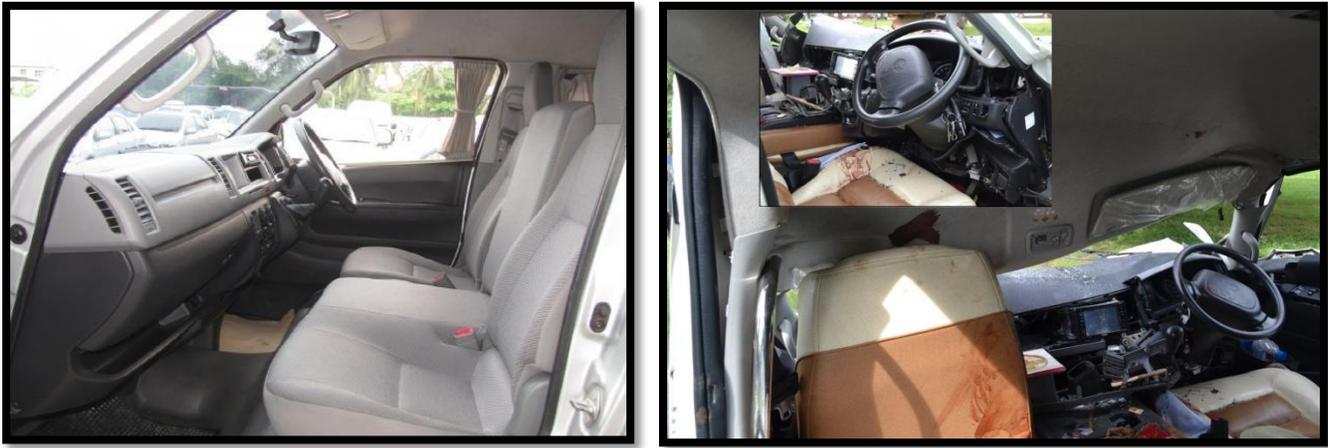
Severe interior intrusion was also observed during the vehicle inspection as shown in Figure 7 (b). The interior frontal part of the van was intruded especially at the driver's compartment and the frontal head roof and windshield was also deformed downwards. The distance between driver's seat to the radio player was found to be too small comparatively from the original structure (Figure 7). And the console was also found to be destroyed by the intrusion of the engine and other frontal components.

Figure 7(a) Original interior structure, (b) Damages on the interior structure of the van after crash

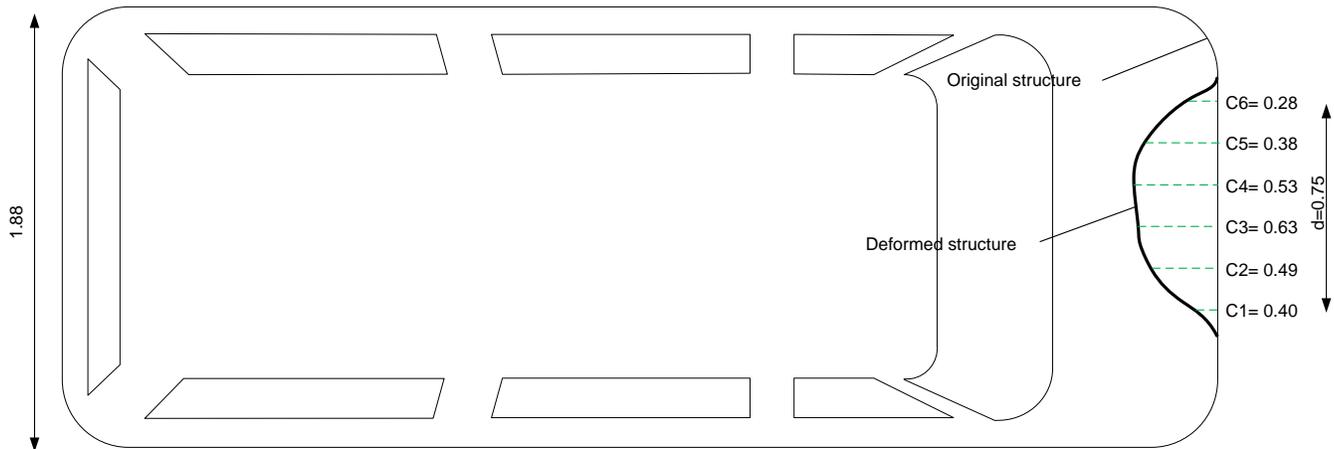
Figure 8 Crush Deformation of the van

TARC performed the crash speed analysis to determine the van speed during the impact and before braking by using the crush deformation as shown in Figure 8. Following steps are carried out:

$$= 28.98 \text{ m/s} = \mathbf{104.35 \text{ km/h}}$$

$$V_{\text{prebrake}} = 31.15 \text{ m/s} = \mathbf{112.14 \text{ km/h}}$$

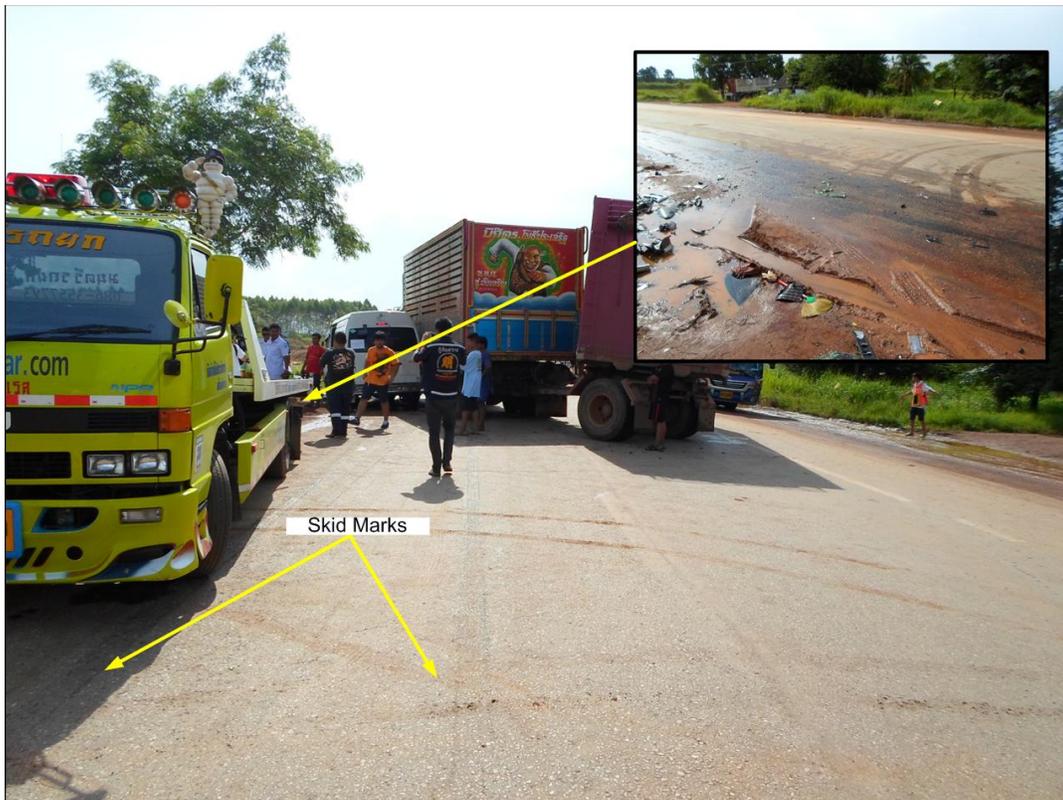
TARC investigated the accident site and found the 16.6 m. long skid marks of both right and left wheels in the travel lane. Also, some tire marks were also found to be continuing on the shoulder and stopped at the point of rest as shown in Figure 9. Skid mark of truck couldn't be found during an investigation. Similarly, several access points on the eastbound approach nearby the accident scene were seen. These are the entrances and exit for the garage and gas station where several conflicts were observed between the through traffic and the turning vehicle towards the gas station.

Figure 9 Skid and Tires mark at crash scene

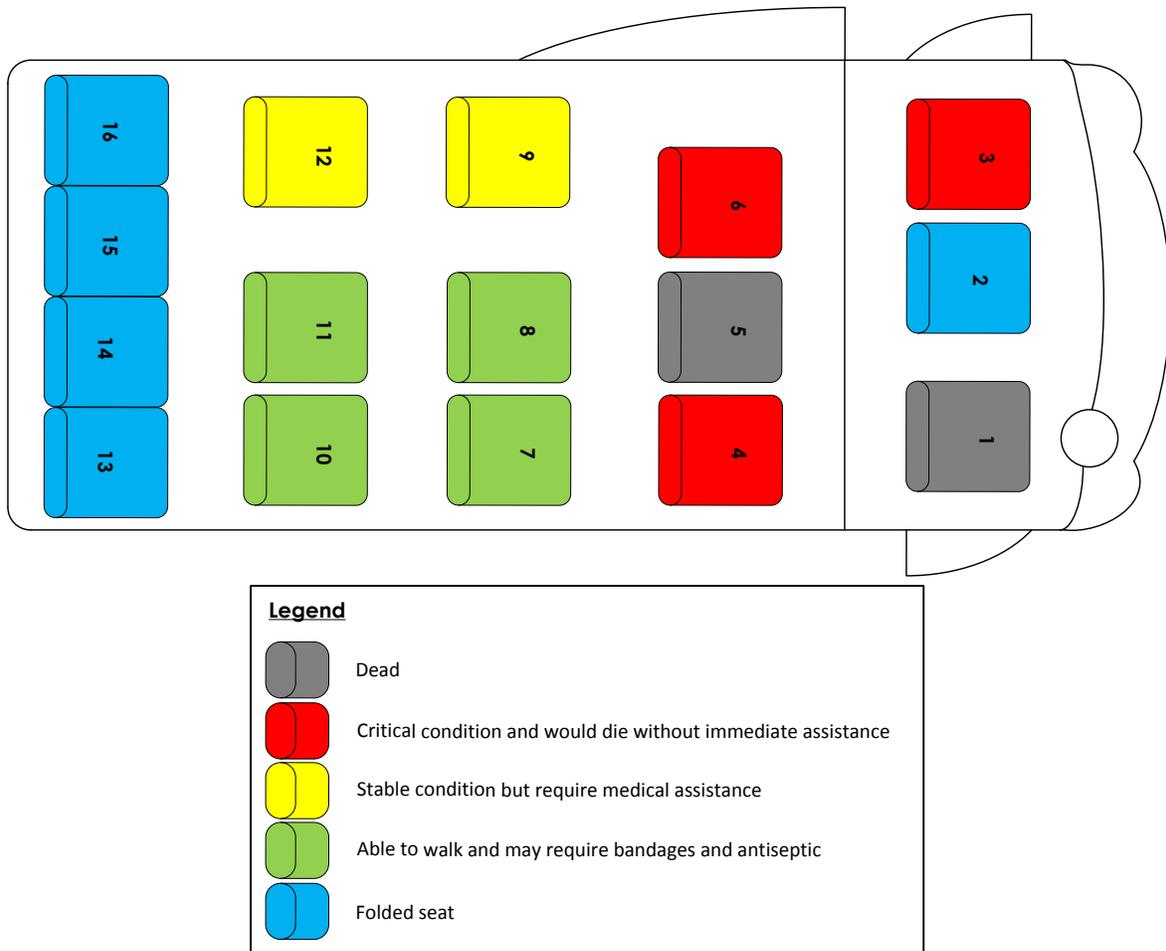
Figure 10 shows the casualties according to the seating position and level of injury in the van. Since this is a head on collision to the van, most of the occupant seating in the front in has more serious injury than others. Also, Table 5 shows the summary of the occupant's injury based on the ICD 10 code.

Figure 10 Seating position and the Injury Level

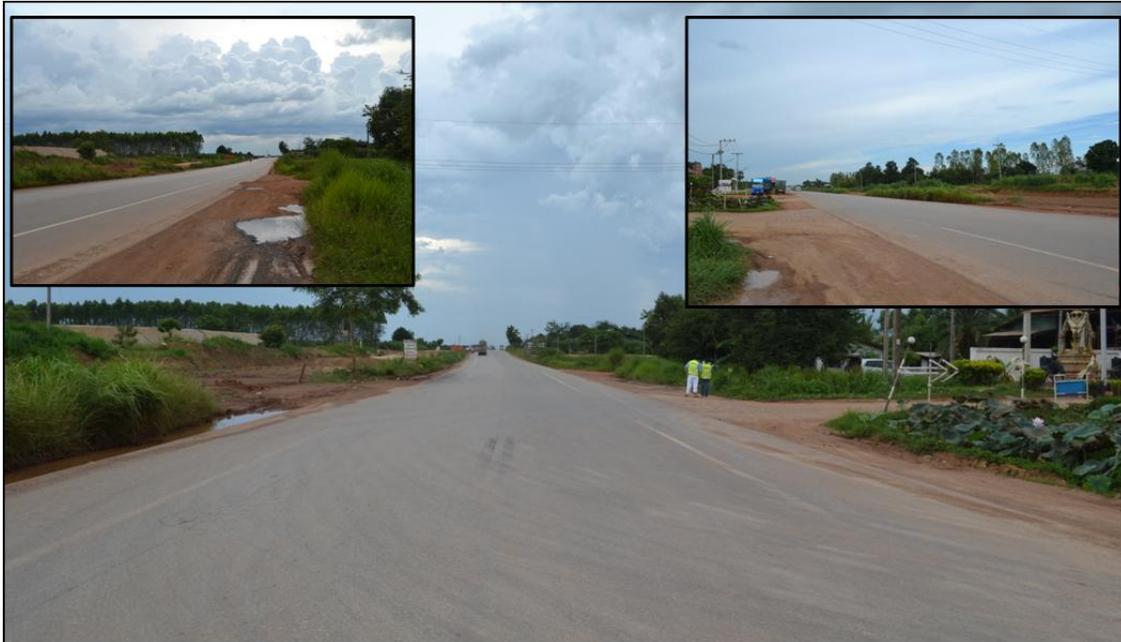
Figure 11 Roadway condition at crash scene

During the investigation at the crash site in the same time of the next day, TARC observed three access points near the crash scene, one access to the motor garage and two accesses to the gas station for entrance and exit purposes (Figure 11). During this time, it was seen that many vehicles were going to the gas station, thereby disturbing the through traffic mostly (figure 12). These types of conflict at the access points may misguide some vehicles and result unexpected crash, especially when a high speed vehicle approaching such access points. Also, we can see from the figure that the marking on the road esp. median is not clear which encourages illegal overtaking and maneuver (Figure 13). Hence, combined effect of these kinds of problems in the roadway is the major contributing factor for the accident.

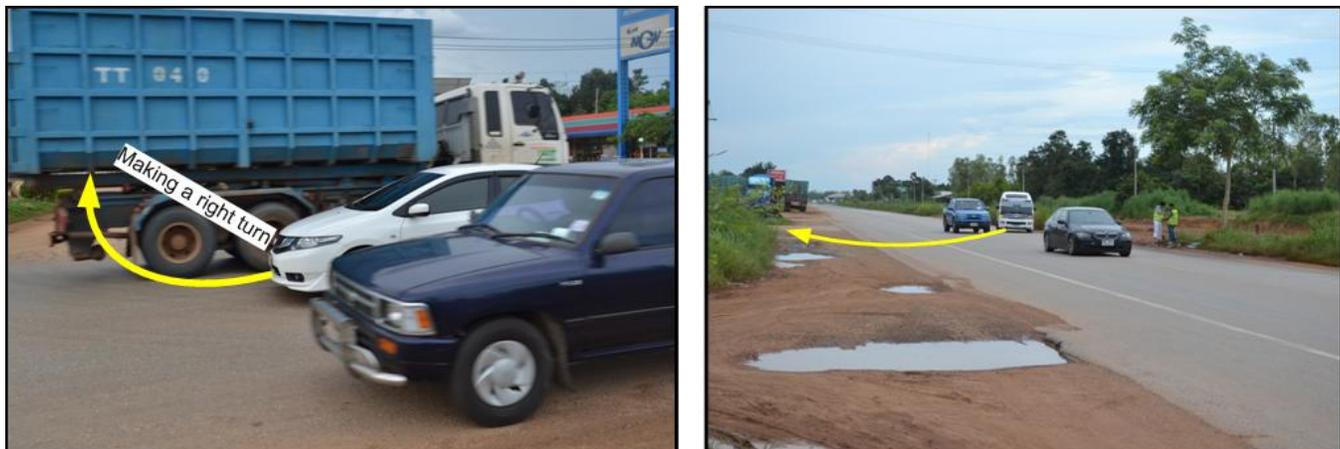
Figure 12 Vehicle Conflicts at the access point

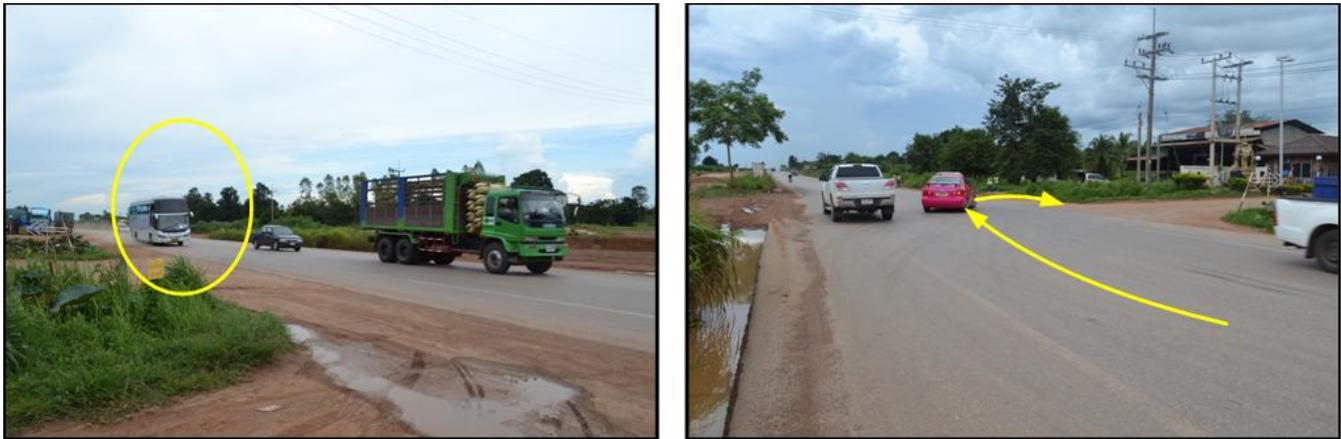
Figure 13 illegal overtaking and sudden maneuvering at the access point
