Crash ID: 150527

Accident Narration

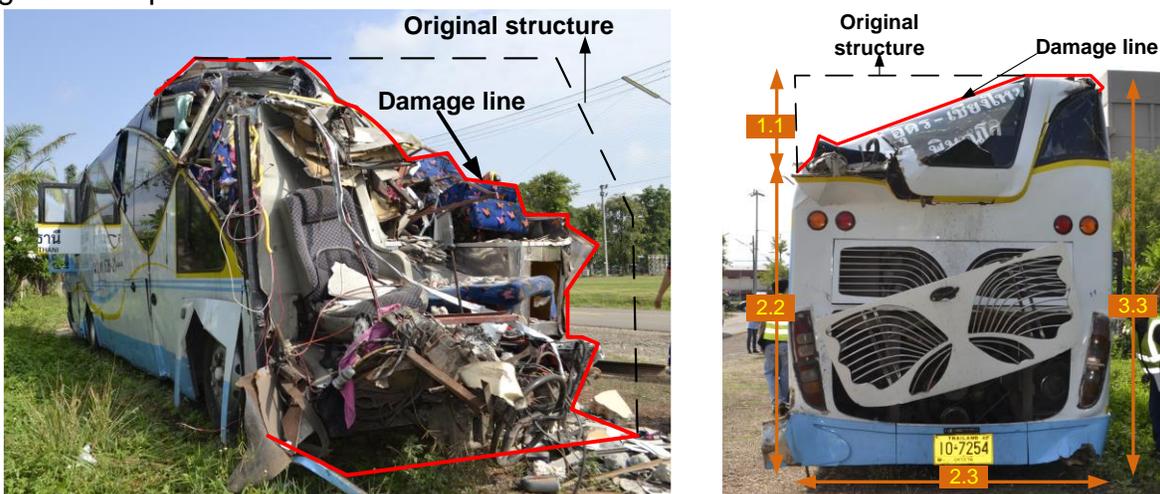
Figure 7 Front and rear view of the bus

The front part of the bus was heavily damaged due to impact with the houses. After running off the road, the bus intruded into the house so the left front side of the bus was observed to be more damaged by the impact. The roof and the supporting pillar of the second floor in left side were collapsed as can be seen in **Figure 7**. **Figure 9** shows the position of the bus after the impact with house. The concrete beam, slab and roof of the house intruded causing the severe damage in front part.

TARC measured the frontal deformation of the bus and found that the damage extended up to 3.37 m in the roof of the bus. The deformation at the first and second floor was 0.97 m and 1.74 m respectively. The roof at left side of the bus touched the second floor as can be seen in **Figure 7**. The overall length of the bus after the crash was 11.40 m. The deformation on the front part of the bus is shown in **Figure 8**.

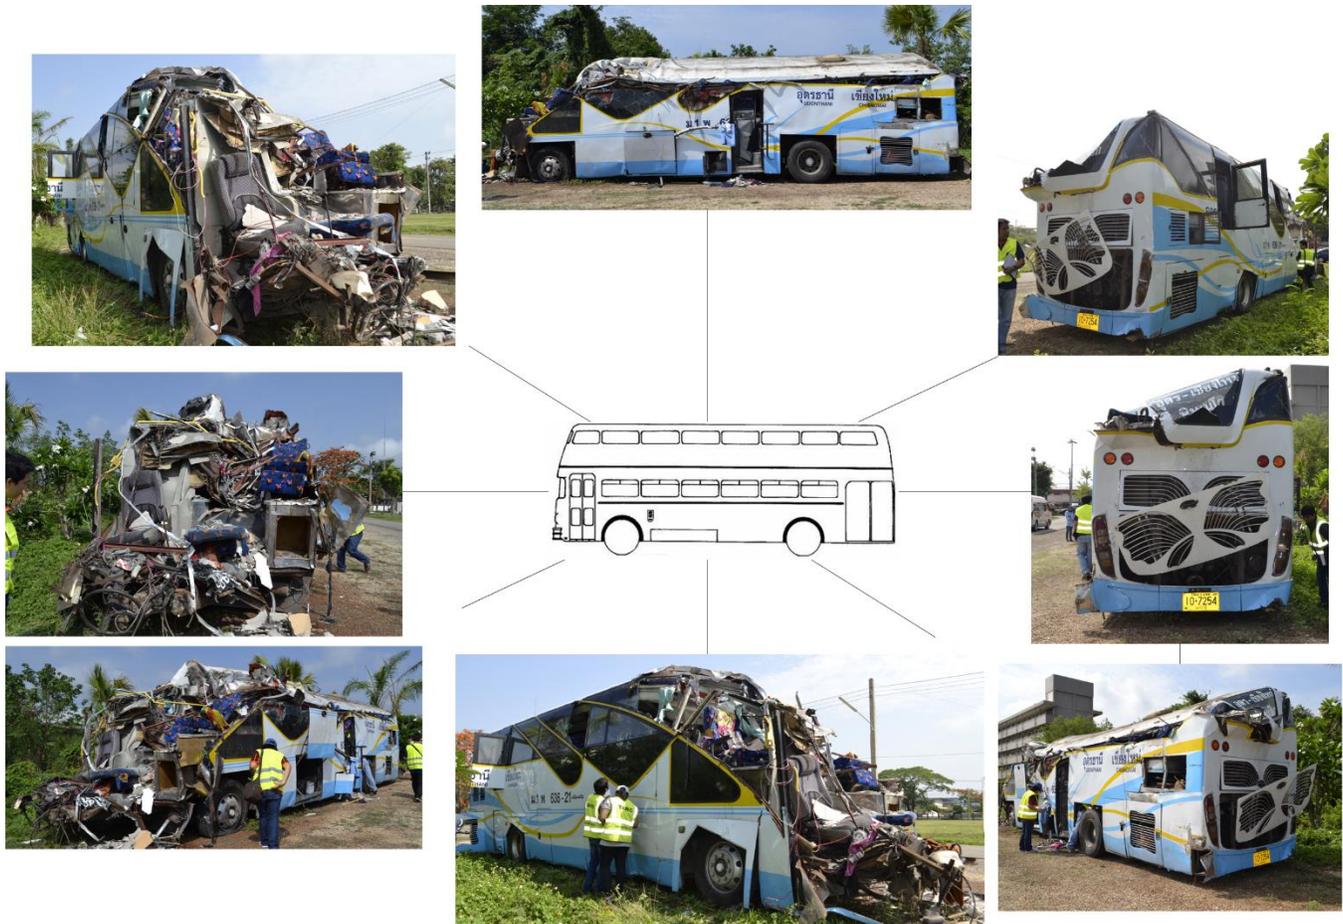
Figure 10 Damaged bus

The bus was manufactured in 1981, which means the age of the bus is 34 years old. Post-crash investigation shows that the bus mechanical equipment's, frame were old and rusted.

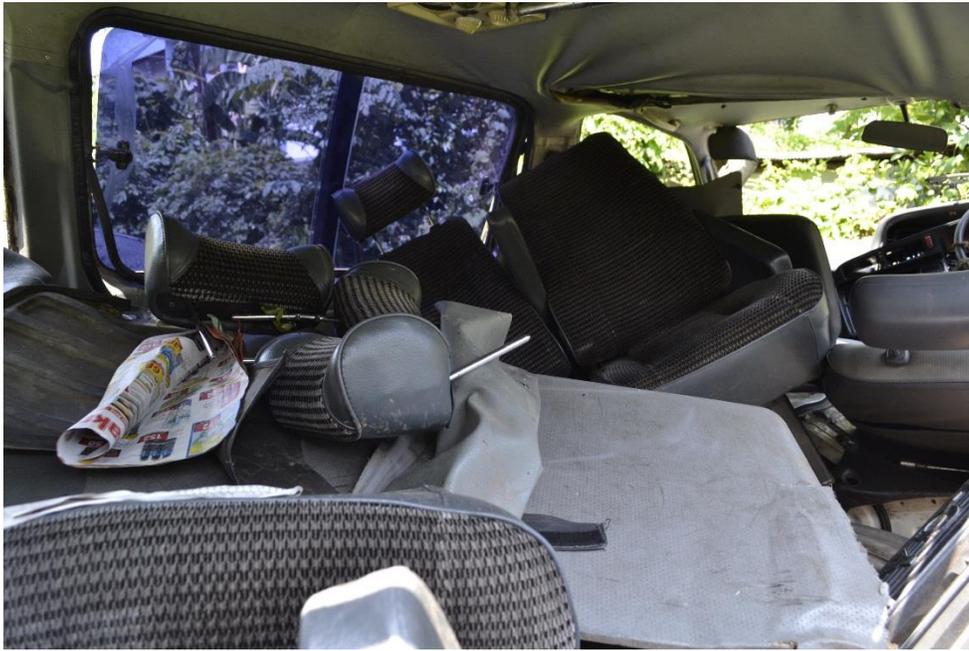
Figure 12 Scattered seat inside the van

Similarly, among the 8 occupants inside the van, one passenger, who was sitting in the middle seat of front row (no.3) died in this accident as shown in **Figure 37**. During the investigation, it was observed that the front row seat (no.2, 3 & 4) was ejected together with the passengers. All passengers including

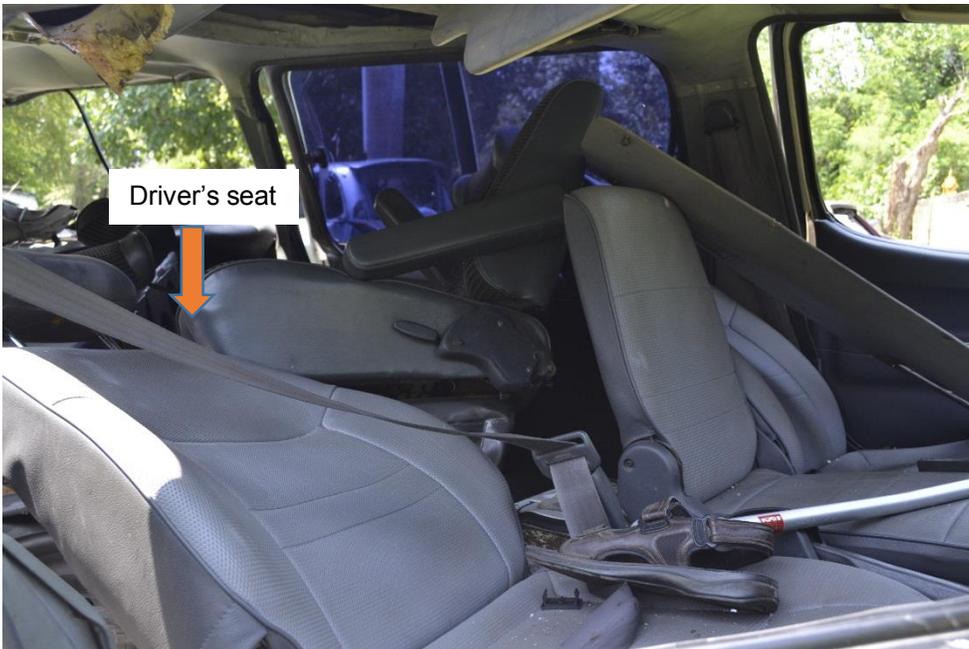
Figure 13 3-point seat belt at front seat

There were a total of 8 occupants inside the van. In front, there was a driver and one passenger. Rest of the passengers were sitting at the back seat of the van. 5 of the passengers were school children and 3 were adults including driver. In total, there were 12 seats inside the van, two in front and 10 at the back. 3 point seat belt was installed in the front two seats while no seat belt was observed to be installed at the back seat. During the crash, the seats were unhooked and scattered inside the van (**Figure 12**) and also first row seat (no.2, 3 & 4) (**Figure 11**) ejected out of the van together with the passenger (**Figure 14**). One of the passengers seating in the first row (no.3) ejected out and died on scene. At the time of accident, the driver was using seat belt, while the front passenger was not using seat belt as shown in **Figure 13**. According to the interview with front passenger, he was holding the handrail when the bus impacted with the van. During the investigation, it was observed that the front passenger's seat belt was strapped behind the seat.

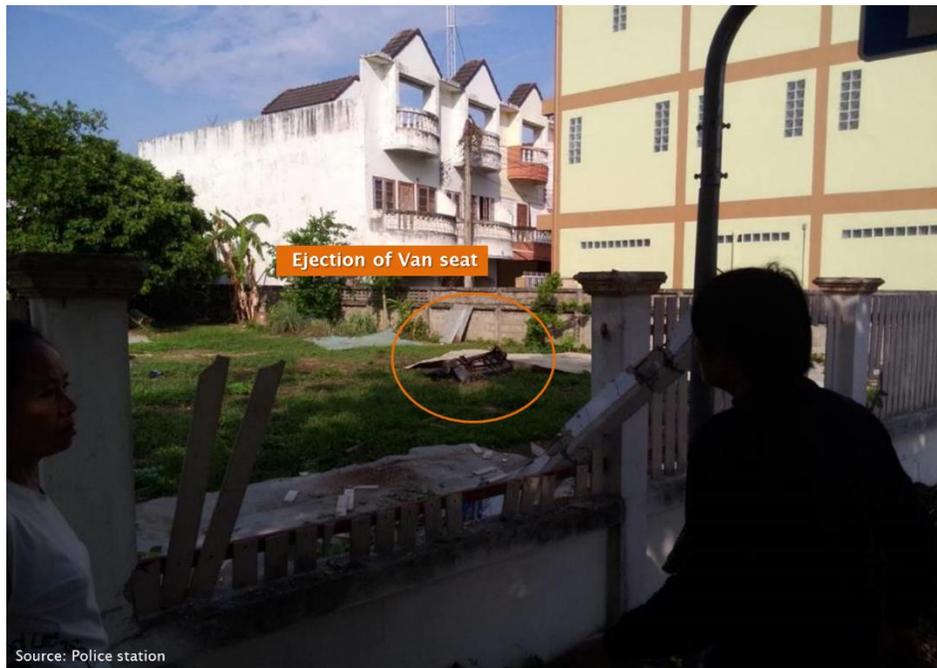
Figure 14 Ejected seat from van near the crash scene

There were 20 passengers sitting in the bus. Out of the total, two (males) were reported to be fatal, seven were severely injured and the rest of them slightly injured. None of the occupants in the bus used seat belts during the accident. The source of injuries of the occupants inside bus was the interior of the bus: broken glass, seat, armrest etc. Similarly, no seat belt was installed at the back of van. And the seat was not properly strengthen which caused the scattering of seat inside the van and even ejection outside. According victims statements, people bouncing on each other and the seats detaching from their position caused harm to the occupants during the event of crash. Also, some occupants ejected together with seat resulting one fatality. So, the main cause of injury inside the van was the poor seat strengthening and restrain system.

Seat belts designed to hold the occupants in place against harmful movements can help significantly reduce this kind of injuries. It is known that the change in an unrestrained occupant's speed in a collision can result in injuries. Generally, if a restraint system is employed, it forces the occupant to change speed while the vehicle is changing speed, thereby lengthening his deceleration time and decreasing the severity of his injuries (TARC, 2008). Additionally, it prevents occupant's ejection and redirects the force from the collision without any serious injury. By using seatbelt, risk to get serious injury is reduced by 40-60% (Napal, 2002). Therefore, the seatbelt is the most important protection device in case of vehicle collisions.

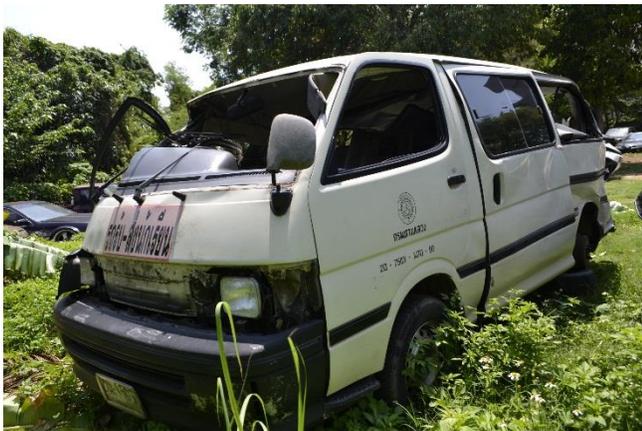
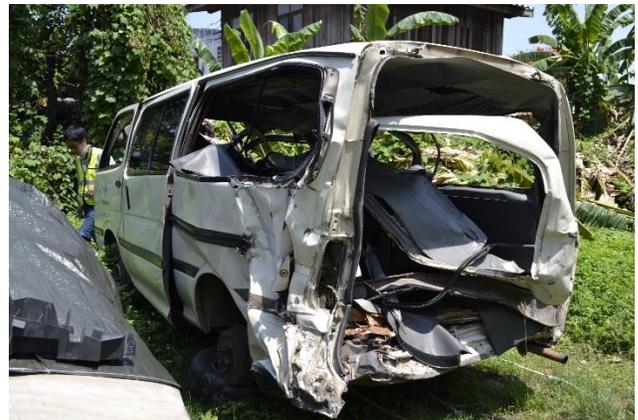
Figure 15 Van damage

Heavy damages were observed in rear and right side of the van as shown in **Figure 15 & Figure 16**. The deformation at the rear side was due to impact by the bus while the deformation in the right side was due to collision with the roadside objects (tree, sign post and electric pole). In addition, the van had some damage in front part as well. The wind shield was broken and the driver's door was damaged by the crash.

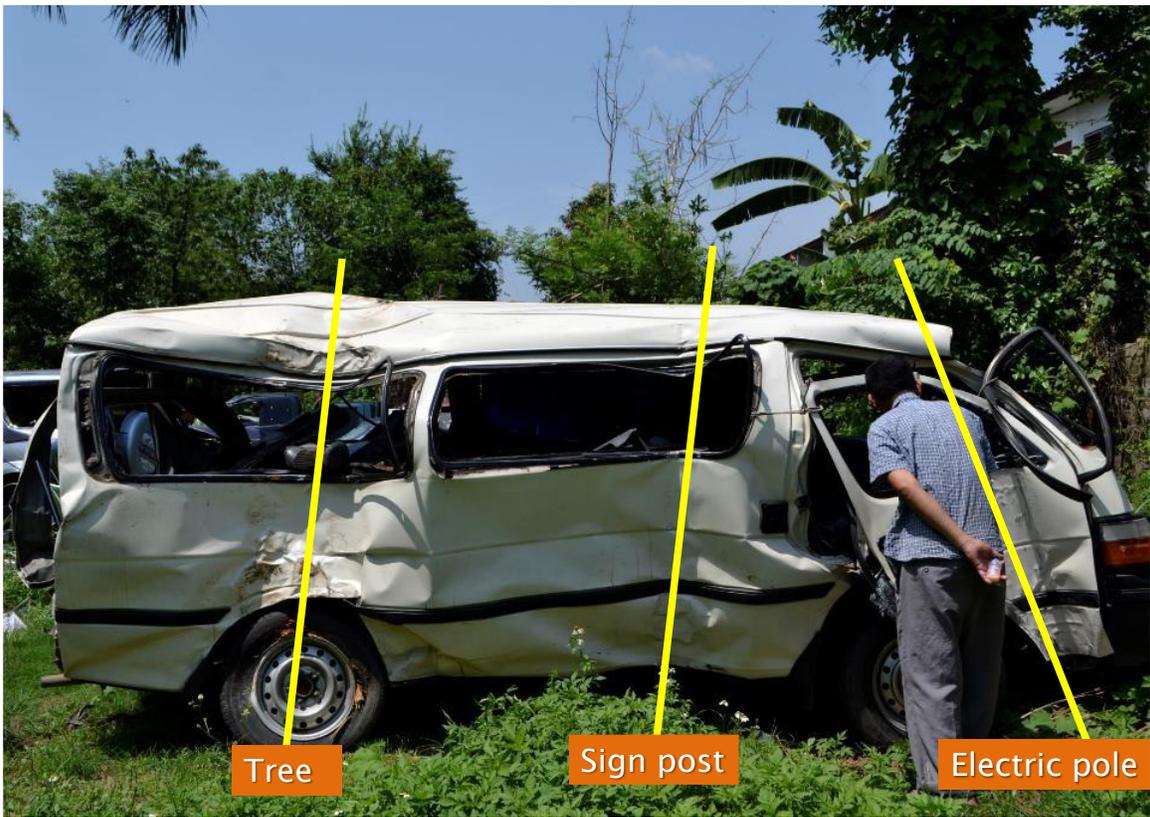
Figure 16 Deformation in right side of van

After the impact with the bus, the van lost control and hit the tree, sign post and electric pole, hence there were three distinct deformation on the right side of the van (**Figure 16**). The maximum deformation by the tree and electric post was 25 cm and by the sign post was 15 cm. The deformation was 14 cm throughout the rear part. Diagram showing the deformation is shown in **Figure 17**.

After the impact, the van collided with the roadside objects: tree, electric poles and signpost that caused heavy deformation on the van and injured the passenger inside. The passenger ejected out from the van during the impact increasing the injury severity. The roadside objects have the potential to be hit by errant vehicles running off the road. Roadside furniture is generally designed to be located outside of the road. However, it could be life-threatening when hit by errant vehicles. This fact is among the findings of the investigation by TARC (2007) which shows that many errant vehicles and their users experience severe damages and injuries as a result of loss of control, running off the road, and finally hit rigid objects at the roadside area.

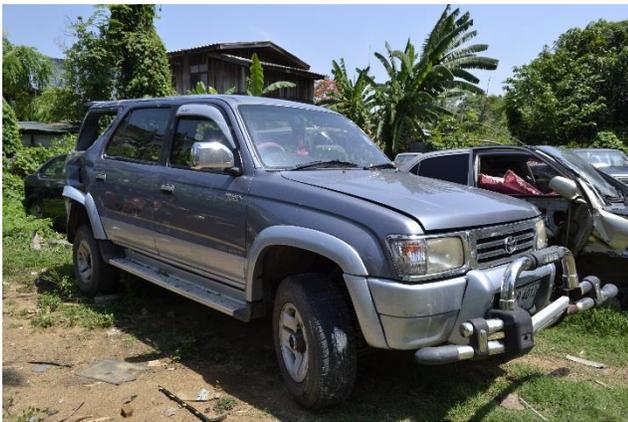
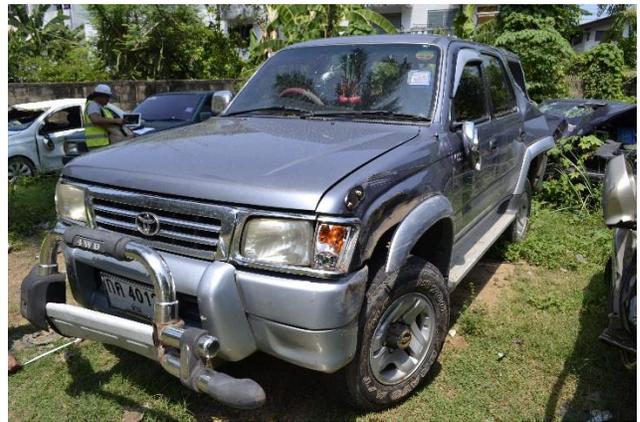
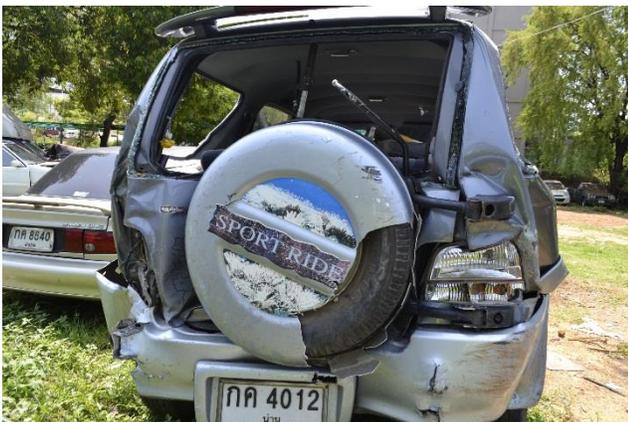
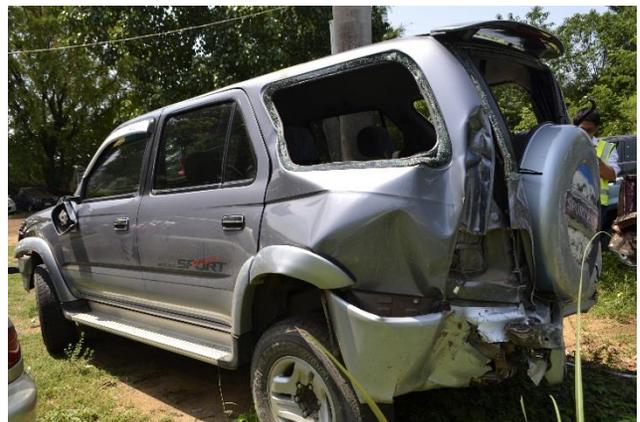
Figure 19 Damage of SUV

SUV had major damage at rear end due to impact by bus. The deformation was measured to be 23 cm at the height of 45 cm from ground level. Rear window and rear bumper were broken. No significant damage was observed in frontal part of the SUV.

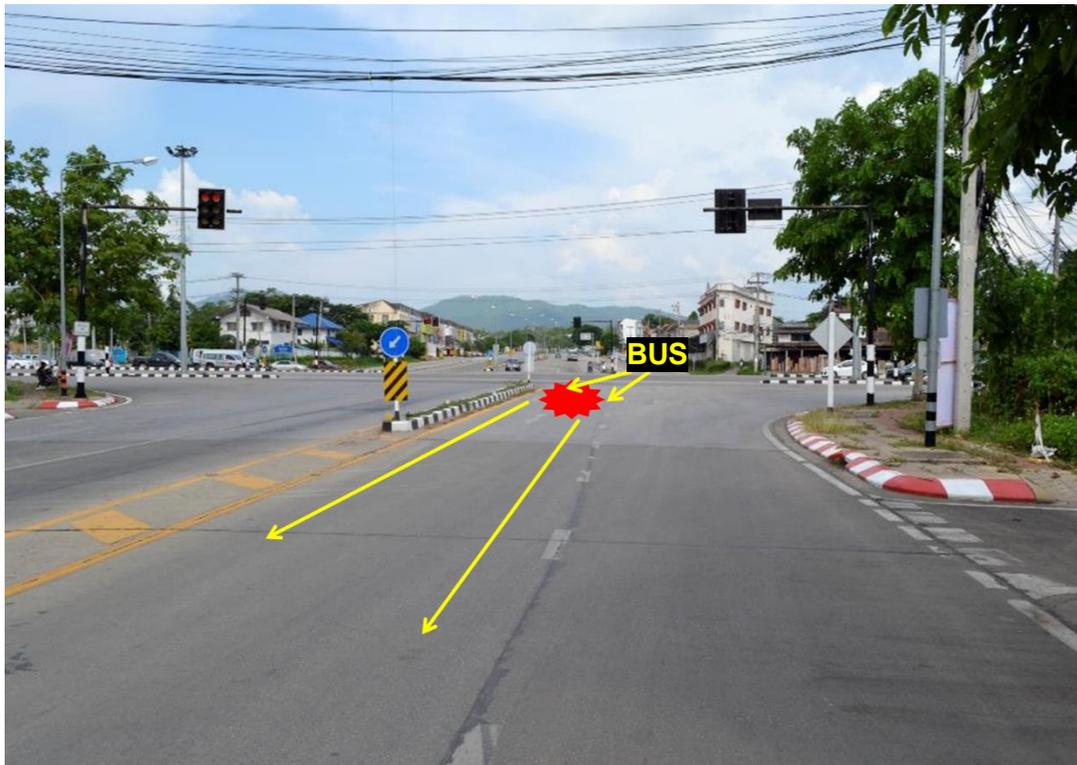
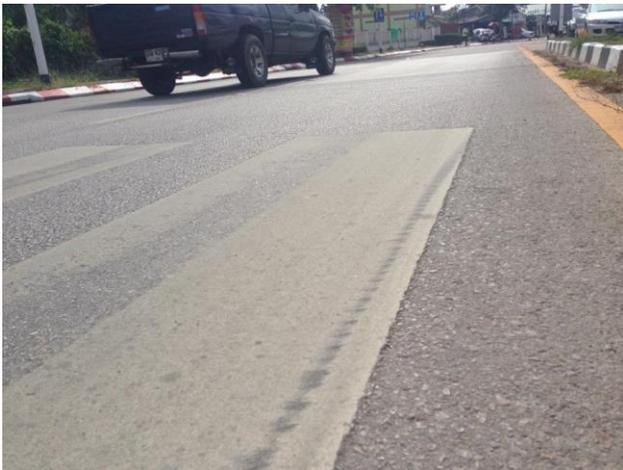
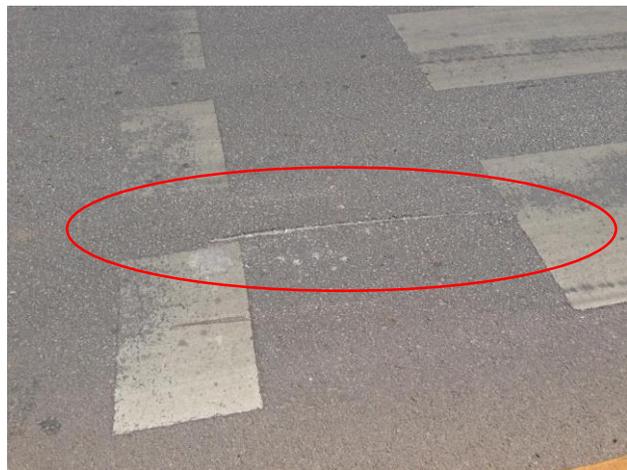
Figure 28 Evidences showing the POI of bus and Van

The bus collided with the van at the zebra crossing line as can be seen in the footage (Figure 27). There was a deep scratch on the pavement and a fresh skid mark made by the van's tire at the zebra crossing line as shown in Figure 28. Based on these evidences, TARC determined the point of impact of bus and van. POI was taken as a reference point to measure other evidences present in the crash field.

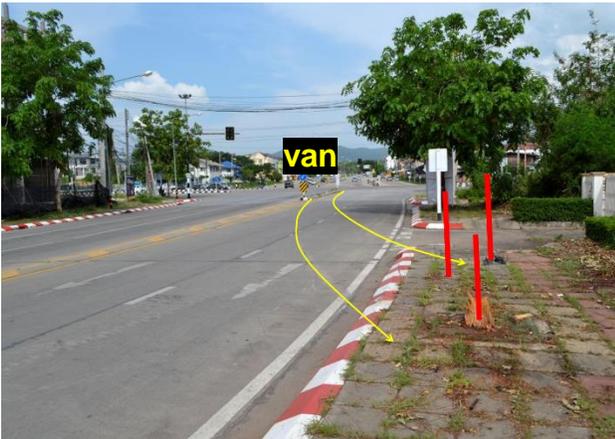
Figure 30 Wreckage of electric poles and tree (collided by van)

After the first impact, the van lost its control, rotated and hit the roadside objects (electric pole and tree), and deflected back to the roadway (**Figure 29**). The right side of the van collided with the tree. There were several evidences presented in the crash field. A long tire marks in different orientation starting from the first POI to the roadside tree, shows that the van rotated for about 50 m anticlockwise before hitting the tree **Figure 31**. **Figure 30 & Figure 32** show wreckage of the tree and the damaged electric poles. The van rested near the tree, at about 52 meter from first POI.

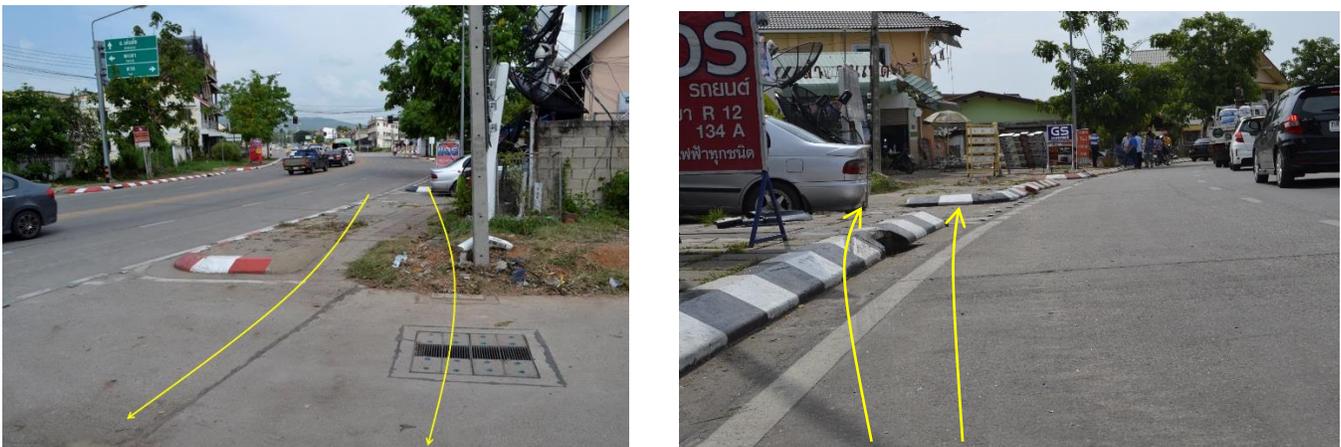
Figure 34 Tire marks showing the bus running off the road

Tire marks of bus were imprinted on the curb, indicating the point where the bus left the roadway as shown in **Figure 34 & Figure 35**.
