Accident Narrative

At about 03:45 on Tuesday, 23 July 2013, a double decker passenger bus caught fire after colliding with a truck in one of the Thailand's busiest highway, killing 19 people and injuring 18. The overnight bus departed from Roi Et and had been heading for Bangkok on the Mittraphab highway - west bound, around km 18+900, in Khaeng Khoi district in the central province of Saraburi (Figure 1).

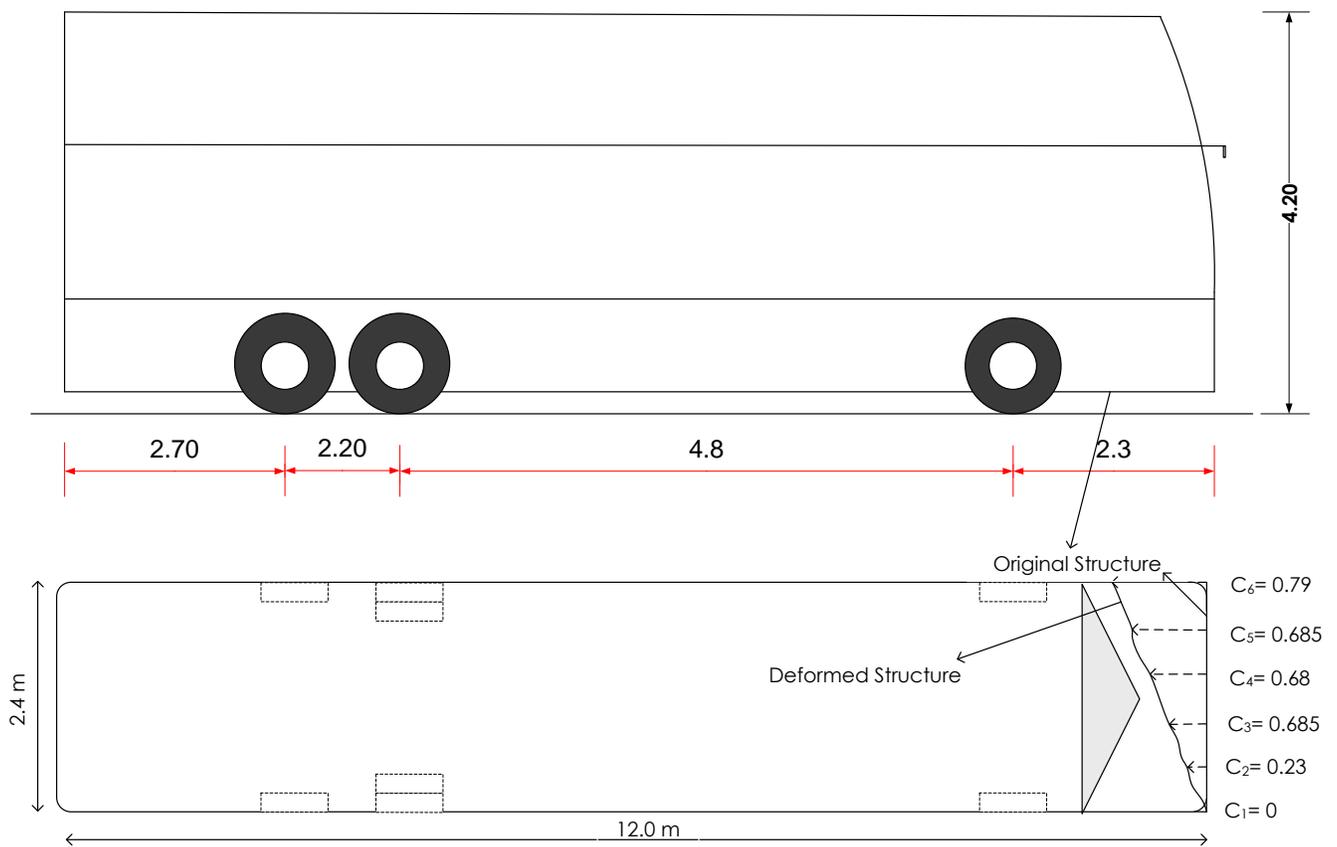
Figure 11 Crush Deformation of the Bus

The bus was 4.2 meters height in original, 12.0 meters in length and 2.4 meters in width. The bus sustained frontal crush and the right frontal corner showed a massive damages, intruding the front bumper and the frame inside the driver's compartment (Figure 12). However, the major measurable deformation was noticed on the front left axles with the maximum deformation at left corner (Figure 11). Some passenger seat were dislodged from the floor and the seat covers, carpet, front tires, ceiling material, blankets, drapes etc. were burnt completely due to the fire (Figure 13). All the windows were broken and the doors were open due to the failure of hydraulic pressure. Also, we can see from the Figure 14 , the batteries which were placed beneath the driver's seat were short circuited and damaged. The fuel tank near by the electric circuit was ejected out after the blast. According to the bus "The transport Company", the speed of the bus from GPS was 79 km/hr before the crash.

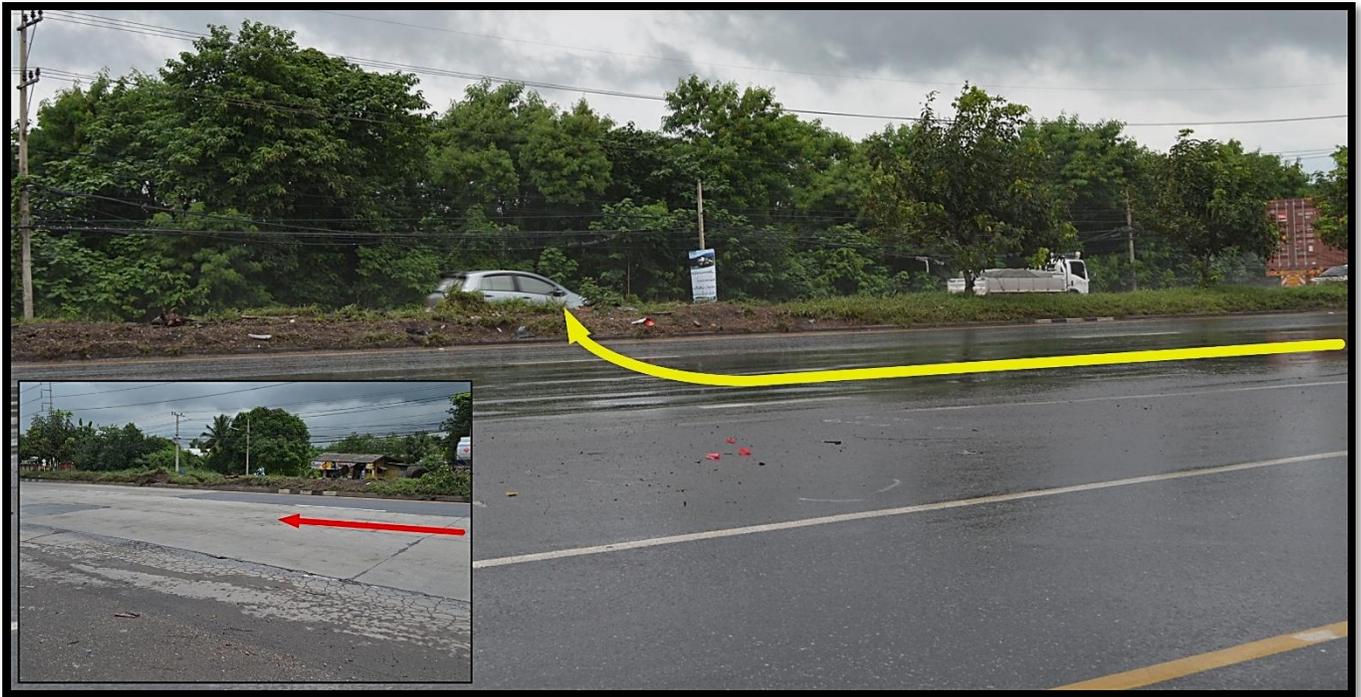
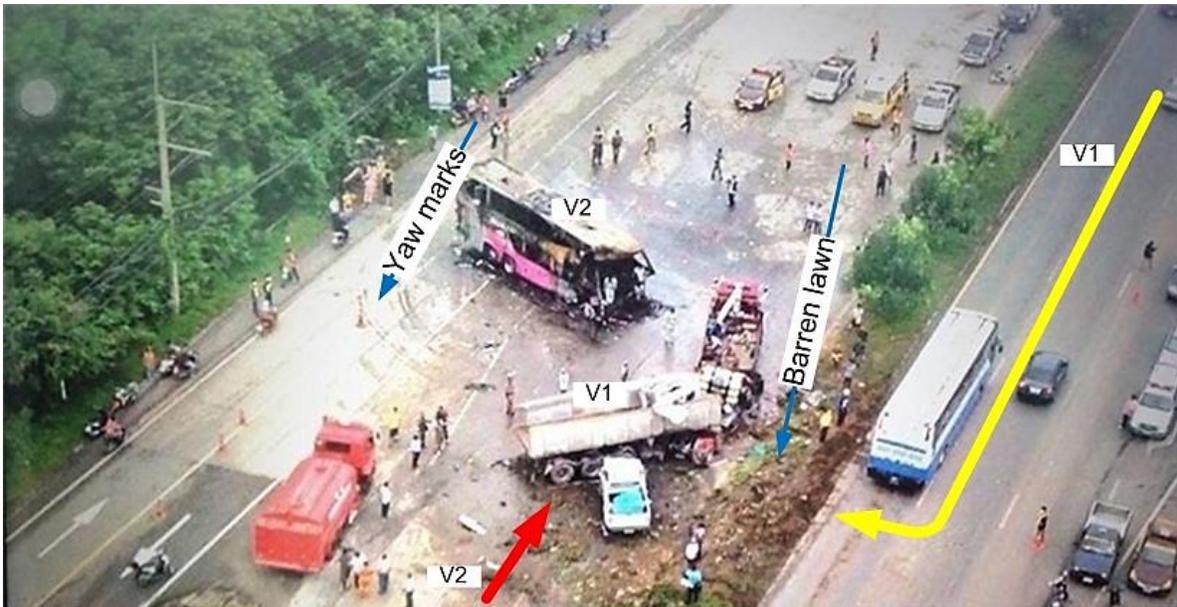
Figure 16 Sequences of the Accident Provided with Evidences (Yaw Marks and Barren Lawn)

TARC investigated the accident site and apparently found a barren patch in the median of the highway (Figure 16), which clearly shows that the truck crossed the median to the opposite direction. Also, the presence of yaw marks in the travel lane indicates that the bus rotated clockwise after it get hit by a truck.

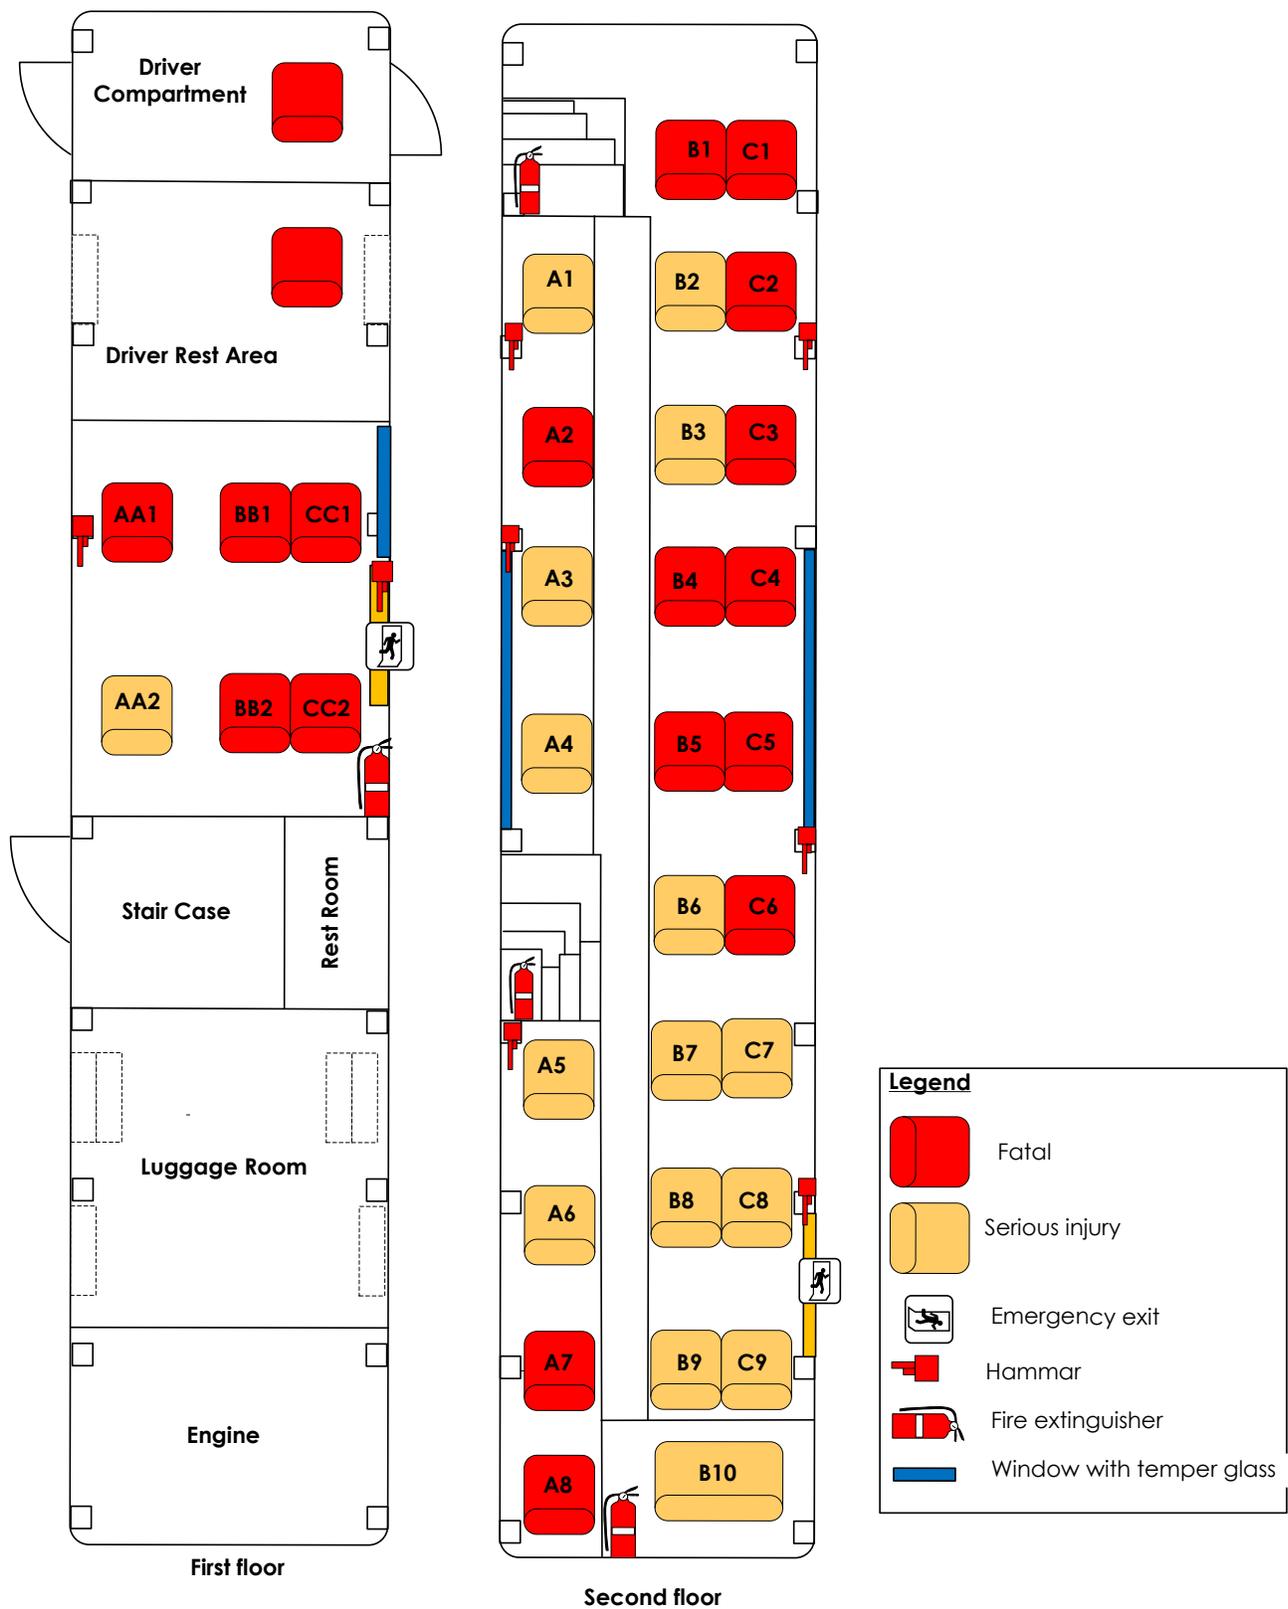
Figure 18 Seating position and the Injury Level

TARC performed an in-depth study of the casualties by classifying them according to the level of injury, seat positions, and cause of death (due to impact or fire). Figure 18 shows the casualties according to the seating position and level of injury. As we can see, most of the occupant seating in the front in both upper and lower deck has more fatality than the occupant seating in the back. The fatality was due to the impact and the fire. According to the report from Institute of Forensic Medicine, 10 out of 19 occupants died before the bus catches fire and the rest of them died because of the respiration failure due to smoke. The details of the fatality and injury according to the seating position are presented in Figure 19. Similarly, the summary of the injury information based on ICD code are presented in

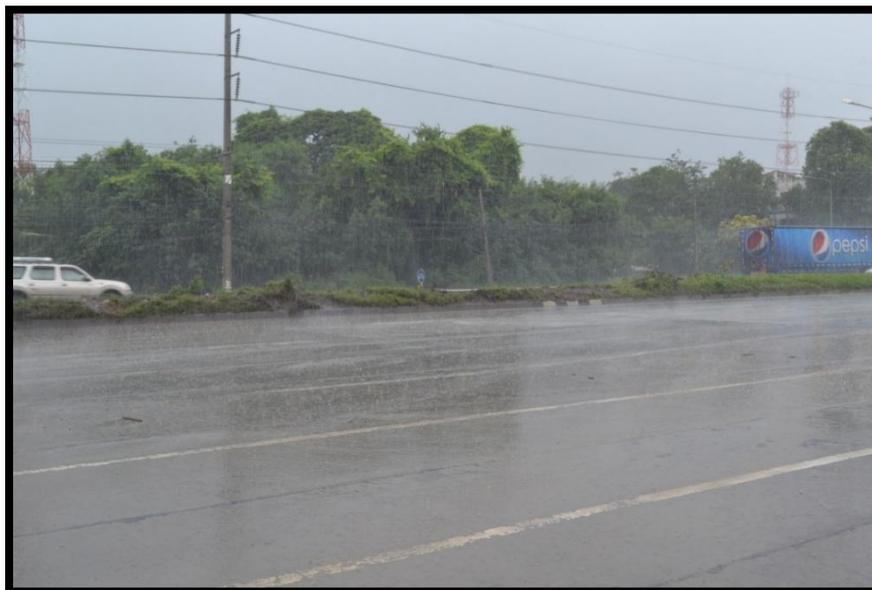
Figure 20 Wet pavement Surface seen at the Crash Site

TARC investigated the crash site, its highway and environmental condition to find out if they have any significant effect on the accident. The wet surface could be one of the factors contributing an accident. According to the witness, during the crash, there was a raw drizzling rain and the road surface was wet (Figure 20). Wet roads have lower level of friction and skidding/loss of control can occur when the forces generated in acceleration, braking or cornering exceed the level of grip available. Similarly, another contributing factor could be the low curb height of the median due to pavement overlaying. The use of curb in high-speed roadways can be dangerous because of their potential to cause drivers to lose control and crash. The vertical curb have some stability to redirect errant vehicles since the impacting wheel is steered by the curb in a direction parallel to the travel way. If the impact velocity and angle are modest, this steering action is all that may be required to prevent the vehicle from leaving the roadway. If the speed and encroachment angle are higher, then the steering action of the curb alone is not sufficient to redirect the vehicle, leaving it from roadway or rollover. Also, the highway in this case has no shoulder between right edges of the road and curb (Figure 21). This can cause the tires of the vehicle has high chance to get over the curb, esp. if the height of the curb is too low. All these factors coupled together might have made a situation for the truck to cross over the median and collide.

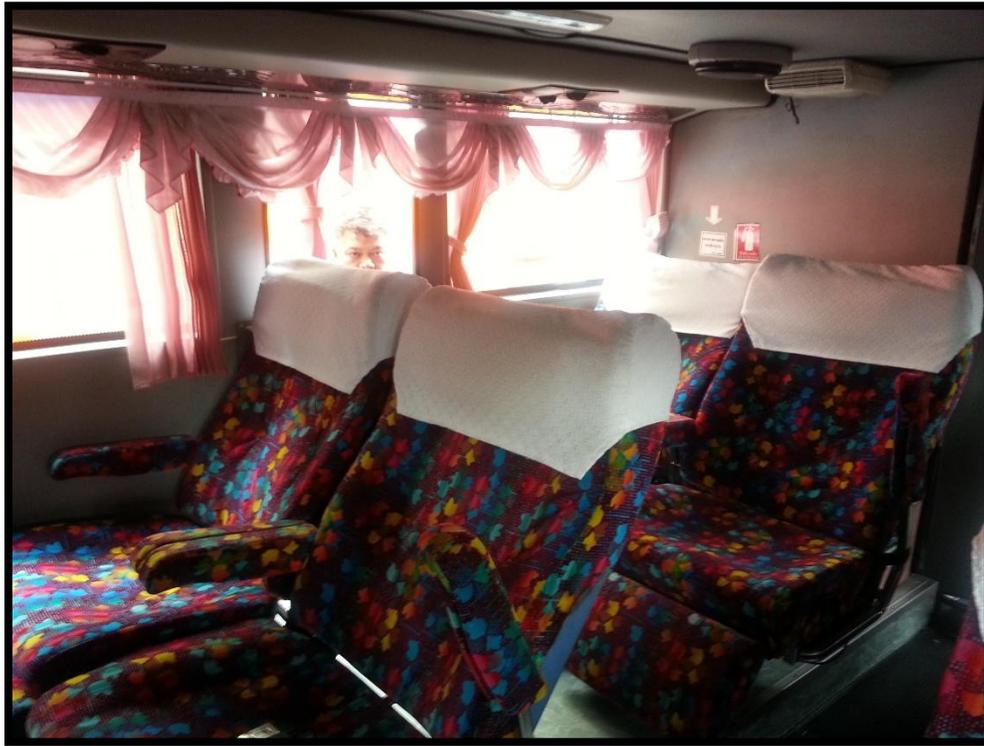
Figure 22 Flammable Materials Inside the bus

The design of fuel tank near the electric circuit was observed in the bus. The source of ignition of the fuel tank could be the short circuit nearby, making an explosion and leading to the fire spreading all over. As seen in Figure 22, the presence of thick seat covers, carpet, ceiling material, blankets and drapes inside the bus can be the another contributing factor for the severity of injuries. These materials can be burn easily and produce excessive smoke when caught with fire. The smoke of these burning cloths and foams can be dangerous for human, which may cause respiratory failure due to choking. From the autopsy report, 10 occupant died

due to the respiratory failure, which might be only due to the smoke from these flammable materials inside the bus.
