Case ID: 060407-01

Accident Narrative

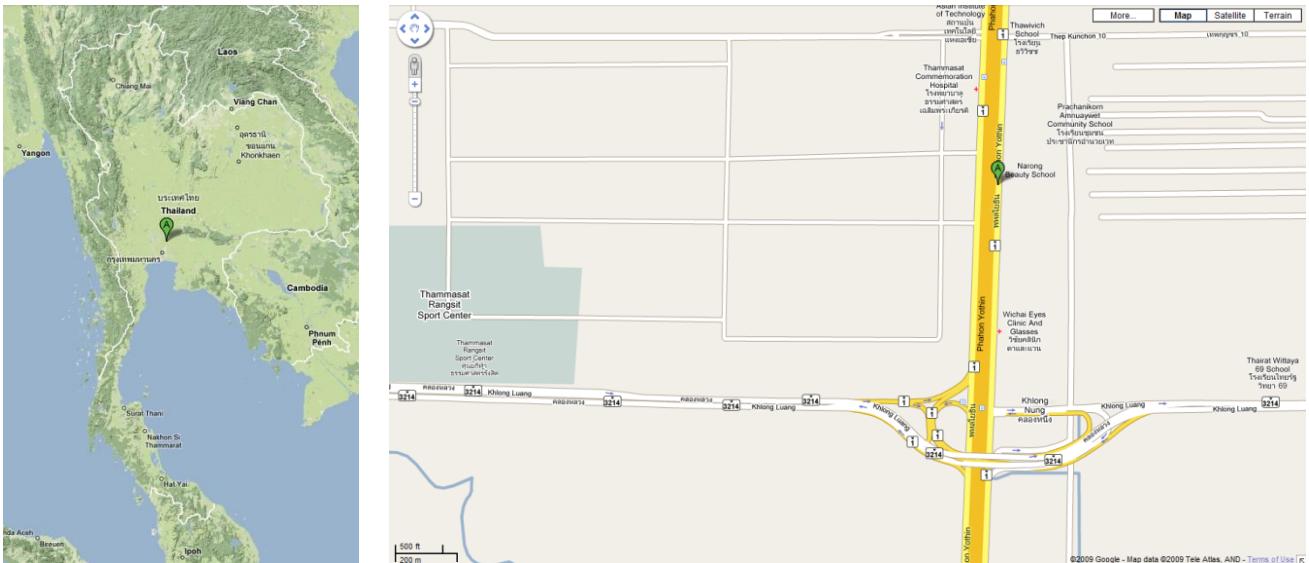
Figure 3-1: Accident Location

On 7 April 2006, at 9:30 A 23 years old male driver started his trip from Hi Tech Industrial Estate, Ayutthaya at about 7:00 in the morning. While he was traveling towards Bang Na on Highway No.1 at KM.41+100 (**Figure 3-1**), the front right tire suddenly blew out. He tried to slow the car by applying the brakes but the car failed to stop. It fell into a roadside concrete open ditch and moved for some distance. The pickup stopped in a roll position, the left wheels were in the canal and the right ones were along the roadside as shown in **Figure 3-2**. The driver, the only occupant, received no injury.
