Case ID: 060811-01

Accident Narrative

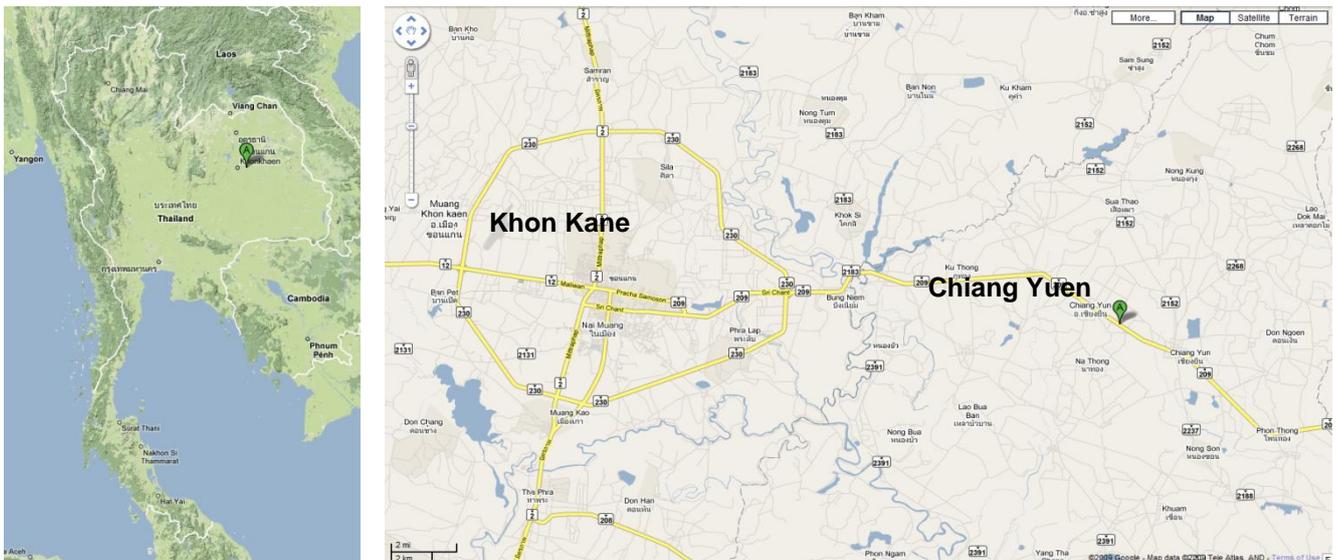
Figure 3-1: Accident Location

At about 07:00 on Thursday, 11 August 2006, a family left Ayutthaya province, planning to join their relative's funeral at Chiang Yeun in Mahasarakham. At about 06:30 on Friday, 11 August 2006, 11.5 hours later, the pickup that was traveling eastbound on Highway no. 209, a four-lane divided highway, near Chiang Yeun, Mahasarakham (**Figure 3-1**), lost control and rolled over by crossing the median into the westbound lane. The vehicle finally stopped on wheel position, facing westbound. **Figure 3-2** shows the major events of the crash.

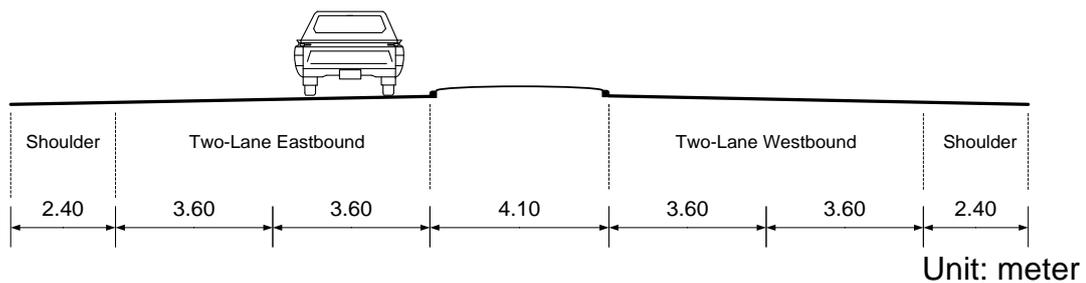
Figure 3-5: Highway Number 209 Cross Section at the Crash Scene

The accident occurred on the east- and westbound lane of Highway number 209 in Chiang Yeun which runs between Khon Kaen and Kalasin. The straight-level section of the two lanes eastbound and the two lanes westbound are divided by a 4.1 m. raised median, as shown in **Figure 3-5**. All lanes are 3.6 meters wide, with a 2.4 meter outside shoulder. The asphalt pavement had a coefficient of friction of 0.82 for the 1nd lane and 0.76 for the 2nd lane with a 3.33 % crown slope.

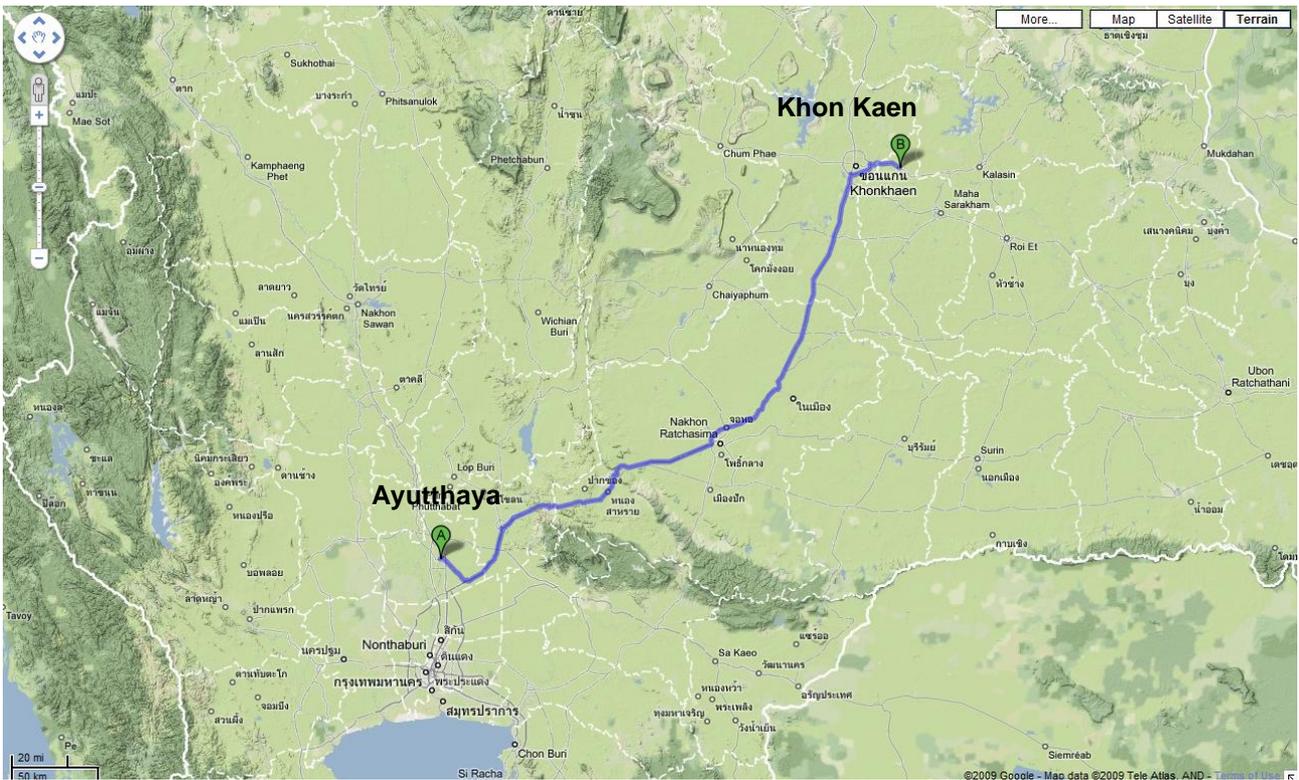
Figure 3-9: Traveled route

The driver started his journey from Ayutthaya at about 19:00. The crash happened in the early morning, at around 06:30. He had been driving for roughly 11.5 hours before the crash occurred. No alcohol related to driving was found during the interview and from medical reports. **Figure 3-9** shows the travelled route prior to the crash. The graphic chart of driving hours is shown in **Figure 3-10**.
