# Case ID: 081017-01

## Accident Narrative

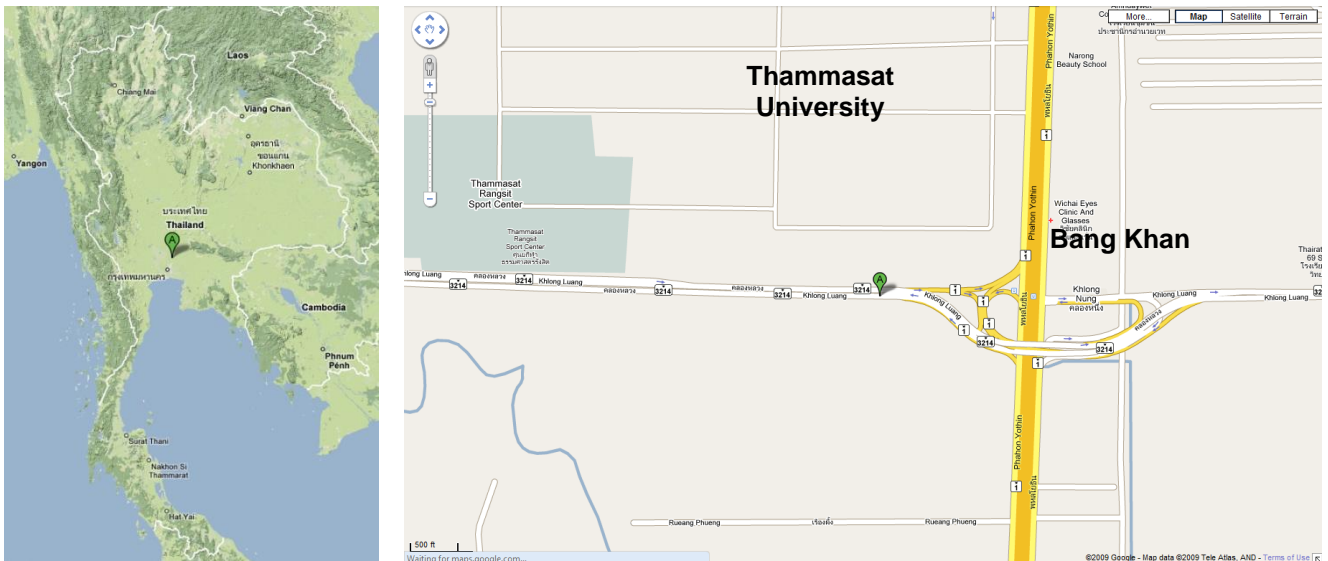
**Figure 3-1: Location of the Crash Site on Highway No.3214 near Klong Luang Interchange**

After a long trip from Chiang Rai, at about 04:30 AM on 17 October 2008, a van lost control on Highway No. 3214, close to the Klong Luang Interchange (**Figure 3-1**). Immediately after leaving the traveling way, the vehicle hit the rear part of another van and crashed into the wall of a workshop's gate and successively hit an electric pole nearby before stopping. The front part of the van intruded into the occupant compartment with an apparent box-shaped deformation and the driver suffered serious leg injuries.

The building and electric pole were located on the roadside at 7.0 m. and 5.5 m. from the edge line, respectively. Some light damages were spotted on the concrete wall but no damage was located at the electric pole. As a result from the crash, the driver suffered leg injuries after being trapped inside the van. An emergency team took about 30 minutes to rescue him before being able to send him to Thammasat University Hospital.

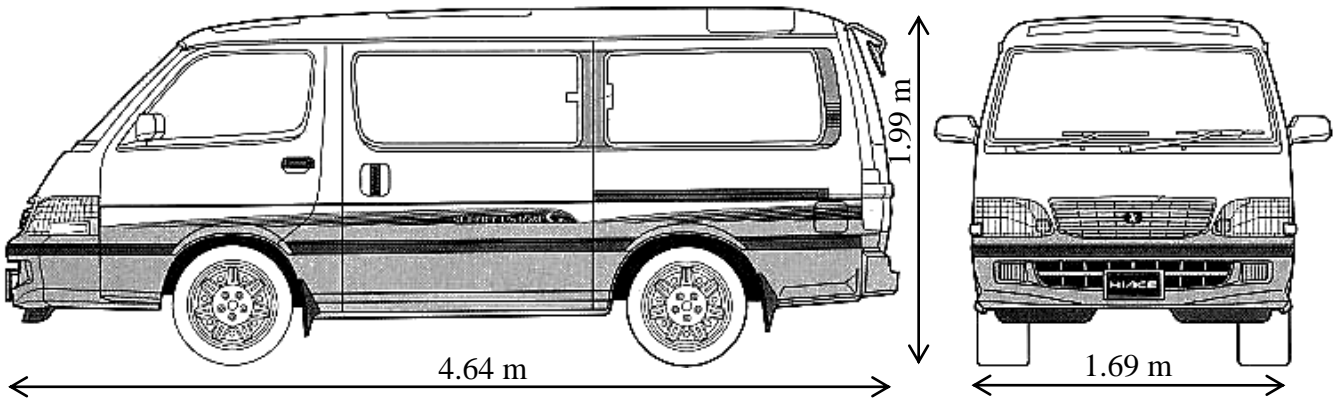
**Figure 3-3: Vehicle Dimension**

The crashed vehicle was a Toyota Hiace Van 3,000 CC., diesel engine and 2,010 kg curb weight. It was 4.64 m. long, 1.69 m. wide, and 1.99 m. high. The wheelbase was 2.33 m. originally. There were two seats in front and 9 seats in 3 rows in the passengers compartment. All the seats were designed as bucket seats without seatbelt, except for the front row. **Table 3-1** presents the detail of the tires information.

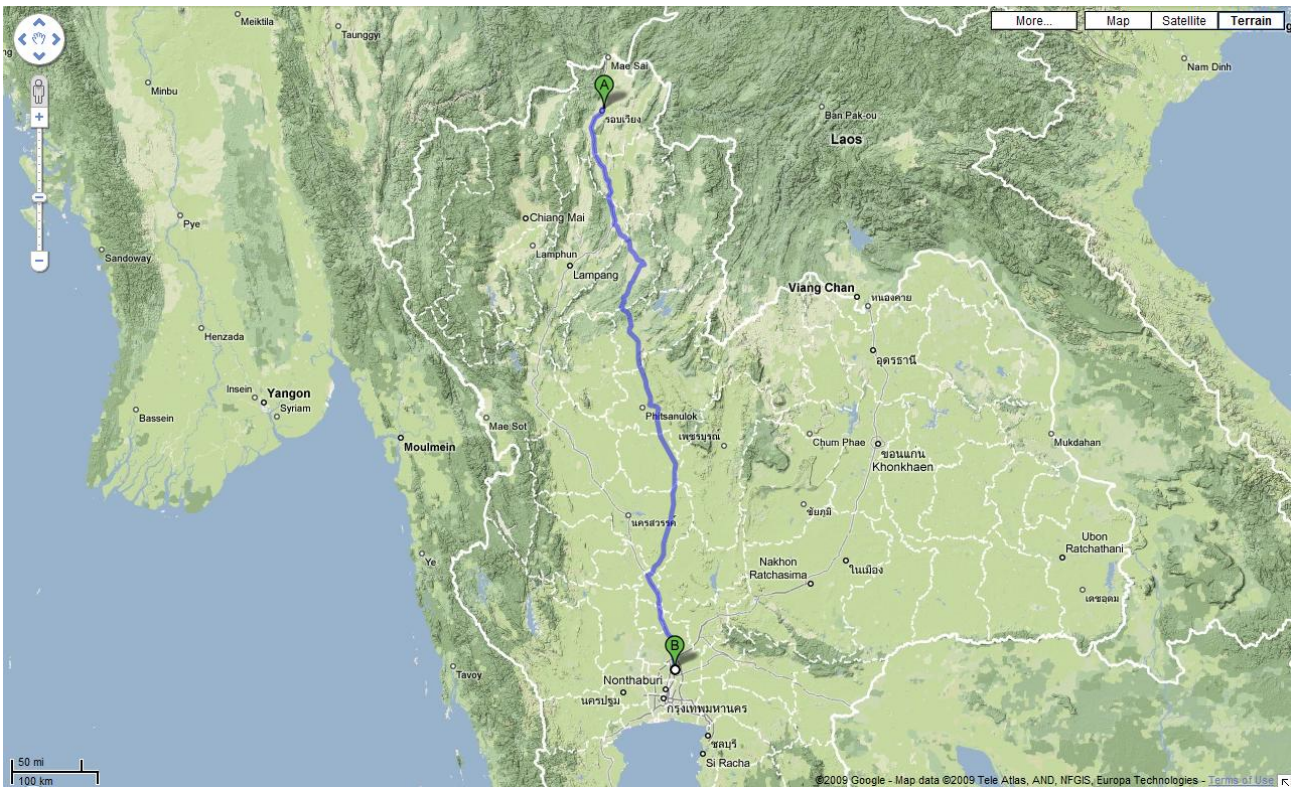
**Figure 3-7: Traveled Route**

This trip started from Chiang Rai, a city in the Northern region, about 750 km. from the crash scene. The driver insisted to the police that the customer offered him to Chiang Rai trip. On the way back, he suddenly fell asleep thus initiating the crash. The driver was not reported for alcohol use, according to the police, rescue team or hospital records. Witnesses made no mention of other vehicles involved in the crash.
