Crash ID: 150221-01

Accident Narration

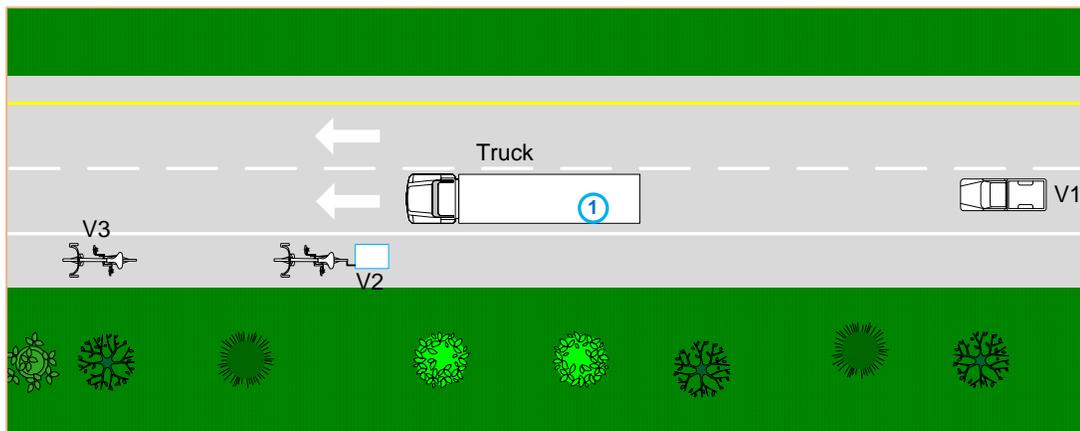
Figure 2 Pre-crash motion of the vehicles

Based on the evidences from investigation, prior to the crash, both bicycles were travelling on the left shoulder and pickup was following a truck in the left lane. According to the pickup driver, the truck was changing lane to right and he was unaware of the bicycles (**Figure 2**). Pickup driver did not wait by the time truck fully changing the lane, but he tried to overtake the truck to the left by using shoulder space on the left side. While overtaking, the pickup collided to the bicycle (V2) with the heading angle of 11 deg. During the crash, at first, the right side of the pickup hit the left side of bicycle carriage (V2) as shown in **Figure 3**. The rod connecting the carriage and bicycle was broken, the male rider was ejected out of the bicycle and hit the windshield bar at left front of the pickup.

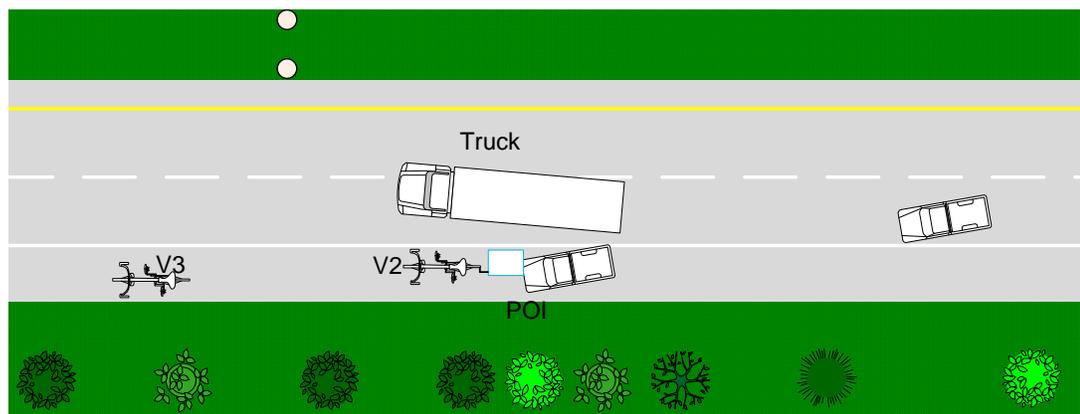
Figure 3 Motion of the vehicles during crash

The pickup lost control and run off the road with its left wheel on the side slope and right wheel on the edge of shoulder, inclined at 20 deg. After running off the road for 20 m, the Pickup swerved right to roadway in order to recover. At that instance, the male rider (V2 rider) fell off from the pickup hood and rested on the side slope .Also, while recovering, the front right side of the pickup hit the another bicycle (V3). Then, V3 rider vaulted for about 17 m and rested in the middle of road. Due to hard braking and swerving, the pickup rotated and overturned with its left side down first. The pickup slid to the median edge, and rested with its upside down. **Figure 4** shows the post-crash sequence of the crash. Moreover, the summary of the schematic sequences of the crash is shown in **Figure 5**.

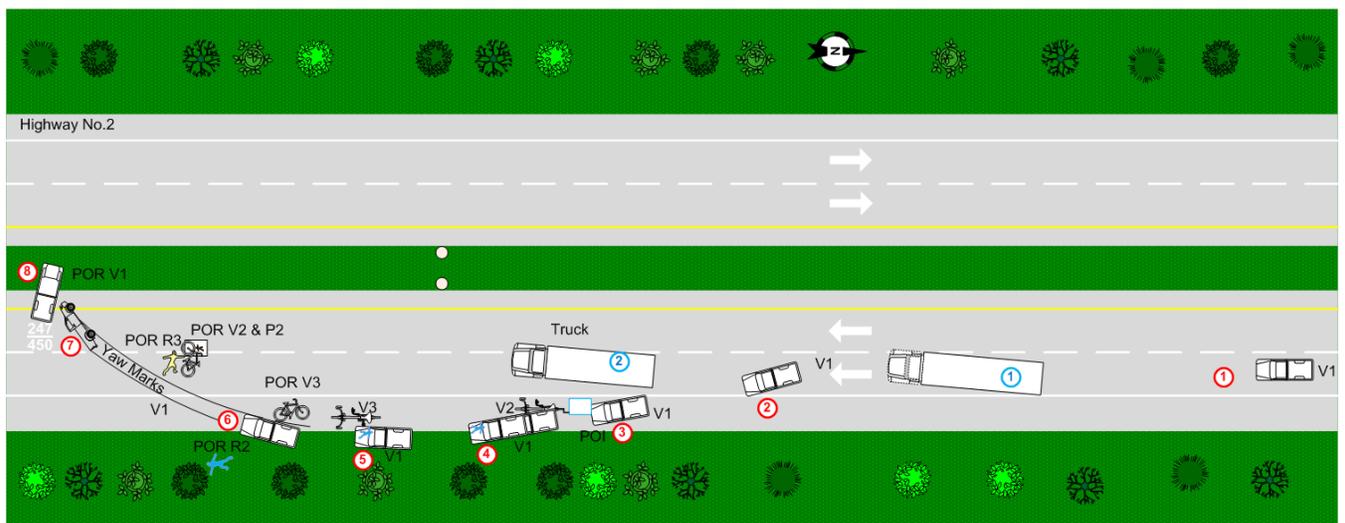
Figure 5 Summary of the schematic sequences of the crash

| ① Pre-crash position of pickup | ⑥ Falling off male rider |
| ② Pickup overtaking using space of shoulder | ⑦ Overturning of Pickup, left side down |
| ③ Point of Impact with carriage and male rider | ⑧ Pickup resting at median, upside down |
| ④ Pickup-run off road, male rider in windshield/hood | ① Pre-crash position of Truck, lane changing |
| ⑤ Pickup braking, swerving to right, and collision with female rider | ② Position of truck during crash, lane changing |

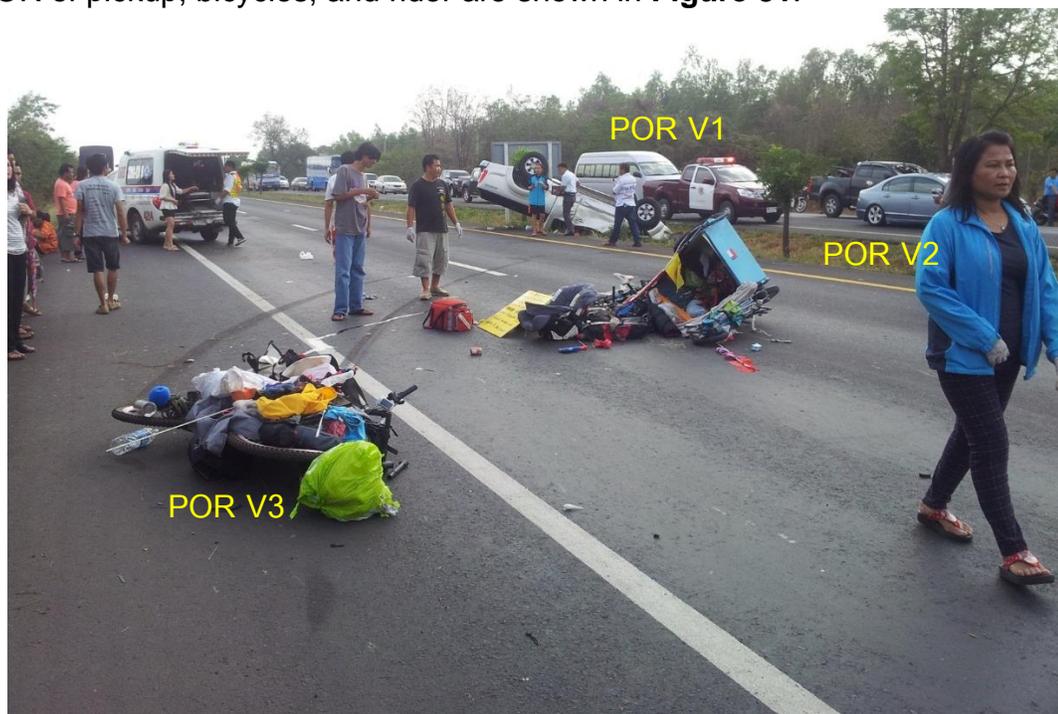
Figure 28 POR of bicycles (V2 & V3) and pickup (V1)

Figure 28 & Figure 29 show the point of impact and point of rest of rider, bicycles and pickup. POR of V2's rider is about 30.02 meters far from POI. The distances between the POR of pickup, bicycles, and rider are shown in **Figure 31**.

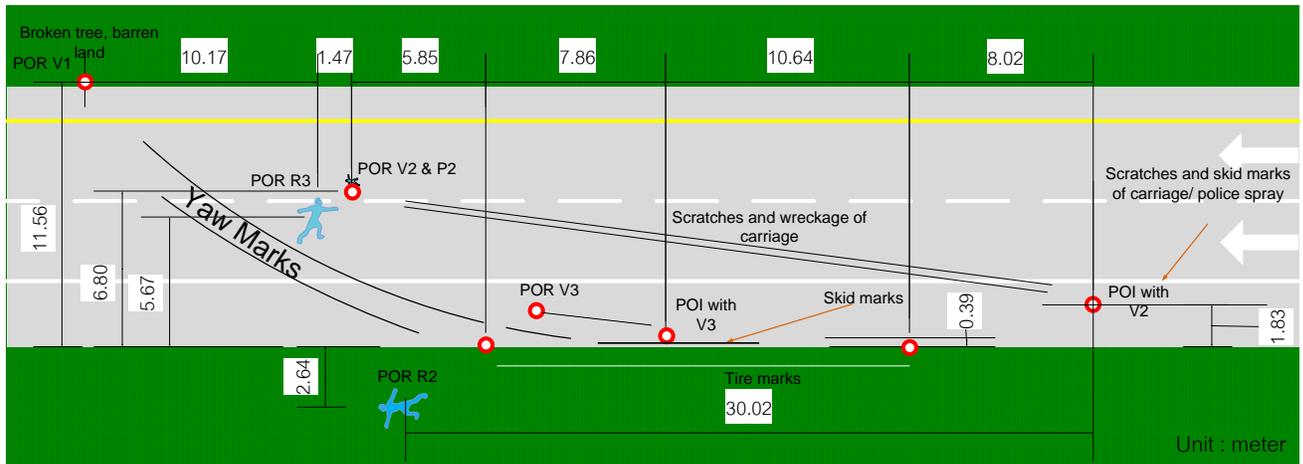
Figure 31 Summary of the physical evidences present in the crash scene

Similarly, **Figure 30** shows the broken metal rod after the impact, POR of V3's rider and the scratches leading to the POR of V2. These evidences indicate that after the impact, the carriage disconnected from the bicycle and slide towards the middle of the road. **Figure 31** demonstrates the summary of physical evidences that were collected in the crash scene after the accident.

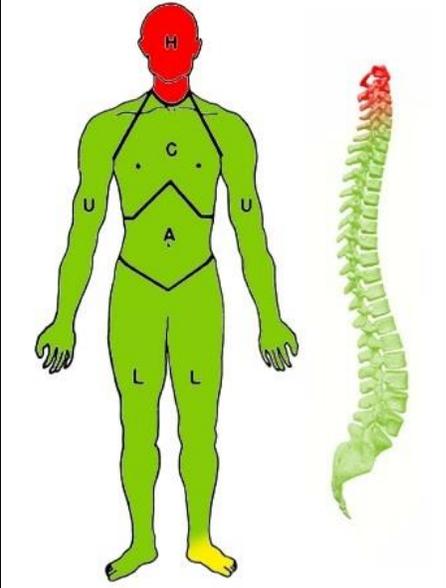
Table 3 Injury information of V2 rider

Head	<ul style="list-style-type: none"> • Fracture of skull • Severe blood loss from head • Open wound on head (4 cm) 	6	
Neck	<ul style="list-style-type: none"> • Fracture of cervical spine • Neck contusion 	6	
Lower extremity	<ul style="list-style-type: none"> • Left foot deformity 	3

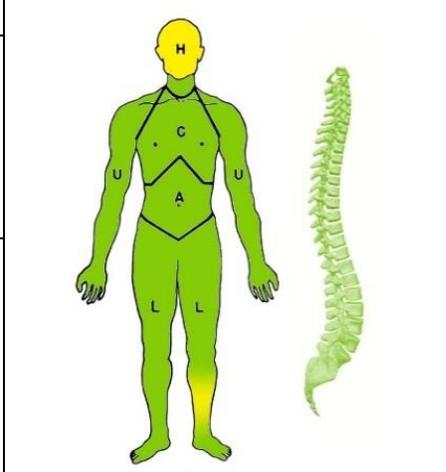
Table 4 Injury information of V3 rider

Face	<ul style="list-style-type: none"> • Laceration wound on lip (3 cm) • Contusion on forehead (5 cm) 	2	
Lower extremity	<ul style="list-style-type: none"> • Fracture of left fibula 	3

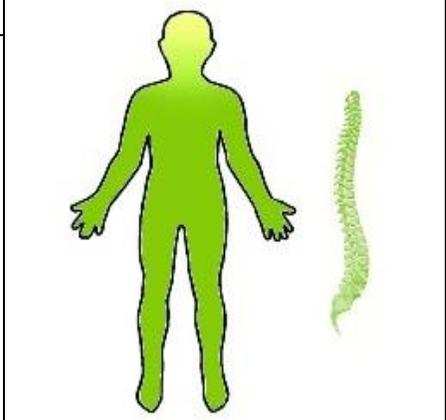
Table 5 Injury information of child

Face	<ul style="list-style-type: none"> • Abrasion wound 	1

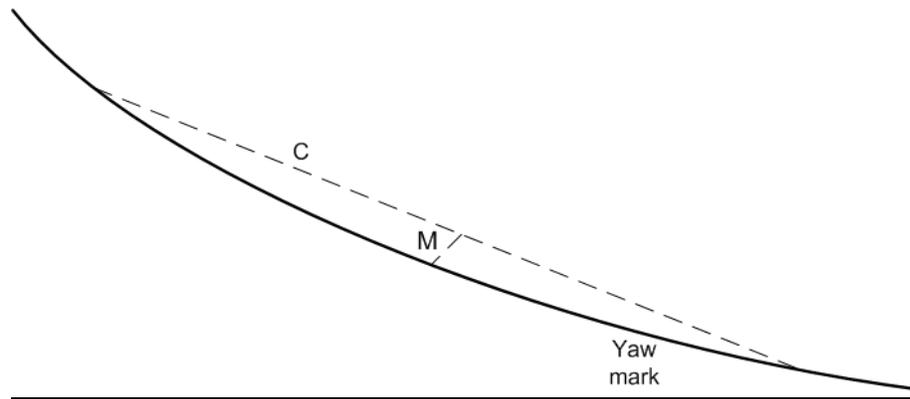
From Yaw marks

- Middle ordinate, $M = 0.84 \text{ m}$, Chord, $C = 19.1 \text{ m}$
- Radius of curvature (R) = $C^2 / (8M) + M/2 = 54.14 \text{ m}$
- Critical velocity, $V_4 = \sqrt{(g \times R \times f)} = 20.08 \text{ m/sec} = \mathbf{72 \text{ km/hr}}$
- Skid mark (d) = 7 m on shoulder
- Impact Speed (V_2) = $\sqrt{(V_1^2 + 2gfd)} = 22.41 \text{ m/s} = \mathbf{80.66 \text{ km/hr}}$

The 60 mm deformation on the frontal frame of pickup indicates that some energy might have dissipated during the collision. Hence, the pre-crash speed of the pickup can be estimated as: 81 to 85 km/hr.

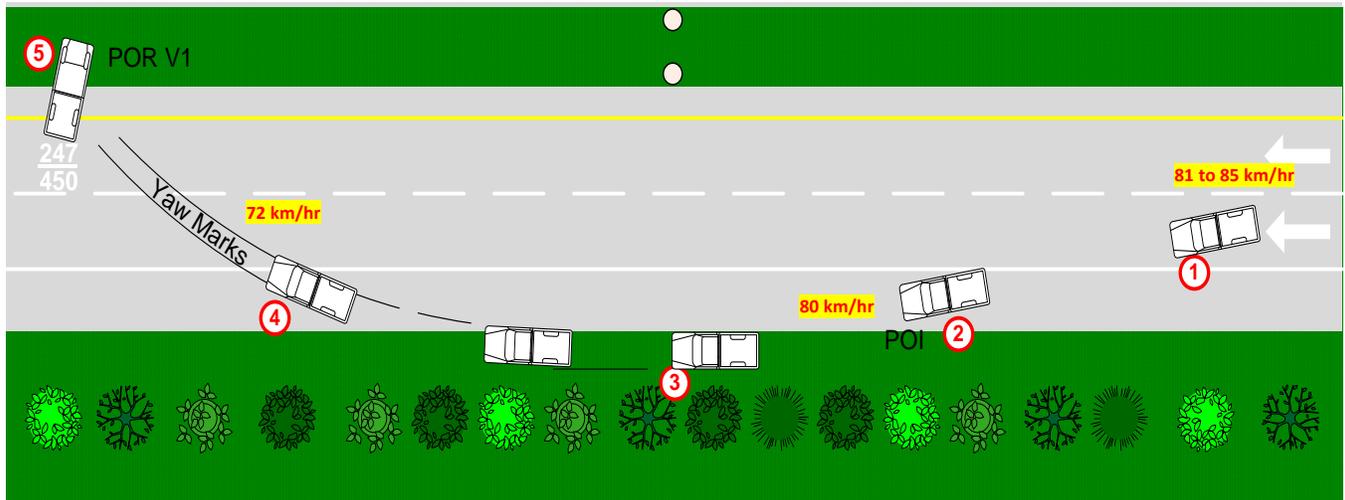
Figure 34 Speed of the pickup at different events

Speed of the pickup at different events are shown in **Figure 34**. Impact speed with V_2 was 80 km/hr. Furthermore, the speed of pickup during collision with female rider was between 73 to 80 km/hr. The operating speed of other pickups on this highway was 92 km/hr.

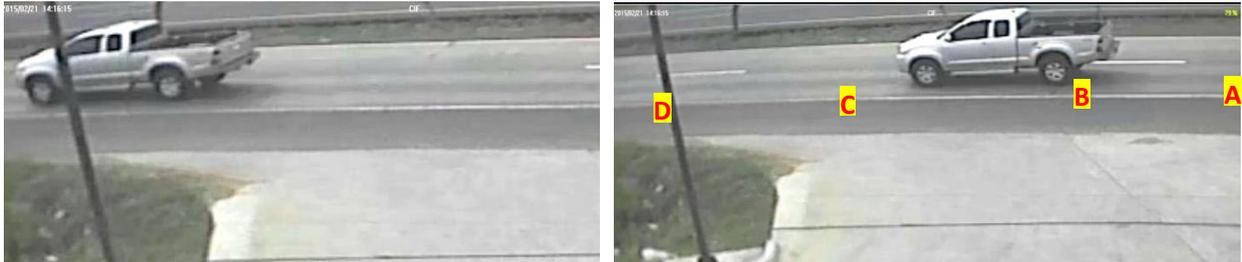
From CCTV footage

- Time at point A = 55.121 s
 - Time at point B = 55.321 s, at distance 4.5 m from A
 - Time at point C = 55.622 s, at distance 11 m from A
 - Time at point D = 55.755 s, at distance 15 m from A
- Speed (V1) from point A to B = $(4.5/(55.321-55.121)) \times 3.6 = 81 \text{ km/hr}$
 - Speed (V2) from point A to C = $(11/(55.622-55.121)) \times 3.6 = 80 \text{ km/hr}$
 - Speed (V3) from point A to D = $(15/(55.755-55.121)) \times 3.6 = 85 \text{ km/hr}$

Hence, average travelling speed of pickup = $((V1) + (V2) + (V3))/3 = 82 \text{ km/hr}$
