Case ID: 060815-01

Accident Narrative

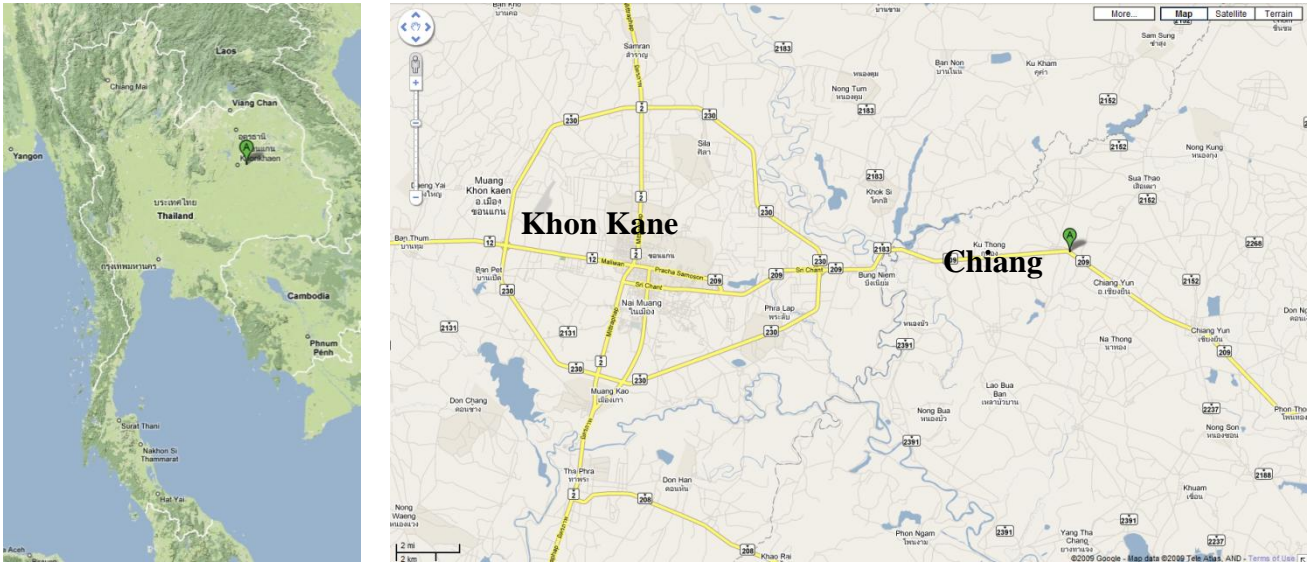
Figure 3-1: Accident Location

On the rainy day of Tuesday, 15 August 2006, at about 14:25 the pickup, traveling eastbound on highway no. 209, a four-lane divided highway, near Chiang Yeun, Mahasarakham (**Figure 3-1**), lost the control and rolled over into median. The vehicle, finally stopped in on-wheel position, heading backward to the oncoming direction. The schematic of the accident scene is shown in **Figure 3-2**.
