Case ID: 060829-01

Accident Narrative

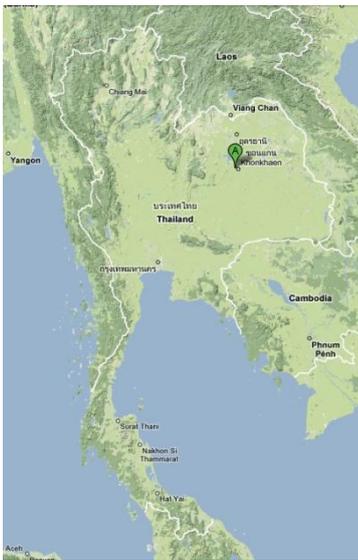
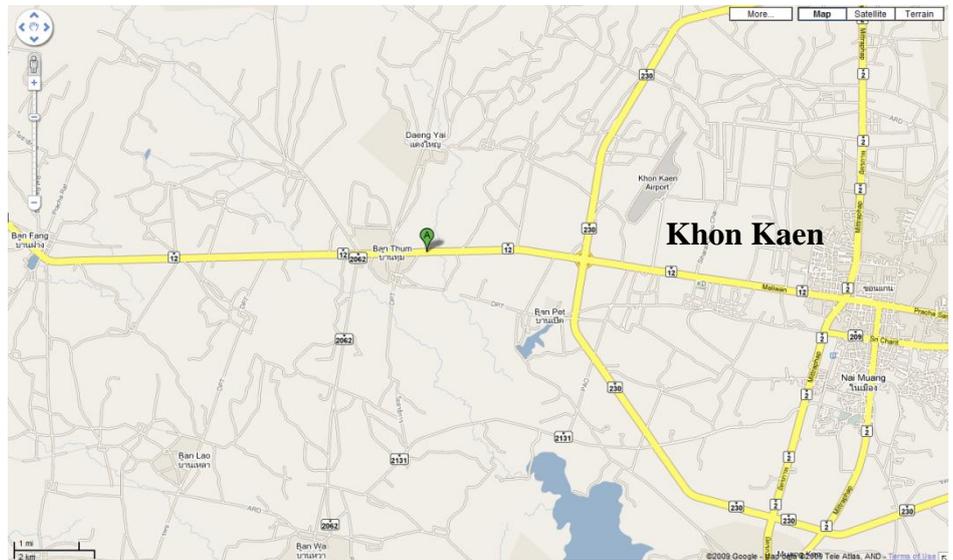
Figure 3-1: Accident Location

At about 14:00 on the rainy Tuesday, 29 August 2006, a pickup traveling eastbound on Highway No.12, a four-lane divided highway, from Ban Fang, Khon Kaen (**Figure 3-1**), and lost control and rolled over into a ditch. The pickup driver informed that he lost control after approaching surface water due to rain on the second lane after trying to overtake a slower van on the 1st lane. The pickup made a complete one turn rollover before hitting the electric pole. The vehicle finally, stopped on its left side, heading north. The driver had no injury while the front passenger suffered serious injuries to the head. **Figure 3-2** shows the major events of the crash.

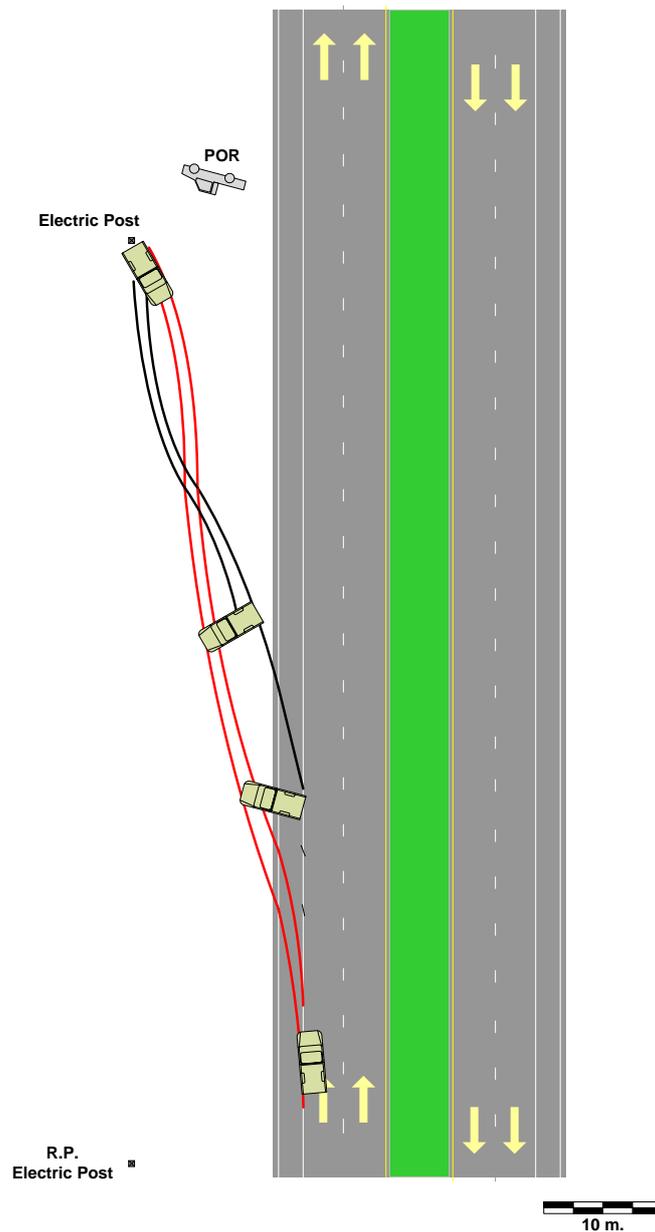
Figure 3-2: Schematic of Accident Scene

The pickup was found to have made a 1-full turn and a 0.25-turn with its rest position on its left side, showing that it rotated and spun over three-axis, supported by the marks on the ditch and at the electric pole. The roadside slope, 4:1, was not “errant-friendly” for the loss of control of the vehicle. In addition, due to rain and low lying ditch the water accumulation made the soil softer than usual in the dry season. This soft soil might have caused imbalance of the errant vehicle resulting in roll-over. **Figure 3-14** shows the location of the vehicle rollover after leaving the roadway.

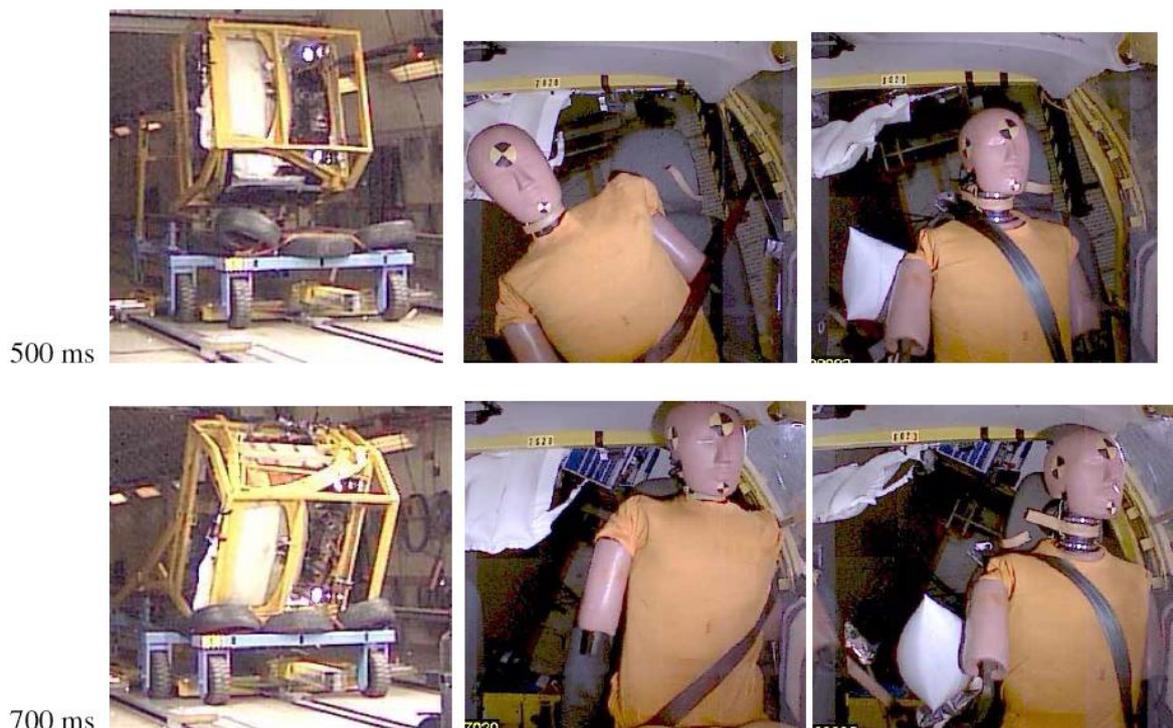
Figure 3-15: Outboard and inboard non-leading occupant views for standard (left) and reversed (right) belt geometry at 500 and 700 ms

reversed geometry and an inboard torso side-support airbag for improved protection in rollover, shows the comparison of lap-shoulder belt in standard geometry and in reversed geometry (Bostrom et. al, 2005), as shown in **Figure 3-15**.

From the study, it is observed that the head of the non-leading side (far-side) dummy impacted the inner roof in the standard 3-point belt configuration, the seat integrated 3-point belt with reversed geometry and buckle pretensioner showed the ability to restrain the torso from moving inboard and towards the roof during the rollover tests.
