Case ID: 080126-01

Accident Narrative

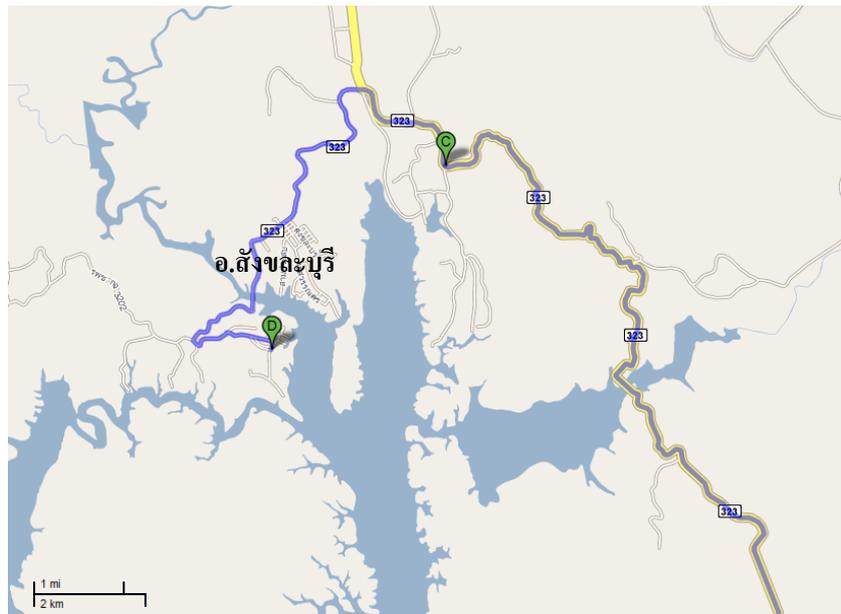
Figure 3-2: Mountainous Section at Sangklaburi

The road section at km. 65+000 is the mountainous area (Before point C in **Figure 3-2**). The driver applied the first gear on the uphill section and change to the second gear on the downhill. At that time, he decided to overtake the slower truck in front but it was not success since there is a set of concrete barriers protecting vehicle overtaking at that area. The bus then collide the truck at its rear because the bus driver could not slow it down.

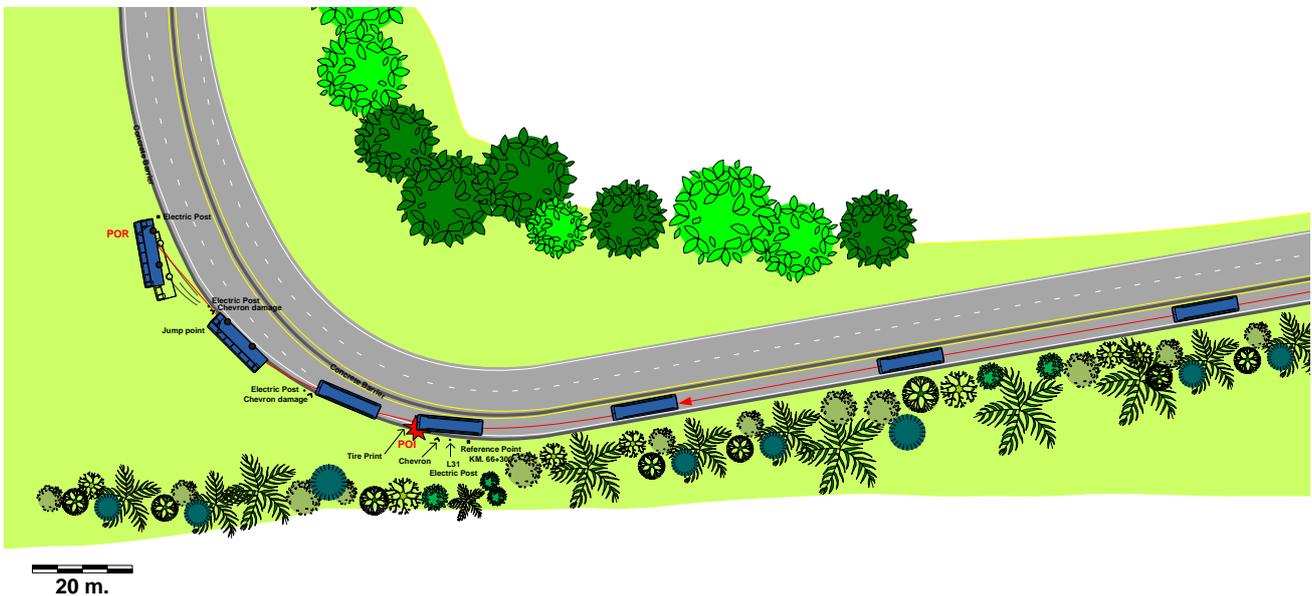
Figure 3-3: Collision Diagram

The truck stopped on the left trying to have some conversation with the bus driver. Some passenger said the truck driver waved his hand guiding the bus entering the emergency ramp. However the driver found the problem of braking system. His wife got out from the bus with a big piece of wood obstructing the bus at the front wheel but it was too small. The bus then moved without turn the engine on to the steep slope about 300 m. The bus hit the concrete barrier at km. 66+310 (**Figure 3-3**) making it rollover and stopped at about 23.5 m further.

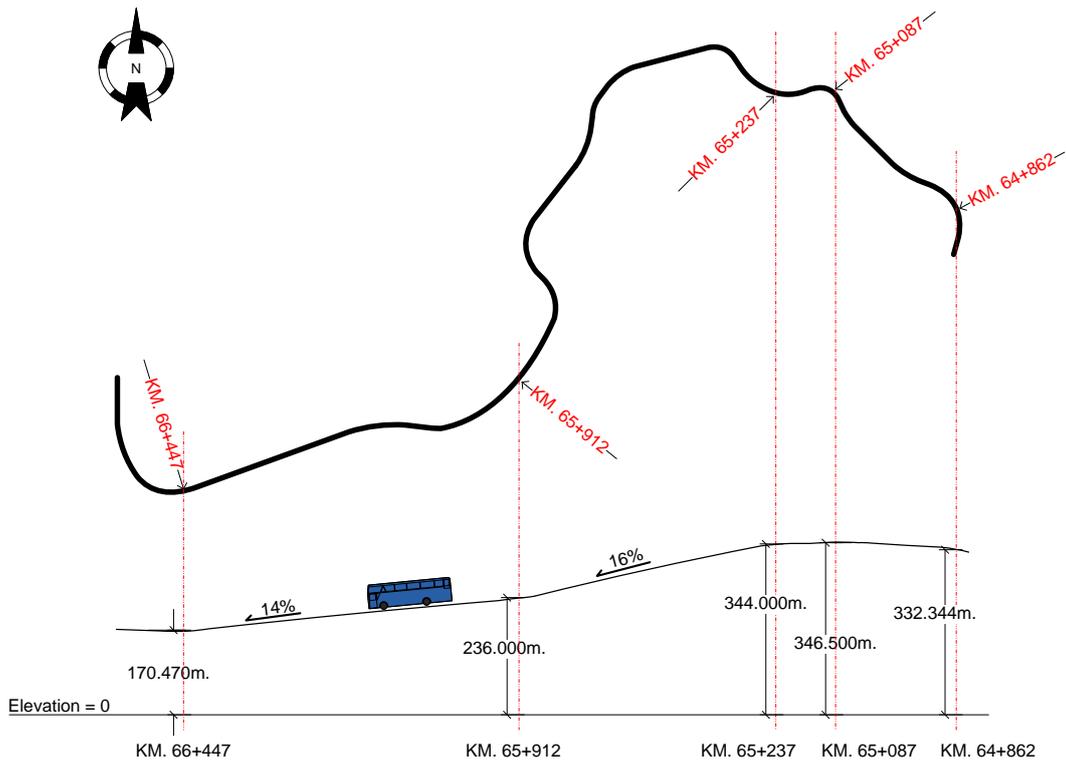
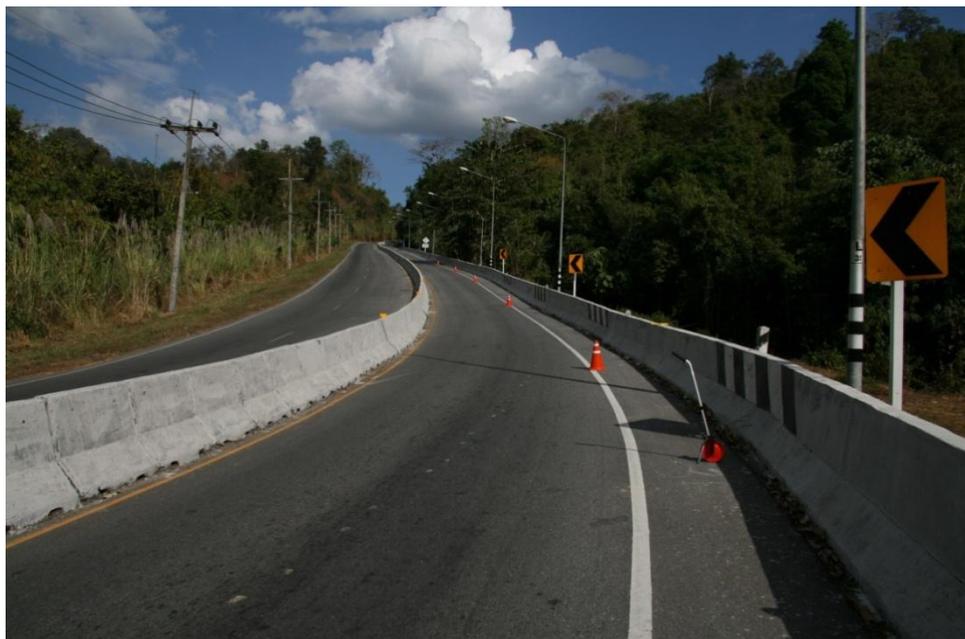
Figure 3-18: The Crash Location

The accident occurred on Highway No. 323, connecting between Thongpaphum and Sangklaburi. The road is two-lane two-way. At the area of crash (**Figure 3-18**), the road expands to two uphill lanes with a concrete barrier installed on the lane line.

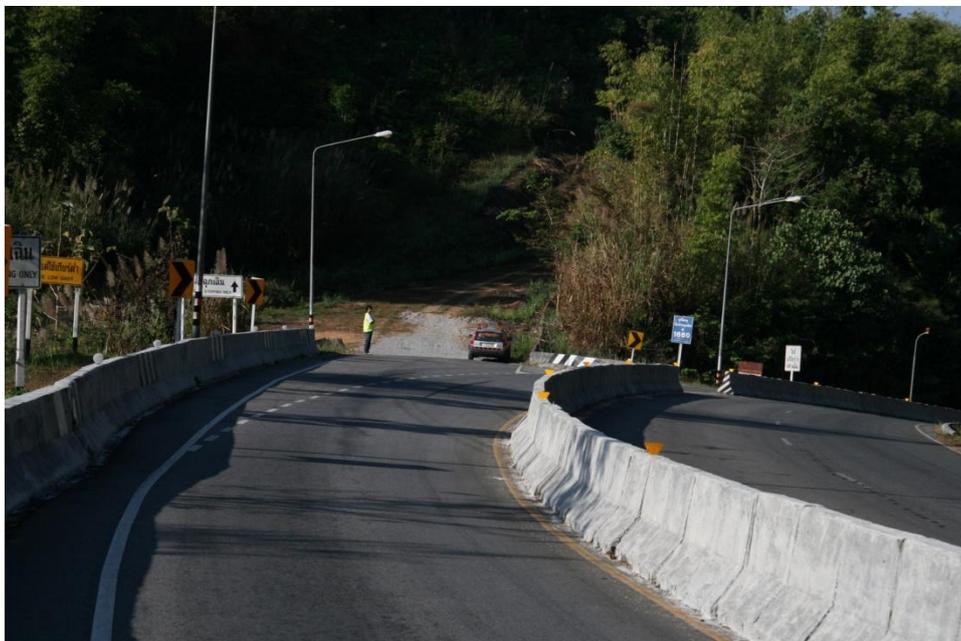
Figure 3-19: Emergency Exit

At km. 66+000, there is an emergency exit (**Figure 3-19**) allowed malfunction vehicle to reduce the speed and stop safely at the top of the exit.

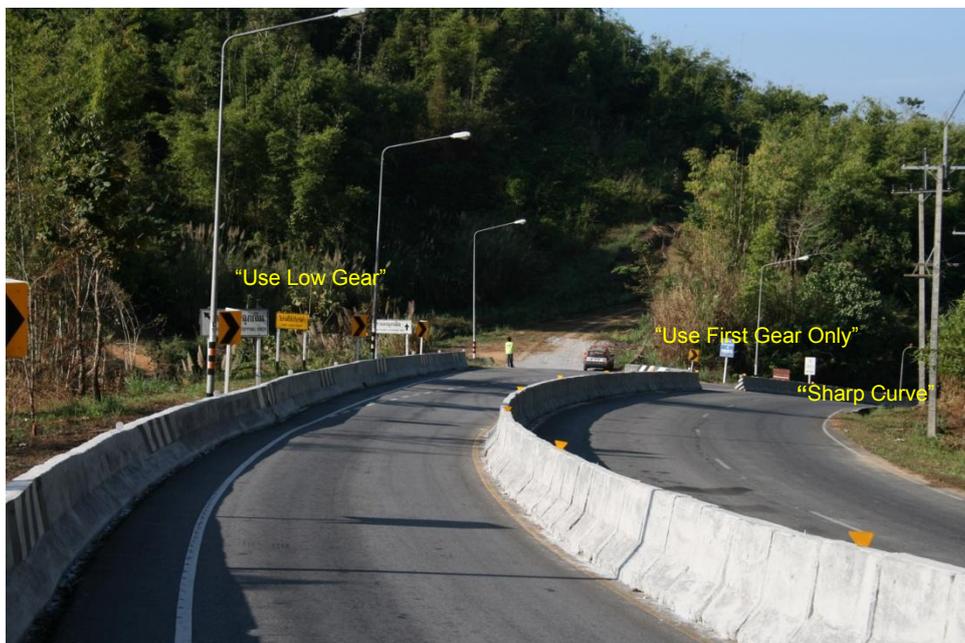
Figure 3-21: Traffic Warning Signs

A set of traffic control is installed prior to approach the curve (Figure 3-21 and Figure 3-22). They include;

- Warning sign "Use Low Gear"
- Message sign "Use First Gear"
- Warning sign "Sharp Curve, reduce speed"
- Warning chevron sign
- Delineator on the top of barrier
- Flashing yellow light
- Lighting System

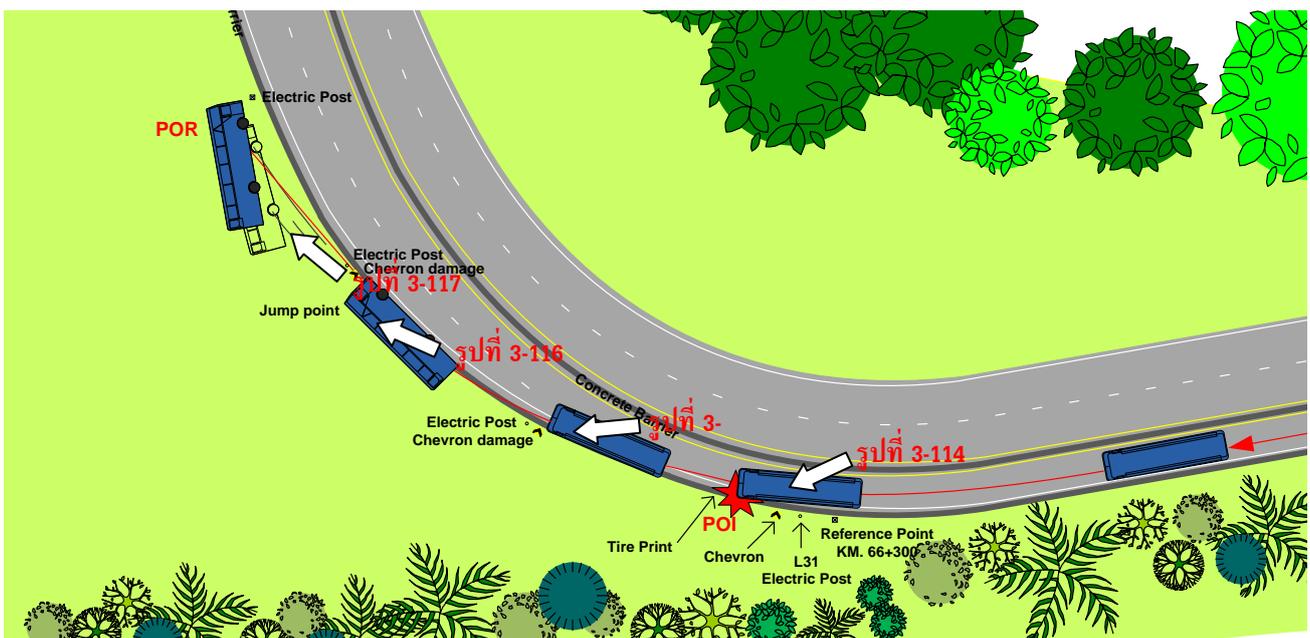
Figure 3-23: Physical Evidences

After closely examine the crash scene, there is evidences showing near the point of impact as (Figure 3-23) as follows;

- POI is located 10.3 m further from the kilometer post 66+300. The bus's body color printed on the concrete barrier, making damages on its top. There was a tire mark printed on the barrier at the next 2.4 m. (Figure 3-24)
- The bus started lost control and left the scratch marks 21.7 m from Point of Impact. The chevron warning sign and electric post were damages. (Figure 3-25)
- The bus starting rollover and falling from the barrier 44.5 m measured from the POI. It hit another electric post and slide on the ground 52.2 m. (Figure 3-26)
- The bus stopped near the sandy mound, measure 23.5 m from the landing point. (Figure 3-27)

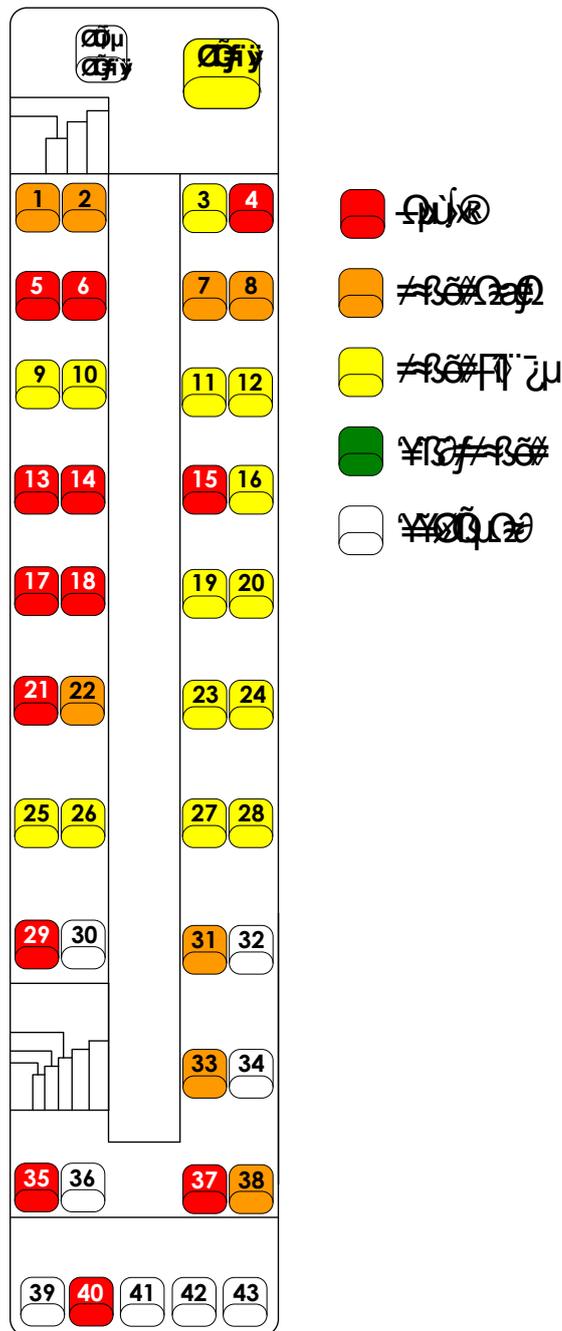
Figure 3-28: Seating Position by Level of Injuries

In total of 37 occupants, there were 13 fatalities, 8 serious injuries, and 15 slight injuries. **Figure 3-28** presents the seating position identified by level of injuries.

Four passengers were reported ejecting from the bus and found dead underneath the wreckage bus. All passengers revealed not use the seatbelt. However, there is only 4 seatbelts available on the front row but there were fasten behind the seats

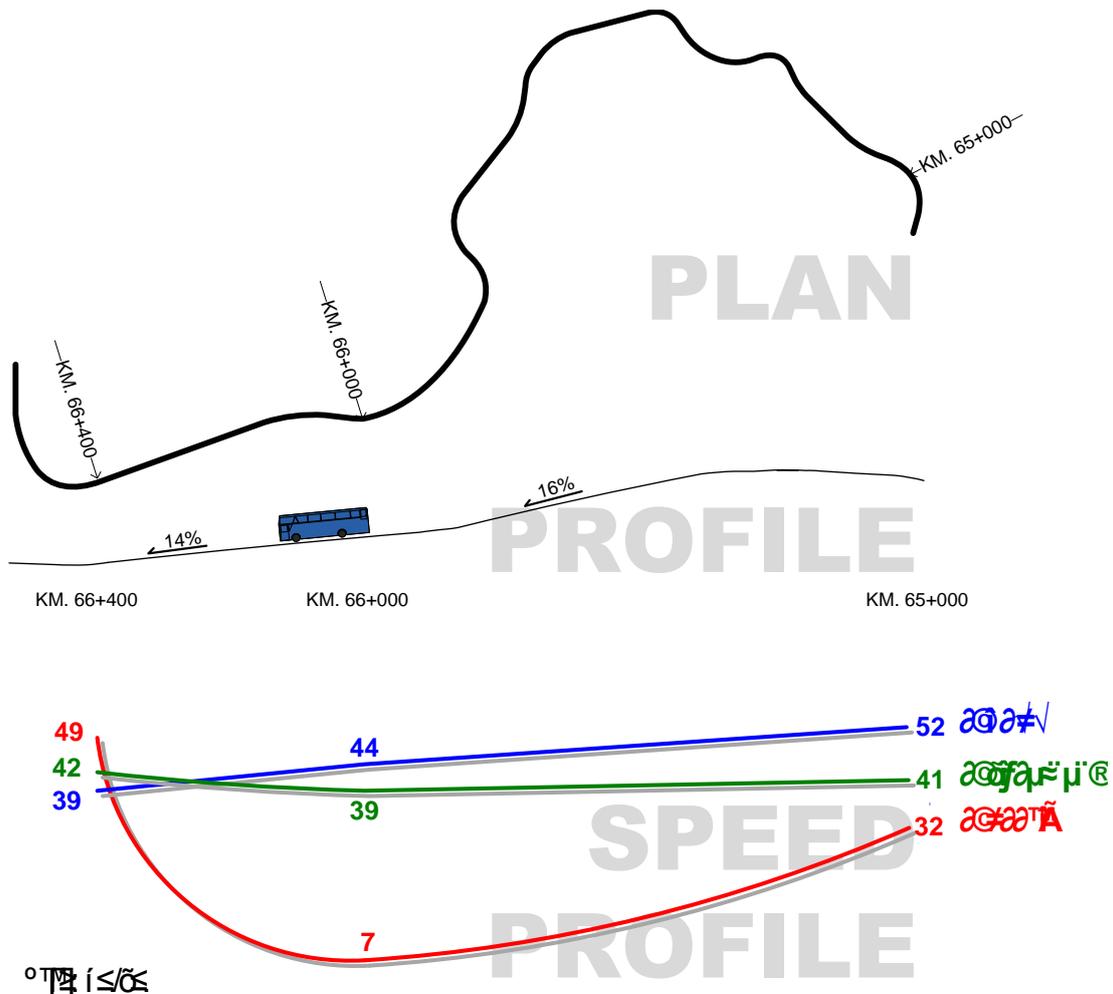
Figure 3-29: Speed Profile

This road section connected between Thongpaphum and Sangklaburi is routed at the mountainous section more than 60 km in length. At km 65+000 at the top of the hill the terrain change to negative 16% grade for 1 km and reduce to 14% before arriving the crash scene. TARC evaluated the traffic speed profile at three locations which are 1) km. 65+000 at the top of the hill 2) km. 66+000 at the emergency exit and 3) km. 66+400 at the crash scene. The mode of transportation was separated for motorcycle, car, and heavy vehicle. However, during the time of doing the survey there were no passenger cars and buses. The result is shown in **Figure 3-29**.

There is a big different of the driving behavior between small vehicles and heavy vehicles. The motorcycle and pickup maintained the relatively same speed entire road section, from 41 km/hr to 42 km/hr for the motorcycles and from 52 km/hr to 39 km/hr for the pickups. However, the truck reduced the speed as low as possible. There were only 7 km/hr driving on 14% grade downhill with a low driving gear. They then started to accelerate after approaching the curve which can be reached to 49 km/hr. This survey has shown that the truck drivers understand well how to drive on this road section. It is unsafe to drive with a high speed without the support of engine brake.
