# Case ID: 080825-01

## Accident Narrative

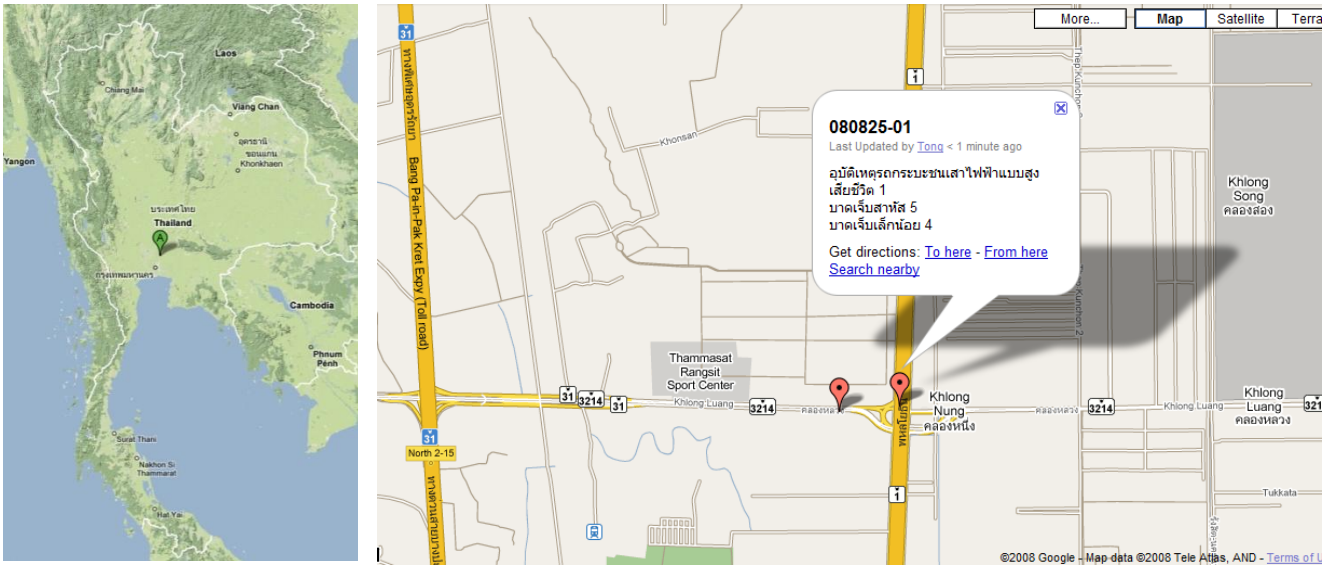
**Figure 3-1: Location of Crash Site Highway No. 1 KM. 40+500**

At about 21:00 AM on 24 August 2008, a pickup with 10 occupants started the trip from Burrirum, heading to Bangkok. In the early morning at about 5:00, while travelling on Highway No.1, a ten-lane highway with frontage roads, at KM.40+500 in front of Thammasat University, the pickup left the roadway on the right side of the road and fell into a depressed median. It moved straight continuously and directly hit a high mast electric pole with its front.

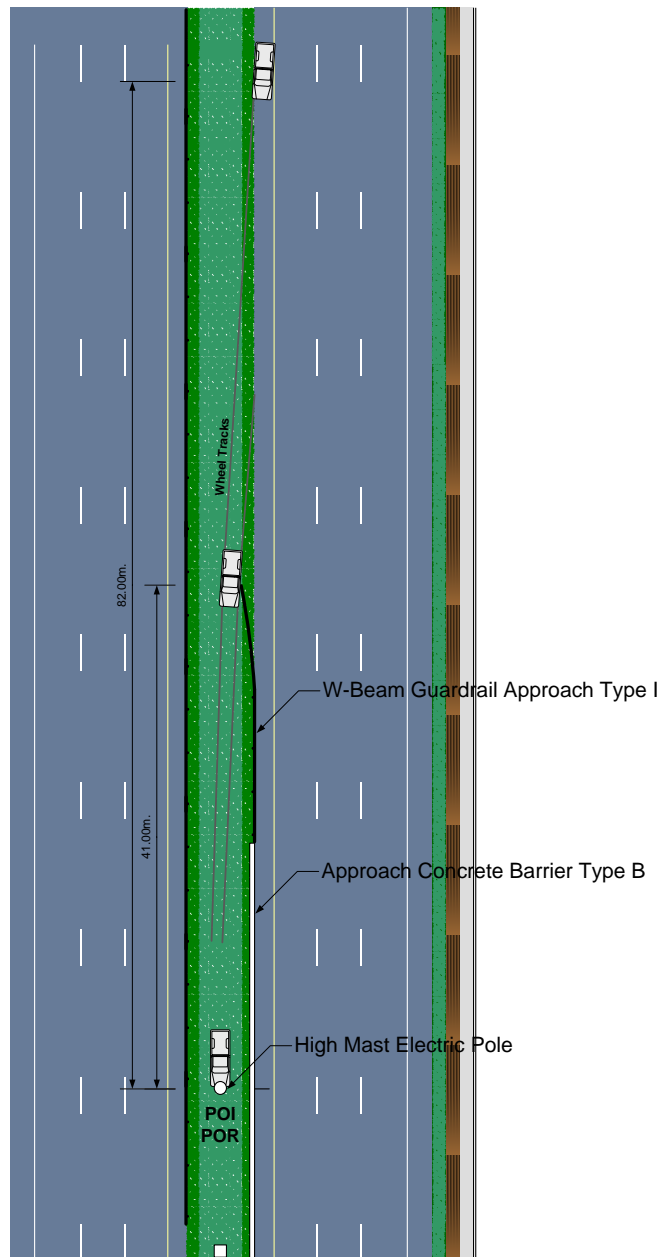
**Figure 3-2: Schematic of Accident Scene**

The depressed median is shielded by a guardrail and a concrete barrier. However, the pickup fell into a space between two sets of guardrails. From 10 occupants in total, one person was found dead while 5 experienced serious injuries and another 4 sustained slight injuries. According to witnesses, the fatality was located at the pickup bed. The victims were treated at Thammasat University and Phatara Thonburi Hospitals.

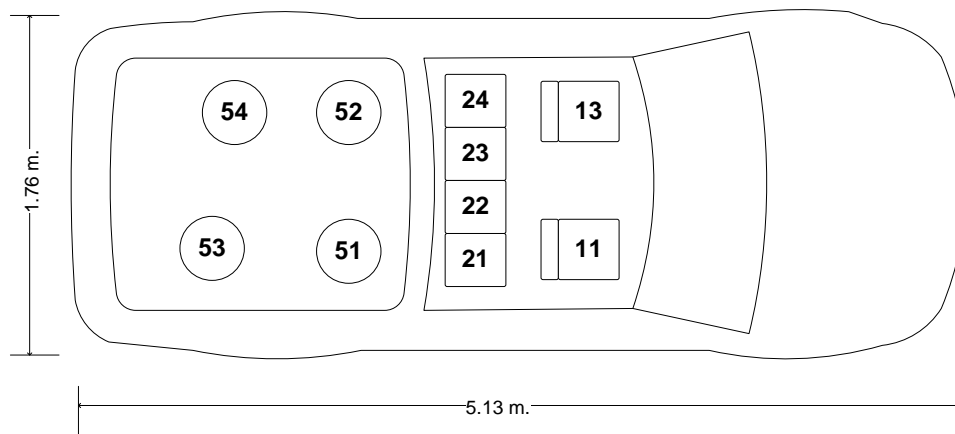
**Figure 3-9: Occupant's Seating Position**

There were 10 occupants on board at the time of the crash. In the occupants' compartment four passengers were sitting on the bench seats in the extended cab. Combined with the driver and front passenger; there were 6 people in this compartment. 4 more persons were on the pickup's bed. The fatality, a 23 years old male, was reported sitting on the right side of the pickup. He was ejected from the pickup and suffered a serious head injury and rib fractures. The detail is shown in **Table 3-3**.

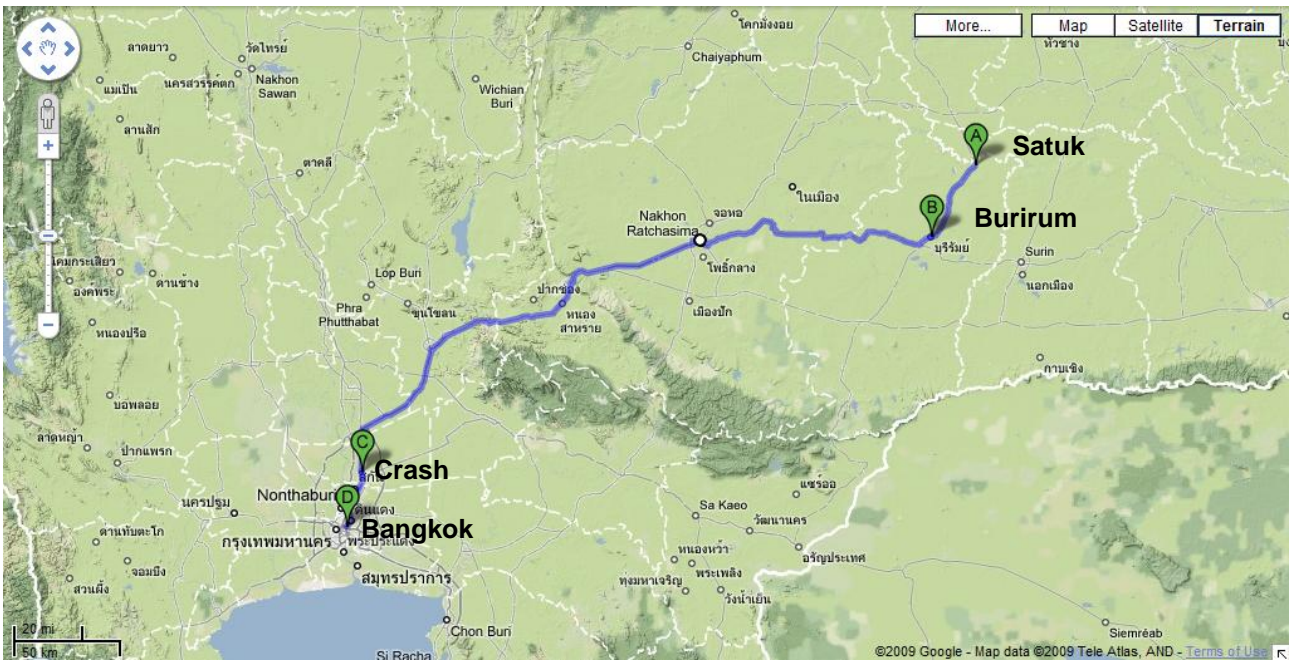
**Figure 3-10: Traveled Route**

The trip started in Satuk, Burirum (A) at about 21:00 on 24 August 2008. They first stopped at Muang, Burirum (B) about 40 km. from the origin. During the long trip to the destination, some passenger mentioned they stopped at several gas stations. The crash occurred in the early morning at about 05:00 on 25 August 2008, at Highway No.1 KM.40+500 (C) at a distance of about 390 km from the origin. **Figure 3-10** shows the travelled route prior to the crash.
