# Case ID: 080909-01

## Accident Narrative

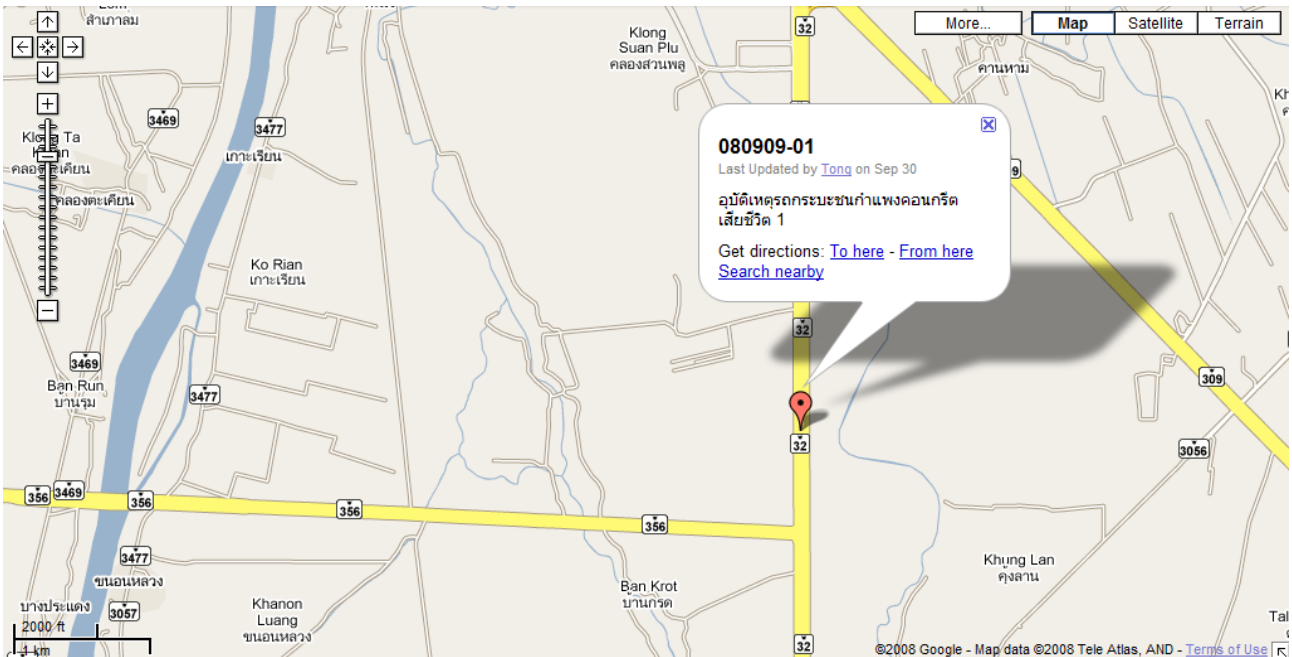
**Figure 3-1: Location of crash Highway No. 32 km. 67+304**

On Tuesday 9 September 2008 morning, a 27 years old male started his lone trip from his home in Chachoengsao, planning to visit his friend. At about 06:00 AM, the vehicle left the traveling lane and hit a concrete barrier perpendicular to its direction at a u-turn dedicated median opening at km. 67+300 of Highway No. 32 (**Figure 3-1**). The vehicle was found with total damage on its front part and stopped close to the impact position. The driver was reported dead during the treatment on the way to the hospital.

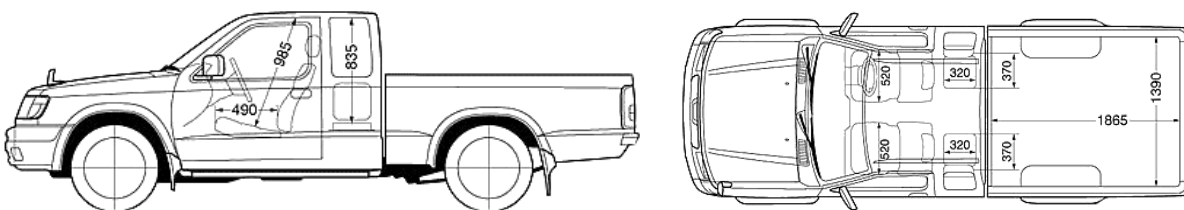
Figure 3-3: Pickup Dimensions

The pickup was a Nissan Big M, 2,500 cc diesel engine, rear wheel drive, manual transmission, without ABS. It was bronze in color. It had an odometer reading of 219,403 km. The wheel base was 2.90 m, 5.12 m in long, and 1.625 m high. The interior dimension is shown in **Figure 3-3**. It was designed for two bucket seats for the driver and front passenger. Both seats were equipped with lap-shoulder belts. The extended cab, space behind the front seats, was fitted with a bench. The safety beam was installed inside on both side of the pickup.

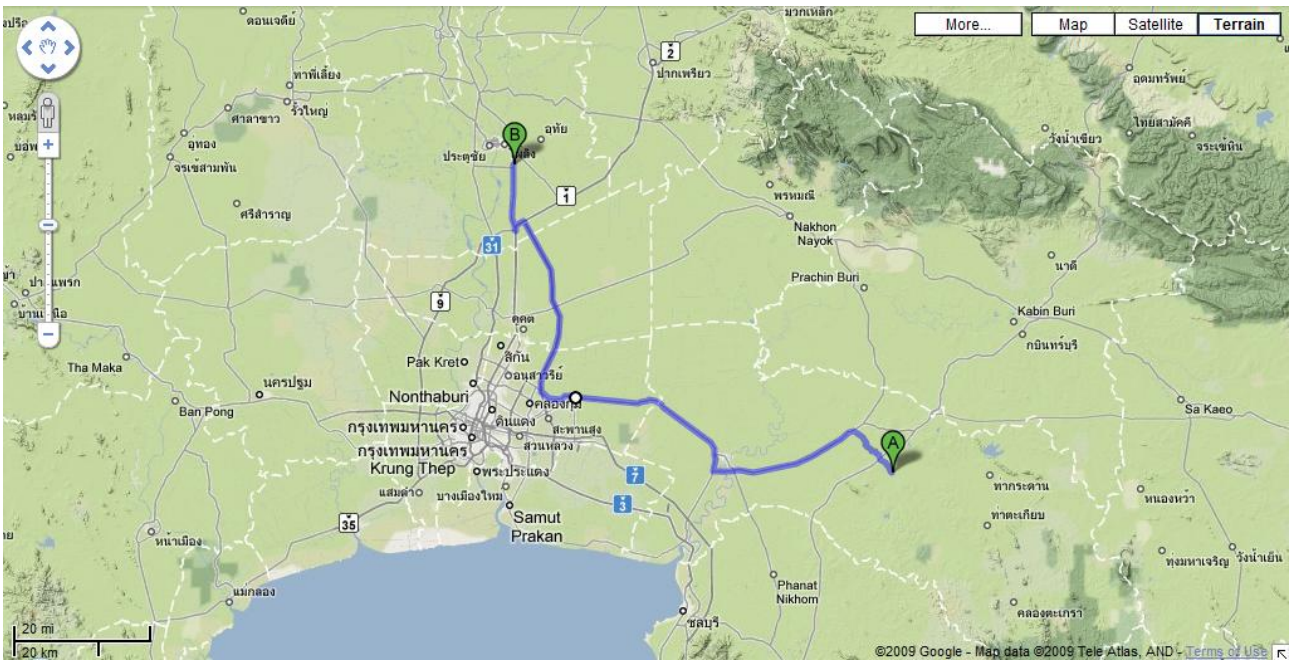
**Figure 3-7: Pickup Route**

The driver was a 27 years old male, the vehicle's owner. He took a course at university and planned to visit his friend for a research work in Ayutthaya (B) (**Figure 3-7**). He started the trip from his home in Sanam Chaikhet, Chachoengsao (A), at about 05:00. According to his parent, this was not his routine trip.
