Accident Narrative

At about 15:00 on Sunday, 1 September 2013, there was a report of crash between a van and a semi-trailer truck. The crash occurred on two lane road, Highway No.359 (Sa Kaew-Kao Hin Son) in front of NGV station, around 59+000 km. A van sustained heavy damage on its frontal part resulting 2 occupants dead including van driver; however, truck had only minor damage on its left part. According to the information, a van was in full capacity with foreign passengers and was heading westward on a trip to Bangkok from Aranyaprathet (Figure 1), whereas the truck was heading east to the border market. According to the truck driver, there was a vehicle suddenly trying to enter to NGV station which forced him to take an evasive maneuver to another lane. However, he was unaware of the van coming in opposite direction and got collided with it. The schematic of the accident scenes are shown in Figure 2.

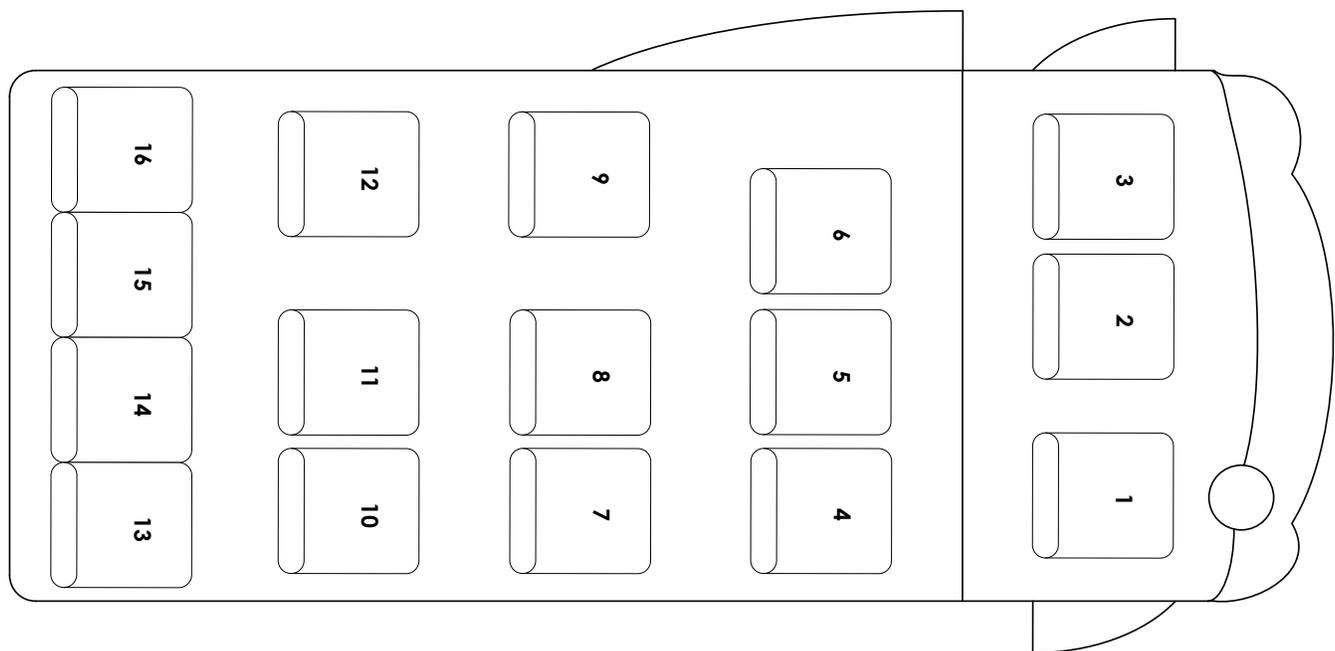
Figure 5 Capacity of the van

Figure 5 shows the capacity of the van to carry the passenger in one trip. It is to be noted that, seat no. 2, 13, 14, 15 and 16 were folded, while the rest of the seat was occupied by the passenger at the time of accident. All the seats were equipped with seat belts and two fire extinguishers were also found inside the wrecked van during investigation.
