Crash ID: 150527

Accident Narration

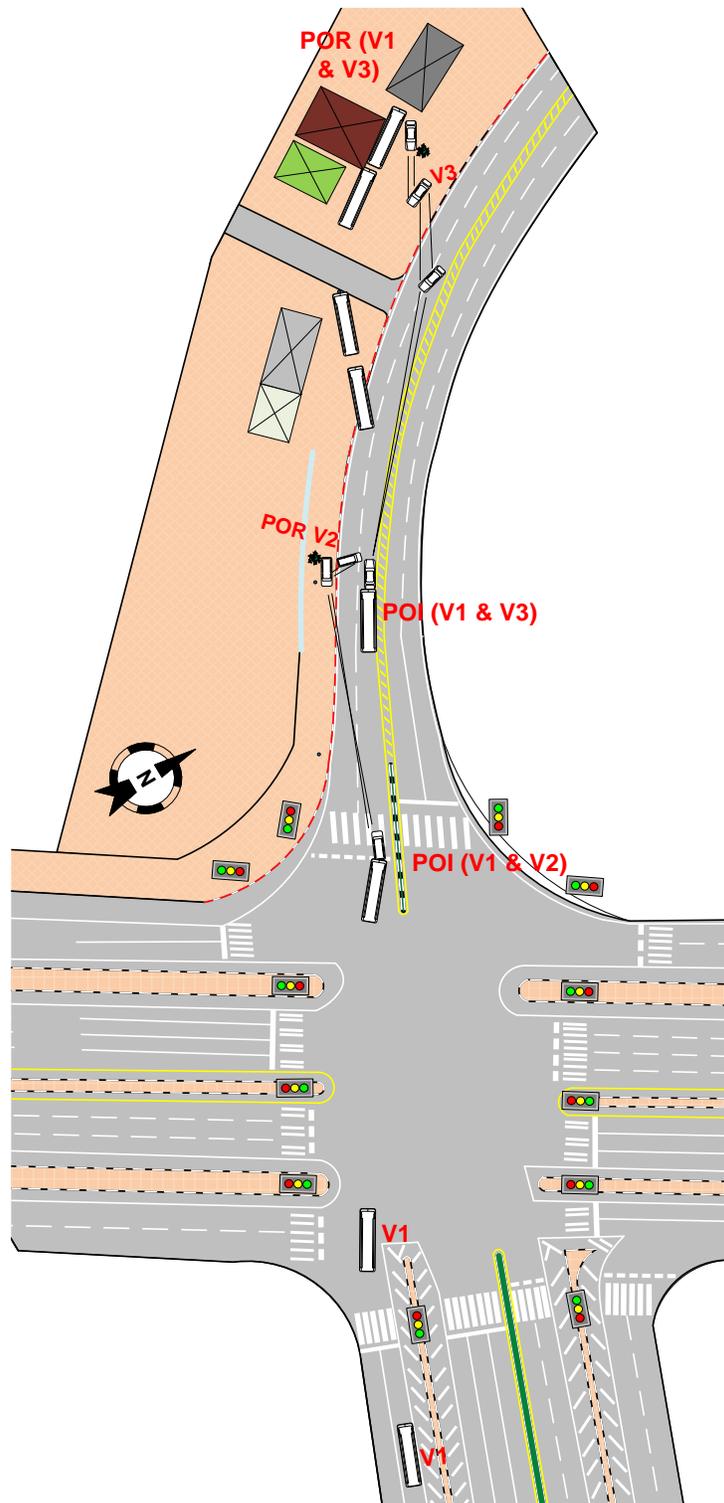
Figure 2 Schematic sequence of the crash

A bus with 20 passengers started the trip at around 20:00, Tuesday, 26 May, 2015 from Udonthani to Chiangmai. In the morning, the bus was travelling across the mountainous area between Phitsanulok and Lamphang. On the downhill section before the Phakham intersection in Lamphang, the driver found a malfunction of the braking system and couldn't slow down the bus, as reported by one of the bus passengers. The bus, then continued to travel straight at intersection and first collided with a Van (V2) and second a sport utility vehicle (V3) at rear end. **Figure 1** shows the location of the accident scene. After the impact with the vehicles, the bus ran off road, hit the electric pole, intruded into the residential houses, and finally stopped there. The van lost control, rotated and hit the roadside objects (electric pole, signpost and tree), and deflected back to the roadway. Due to the impact with roadside objects, 3 passengers inside the van ejected together with the seat and rested on the footpath. Likewise, SUV (V3) also lost control after the impact by bus, run off road, and rested near the bus. The diagram showing the schematic sequence of the crash is shown in **Figure 2**.

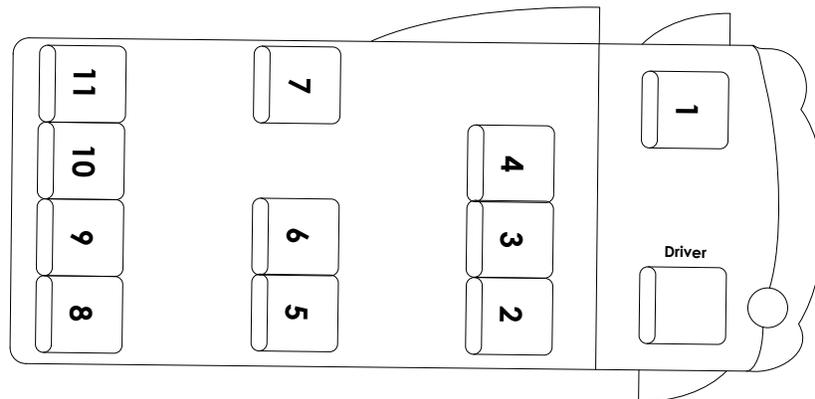
Figure 11 Seat configuration of the van

There were a total of 8 occupants inside the van. In front, there was a driver and one passenger. Rest of the passengers were sitting at the back seat of the van. 5 of the passengers were school children and 3 were adults including driver. In total, there were 12 seats inside the van, two in front and 10 at the back. 3 point seat belt was installed in the front two seats while no seat belt was observed to be installed at the back seat. During the crash, the seats were unhooked and scattered inside the van (**Figure 12**) and also first row seat (no.2, 3 & 4) (**Figure 11**) ejected out of the van together with the passenger (**Figure 14**). One of the passengers seating in the first row (no.3) ejected out and died on scene. At the time of accident, the driver was using seat belt, while the front passenger was not using seat belt as shown in **Figure 13**. According to the interview with front passenger, he was holding the handrail when the bus impacted with the van. During the investigation, it was observed that the front passenger's seat belt was strapped behind the seat.

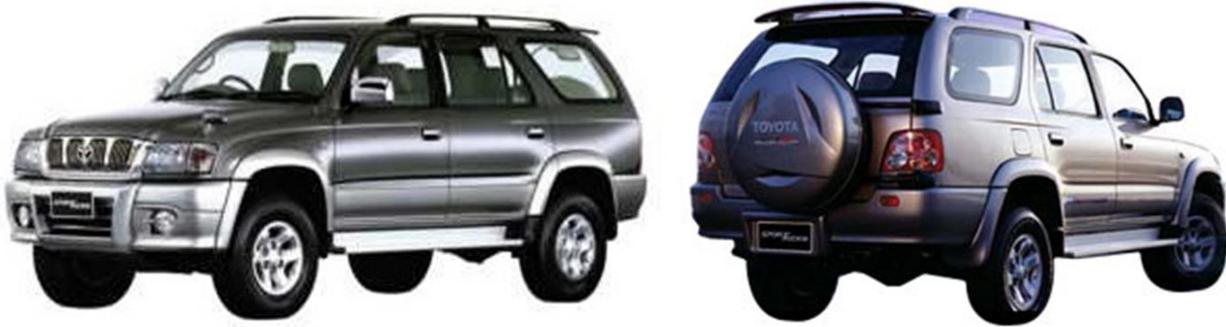
Figure 18 Original Structure of SUV

SUV (V3) was a Toyota Hilux 3.0 D, Sports Rider, 3000 cc, blue grey in color. The original structure of SUV is shown in **Figure 18**. The dimension of SUV was 4.30 m long, 1.50 m wide,

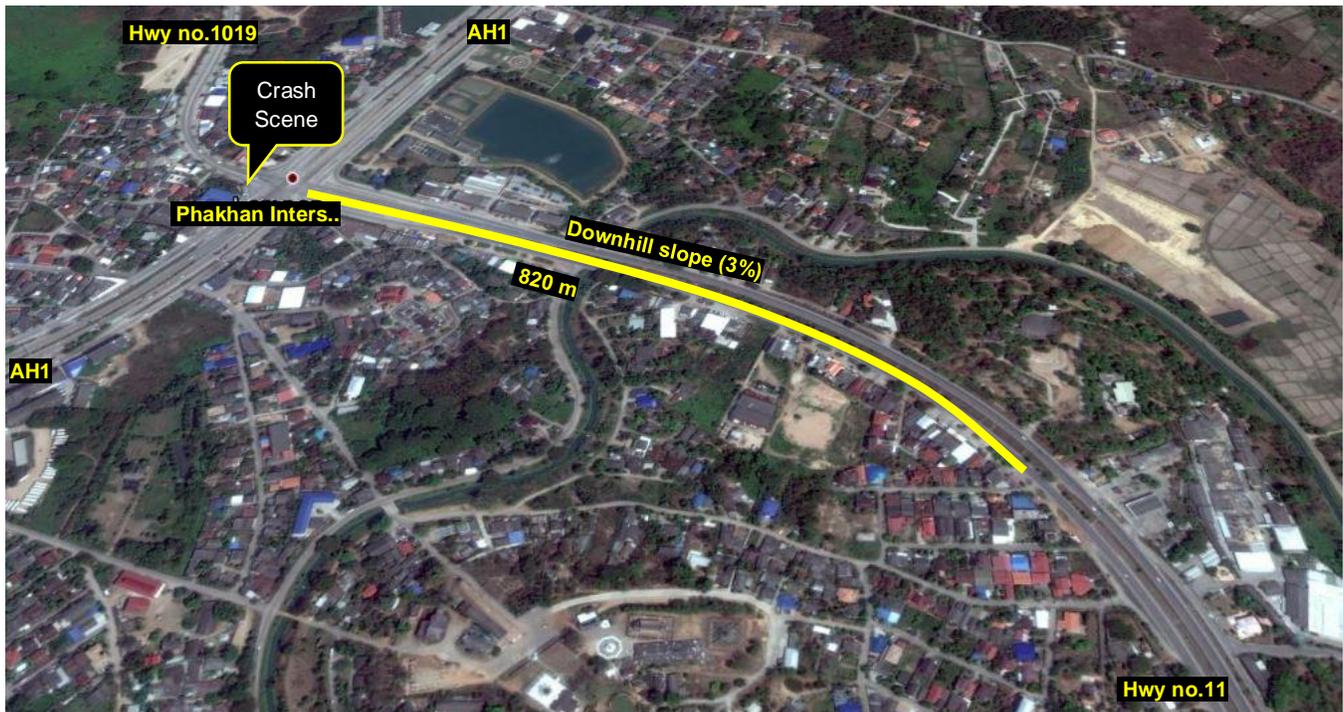
Figure 20 Highway information

The bus was approaching from highway no. 11 and intersects the Asian highway 1. The crash occurred on the west approach of Phakhan Intersection in highway no. 1019. The intersection is signalized intersection. At the crash scene, the road is a straight, levelled section, however the highway no. 11 has 3% downhill slope for about 820 m before the intersection approach as shown in **Figure 20**.

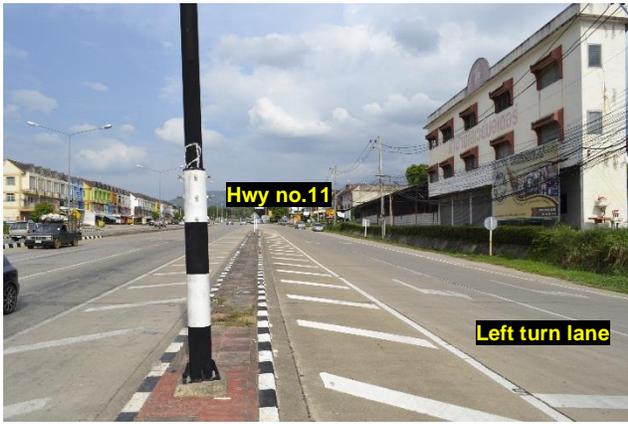
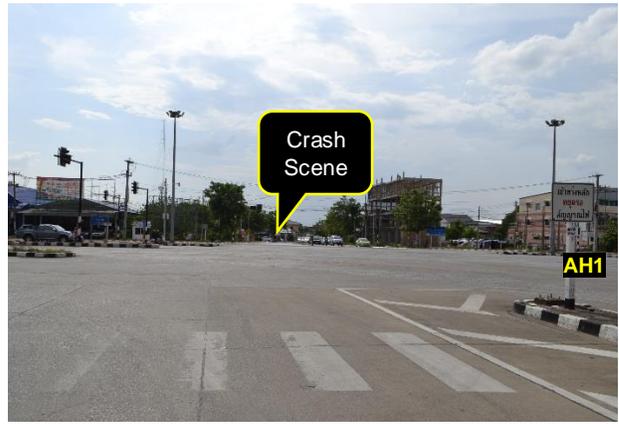
Figure 21 Approach of intersection from hwy no.11

Before the crash, the bus was travelling in highway no 11, 2 lane in each direction. At the intersectional approach, the bus used left turn lane, which was 2 lane with 3.34 m lane width. **Figure 21** shows the Approach of the intersection from hwy. no 11.

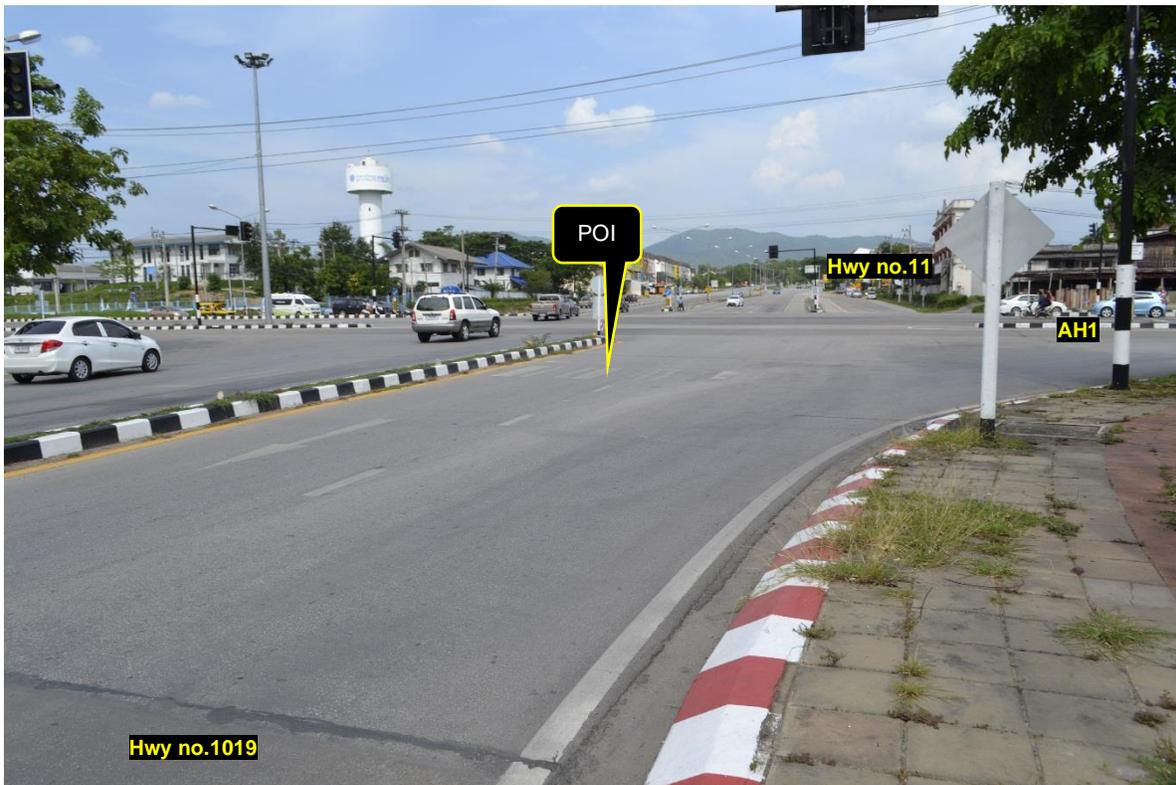
Figure 22 Highway information

The bus collided with the van at the beginning of Highway no 1019 leaving the intersection as shown in **Figure 22**. It has 3.0 m wide outer lane and 3.3 m wide inner lane. The width of the footpath is 4.5 m in both direction. The road has a 1.50 m wide raised median. The cross section of the road at POI between bus and van is shown in **Figure 23**.

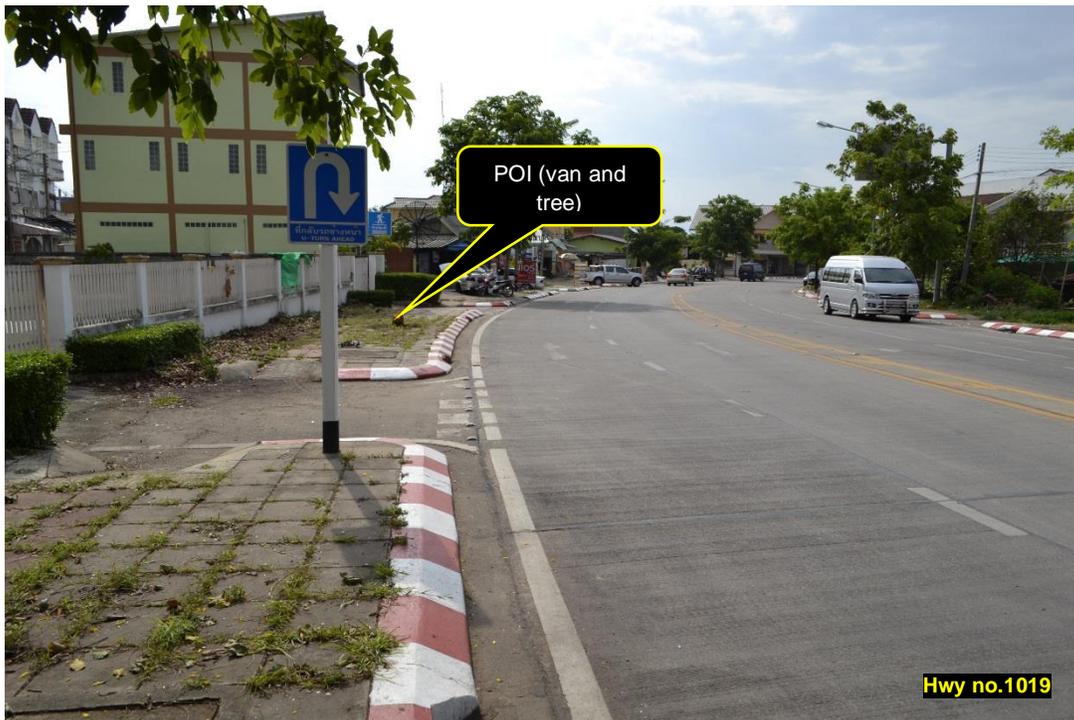
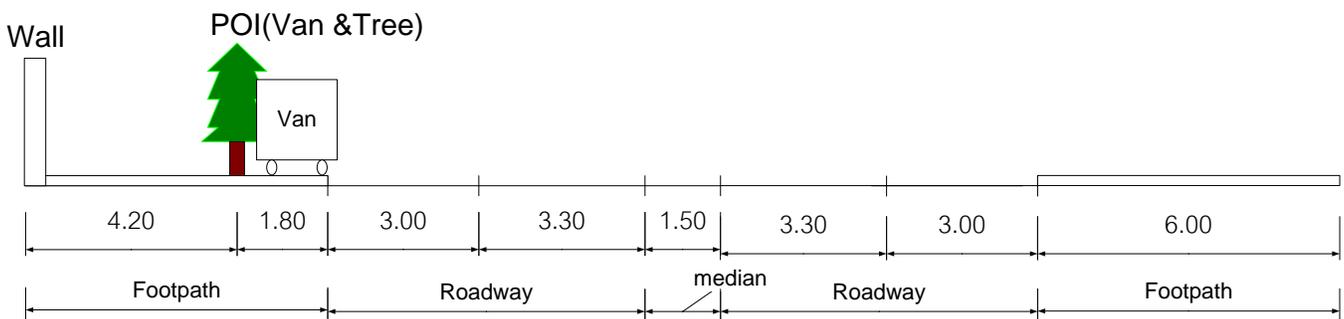
Figure 24 Cross section of the road at POI between Van and roadside tree

After the bus hit the van, the van lost control and hit the roadside tree and electric post. **Figure 24** shows the cross-section of the road at POI between van and tree. The road has 3.0 m wide outer lane, 3.3 m wide inner lane and 6.0 m footpath. The tree is located at 1.8 m far from the edge of the pavement. The median is undivided types in this section.

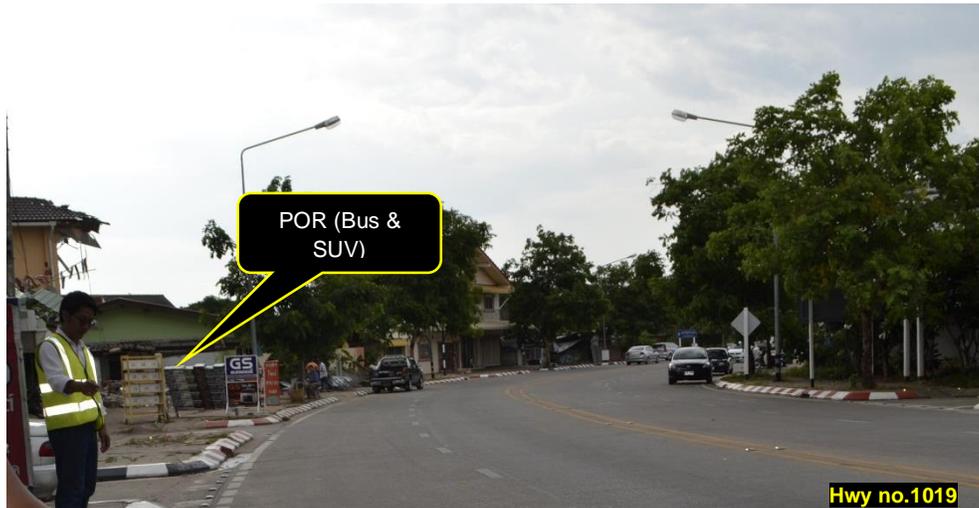
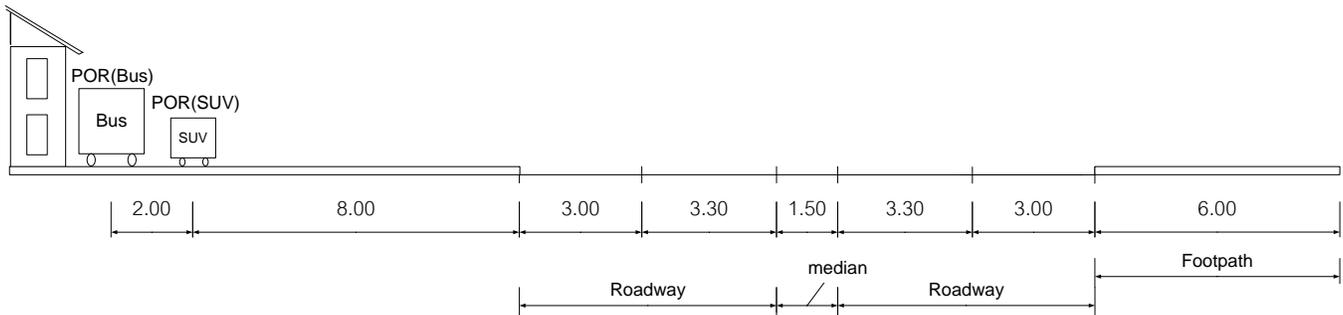
Figure 25 Road section at POR of bus and SUV

Figure 25 shows the cross section of the road at POR of bus and SUV. The bus rested at 10 m far from the edge of the roadway. The road has 3.0 m wide outer lane, 3.3 m wide inner lane and 1.50 m wide median.

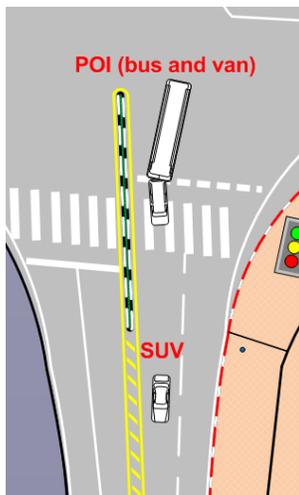
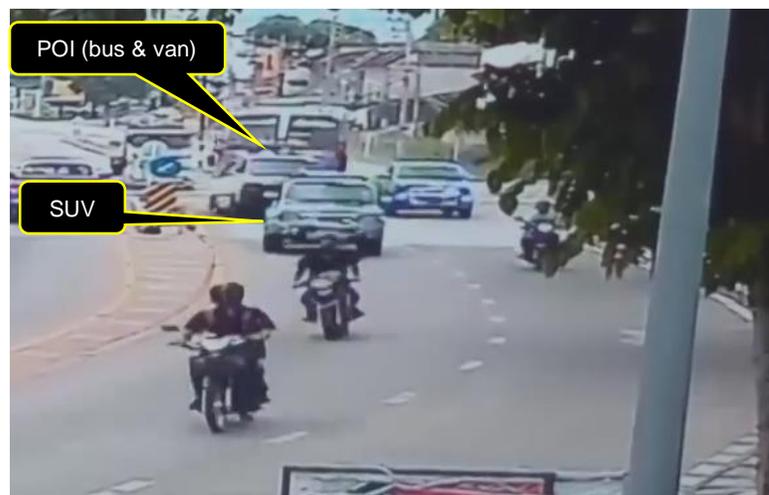
Figure 27 POI between bus and van

The bus collided with the van at the zebra crossing line as can be seen in the footage (Figure 27). There was a deep scratch on the pavement and a fresh skid mark made by the van's tire at the zebra crossing line as shown in Figure 28. Based on these evidences, TARC determined the point of impact of bus and van. POI was taken as a reference point to measure other evidences present in the crash field.

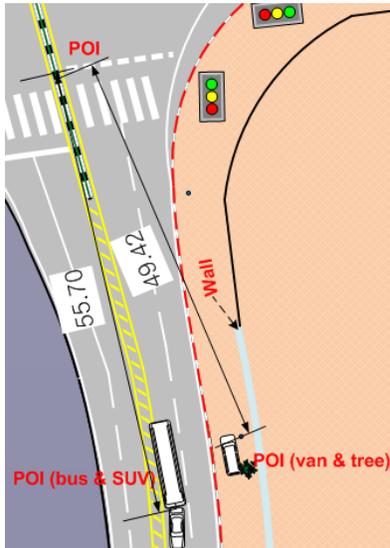
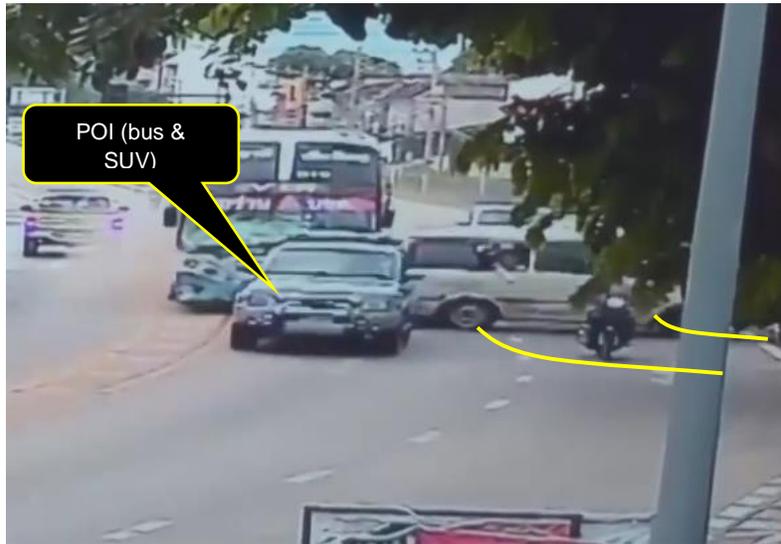
Figure 29 POI between bus and van, and rotation of van before impact

After the first impact, the van lost its control, rotated and hit the roadside objects (electric pole and tree), and deflected back to the roadway (**Figure 29**). The right side of the van collided with the tree. There were several evidences presented in the crash field. A long tire marks in different orientation starting from the first POI to the roadside tree, shows that the van rotated for about 50 m anticlockwise before hitting the tree **Figure 31**. **Figure 30 & Figure 32** show wreckage of the tree and the damaged electric poles. The van rested near the tree, at about 52 meter from first POI.

Meanwhile the van hit the roadside objects, the bus collided with the SUV as can be seen in **Figure 29**. Second POI between bus and SUV was about 55.70 m far from the first POI.

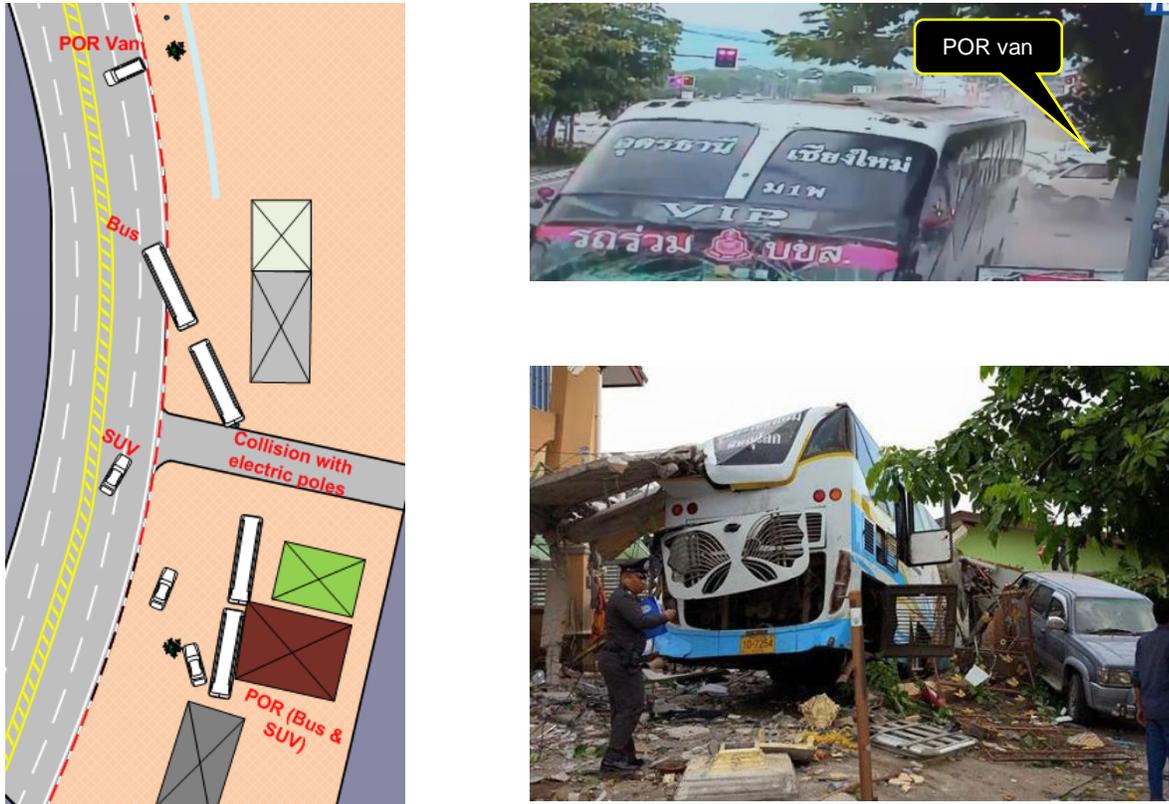
Figure 33 Post crash motion of bus and SUV

After the impact with SUV, the bus run off road at about 75 m far from the POI. **Figure 33** shows the post-crash motion of bus and SUV before coming to rest. The bus and SUV rested at about 121 m far from POI, 8 m far from the edge of the roadway. The bus hit the electric poles and houses before coming to rest.

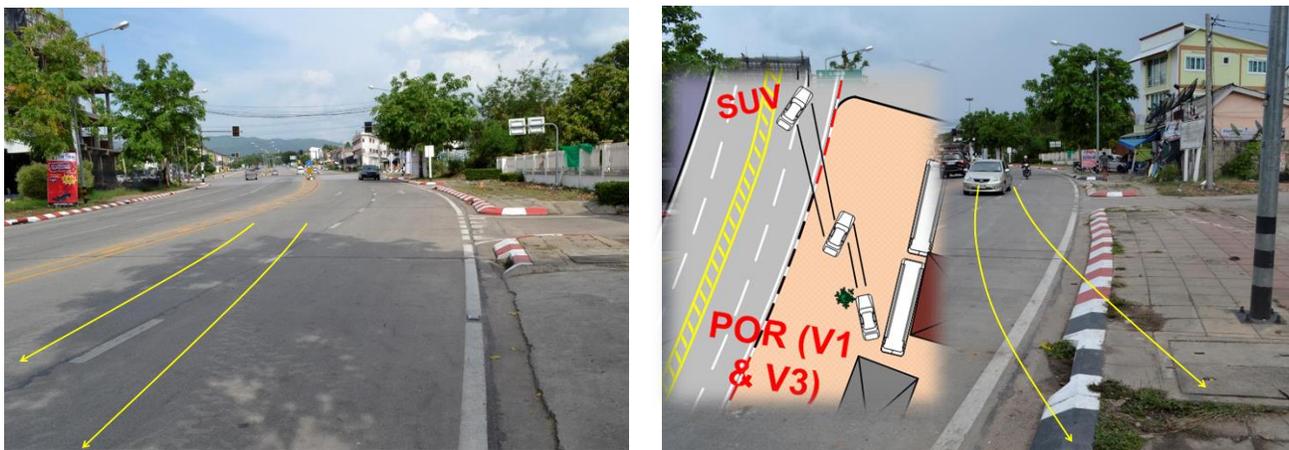
Figure 36 Post crash path of SUV

Figure 36 shows the post-crash path of SUV after the impact. The SUV lost control and run off road at about 60 m from second POI. There were several scratches and tire marks on the roadway from second POI that runs to POR, which helped the team to find out the post-crash motion of the SUV. SUV rested in a rotated position near POR of bus.

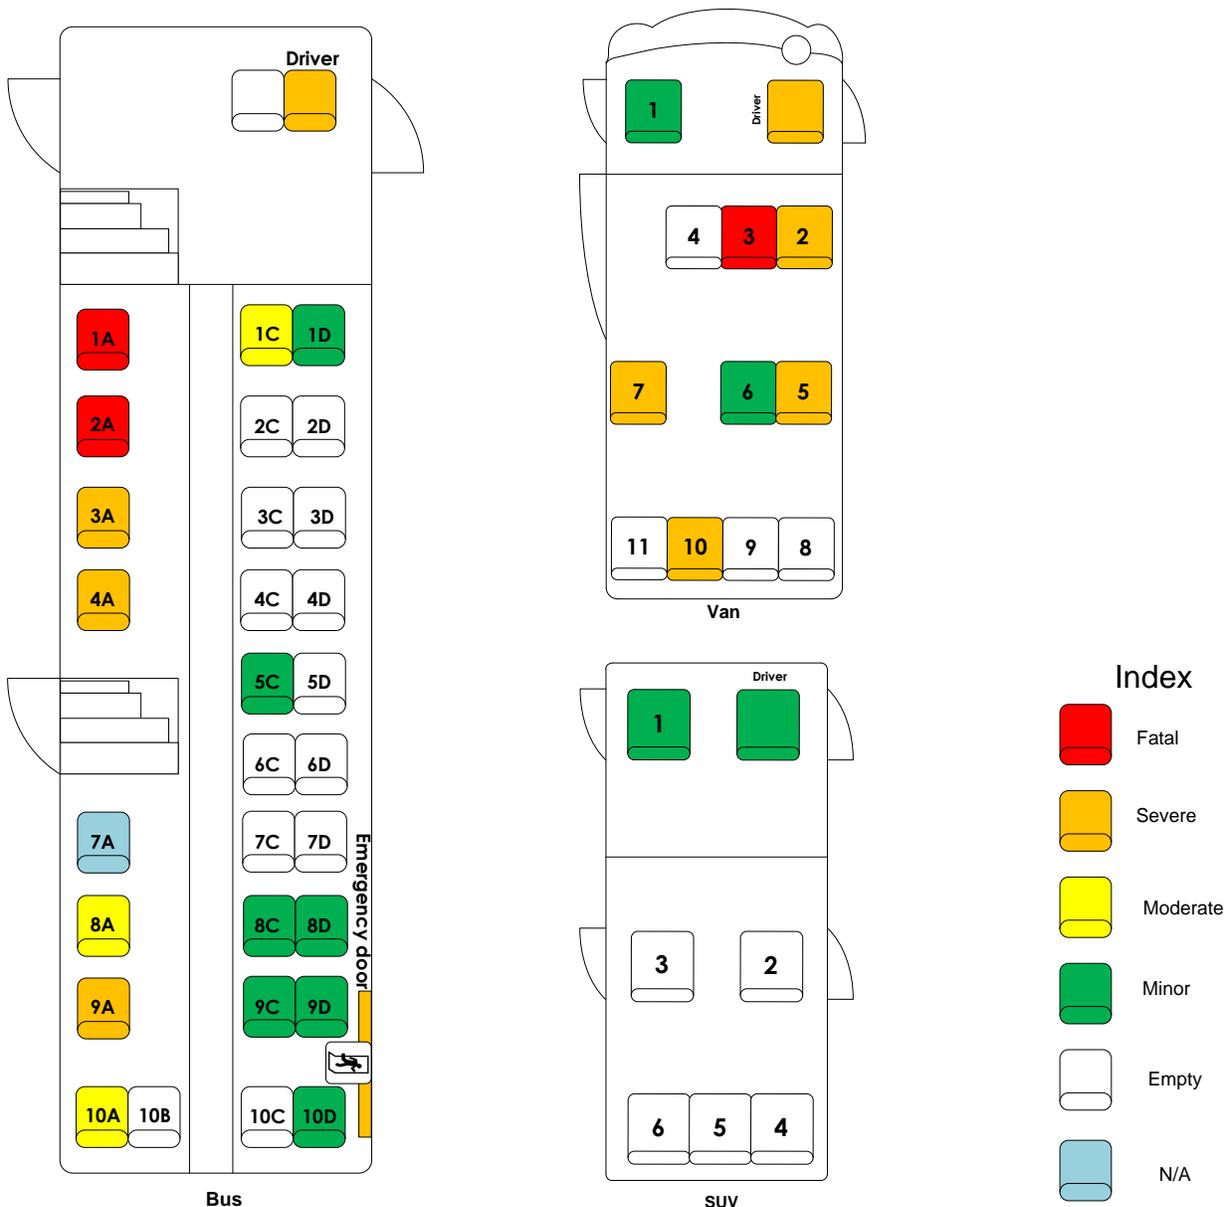
Figure 37 Injury Information and seating position of occupants

There were 3 fatalities, 12 severe injuries, 3 moderate injuries and 12 minor injuries reported from this crash. **Figure 37** shows the diagram of seating position of the occupants by severities in bus, van and SUV. Degree of severity are indicated by different colors. The red color shows

There were 20 casualties from the bus. The four passenger sitting in the front left row of the bus sustained severe injury resulting 2 fatalities. It is because the bus collided to the houses with its left front side and had severe damage. Majority of the passengers in right row received only minor injury, however, the driver, who was in right front, was severely injured as illustrated in **Figure 37**. In right row, the seating position of four passengers were unknown, among them, one was severely injured.

Similarly, among the 8 occupants inside the van, one passenger, who was sitting in the middle seat of front row (no.3) died in this accident as shown in **Figure 37**. During the investigation, it was observed that the front row seat (no.2, 3 & 4) was ejected together with the passengers. All passengers including

driver of van received severe injury except front passenger and a passenger sitting in the middle seat of second row (no. 6).

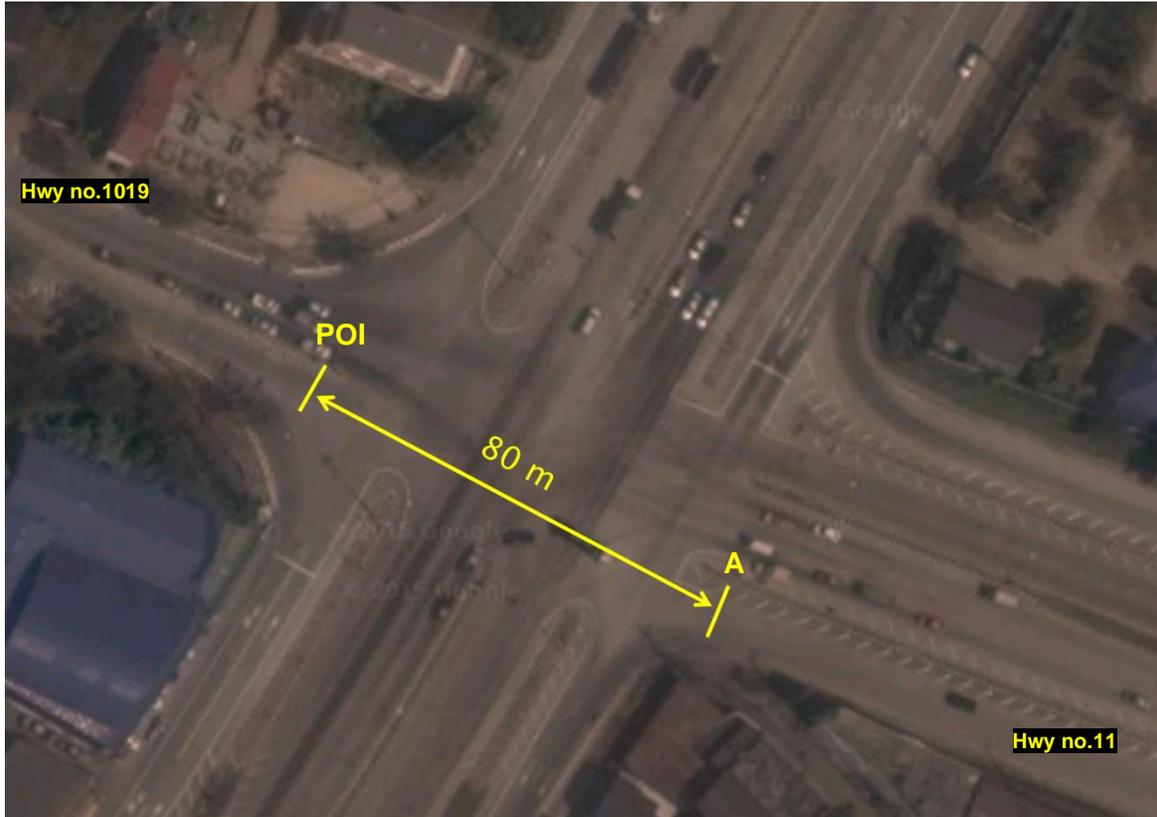
Figure 39 measurement of Intersection

From the CCTV footage, the pre-crash speed of the bus was calculated. Point A is the stop line of Hwy no.11 at intersection, from where the bus continued straight to Hwy. no 1019 as shown in **Figure 39**.
