Accident Narrative

At about 03:45 on Tuesday, 23 July 2013, a double decker passenger bus caught fire after colliding with a truck in one of the Thailand's busiest highway, killing 19 people and injuring 18. The overnight bus departed from Roi Et and had been heading for Bangkok on the Mittraphab highway - west bound, around km 18+900, in Khaeng Khoi district in the central province of Saraburi (Figure 1).

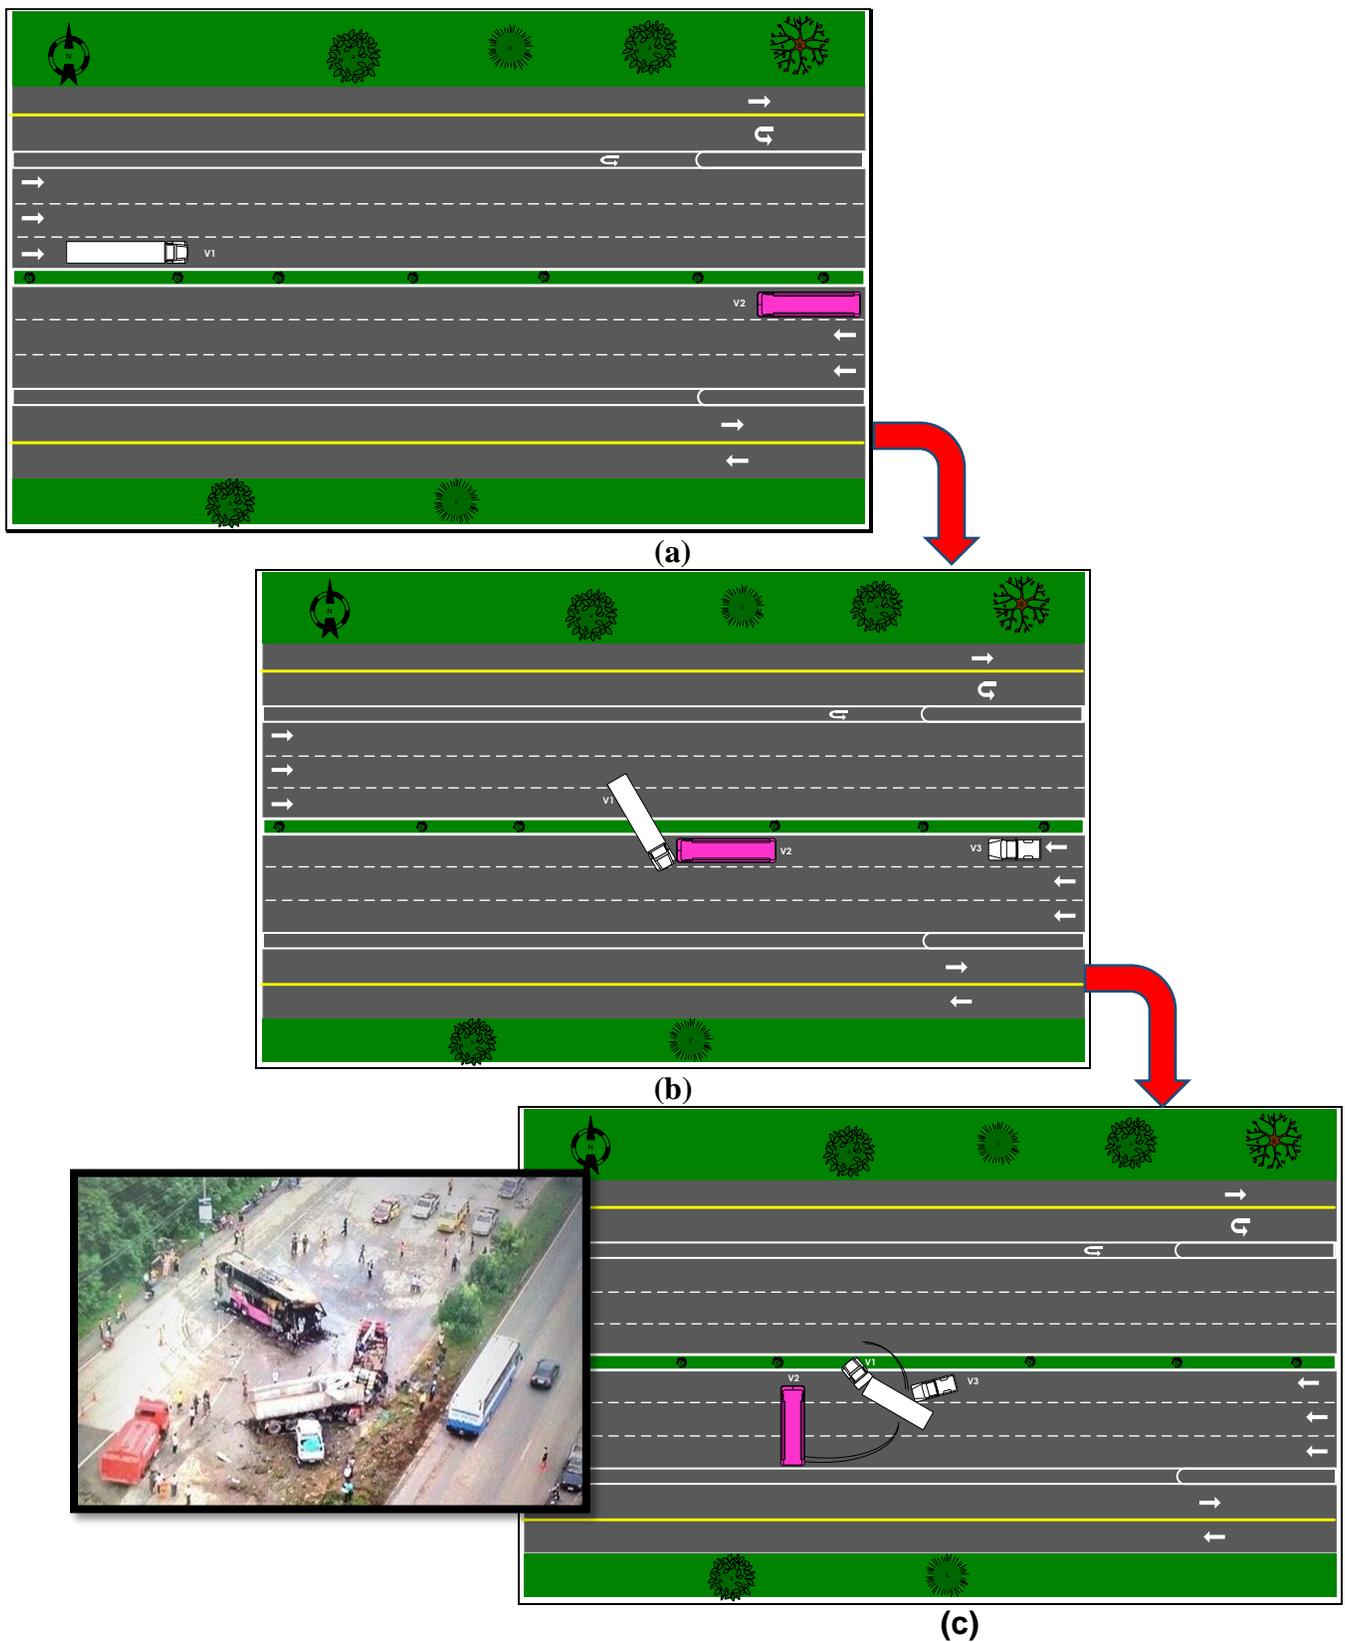
Figure 2 Schematic of Accident Scene, (a) before Collision, (b) during Collision (POI) and (c) after Collision (POR)

According to the bus schedule, the bus departed from RoiET at 9:30 pm and stopped in Maha Sarakham to pickup some additional passenger at about 10 pm. One of the passenger in the bus informed TARC team during the interview that the bus was not travelling fast and most of the passenger were sleeping before the accident. After the crash, the bus caught fire and according to one witness, it took 10 until the bus was completely burn. Bus rotated left to the edge of the highway and truck rotated left and rest with the drivers compartment in the median (Figure 2). After the initial crash, a pickup hit the piled-up truck, injuring 3 people.

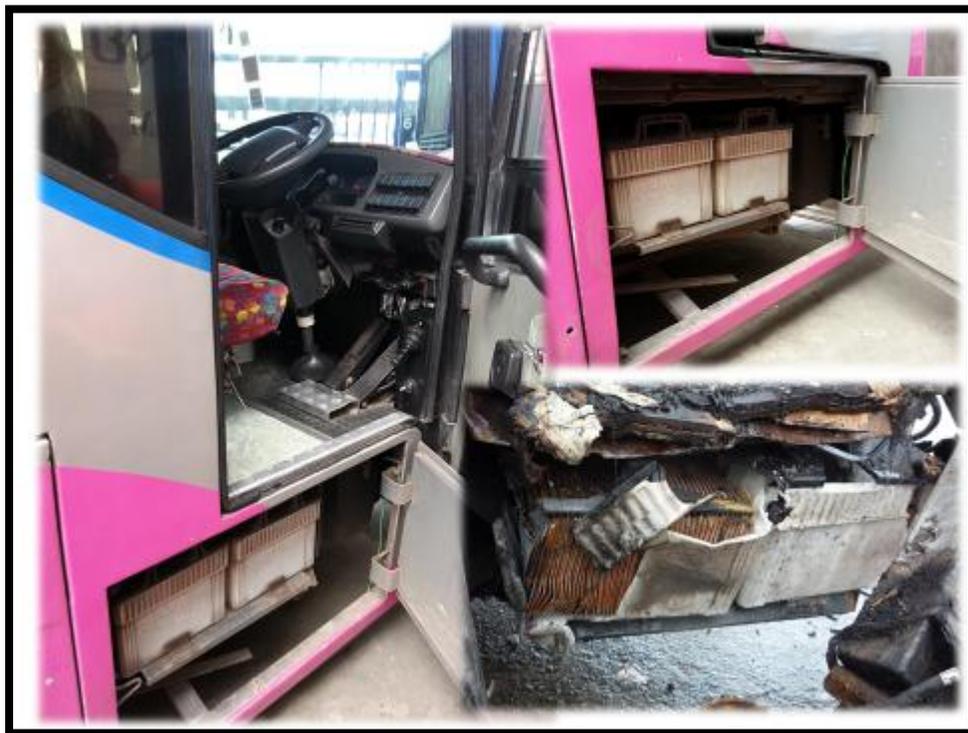
Figure 14 Location of the Batteries

The design of fuel tank near the electric circuit was observed in the bus. The source of ignition of the fuel tank could be the short circuit nearby, making an explosion and leading to the fire spreading all over. As seen in Figure 22, the presence of thick seat covers, carpet, ceiling material, blankets and drapes inside the bus can be the another contributing factor for the severity of injuries. These materials can be burn easily and produce excessive smoke when caught with fire. The smoke of these burning cloths and foams can be dangerous for human, which may cause respiratory failure due to choking. From the autopsy report, 10 occupant died

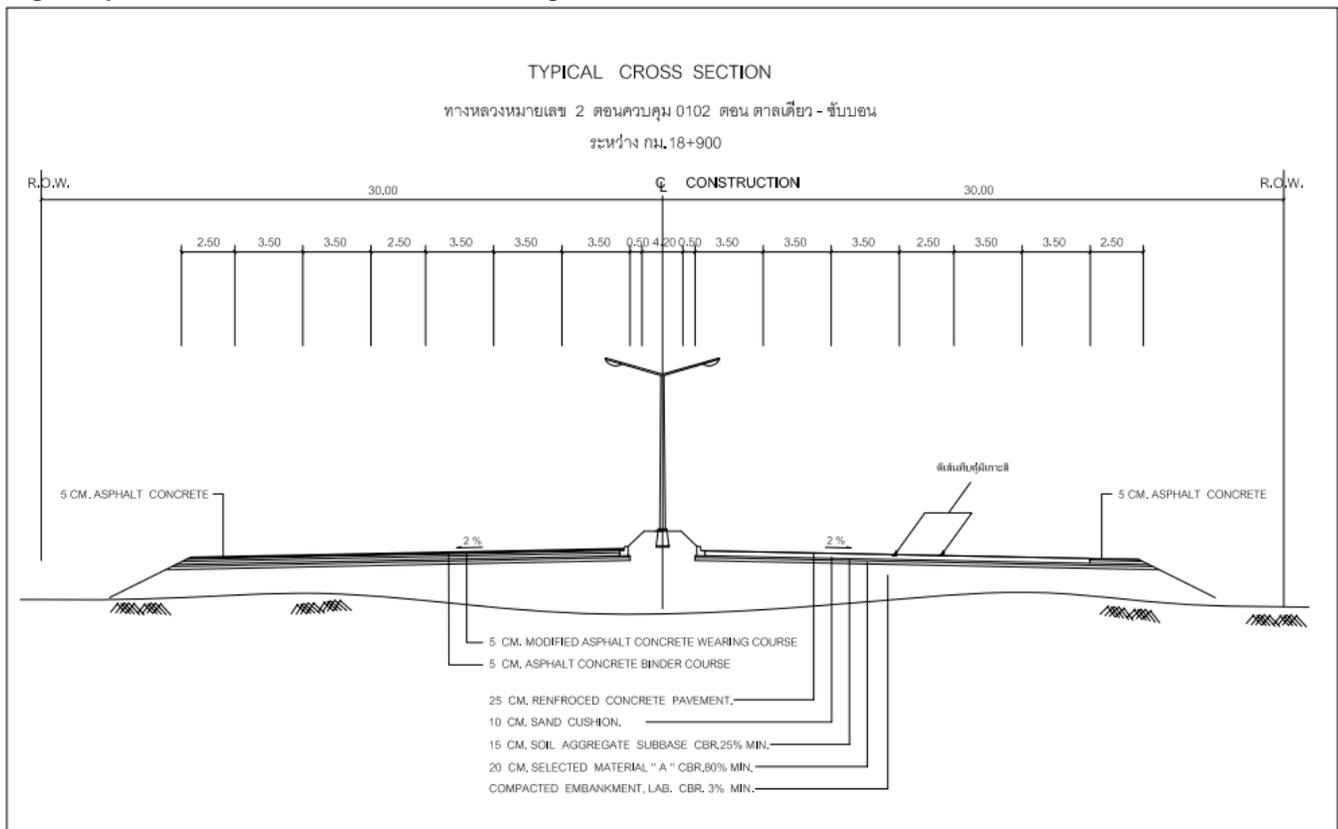
Figure 15 Cross-section of the Mittraphab Highway at km 18+900

The accident occurred on the Mittraphab road, highway no. 2 in Saraburi province, at 14°36'28.39" N, 101°04'02.26" E. It is the first highway in Thailand to use both asphalt and concrete. It is the main road that connects Isan (northeastern Thailand) across the Dong Phaya Yen Range with Saraburi with the total of 508 km. It passes through the provinces of Nakhon Ratchasima, Khon Kaen, Udon Thani, and ends in Nong Khai. The accident occurred at around km 18+900, downhill section and has 4 % gradient, raised median, 3 lane meging with 2 lane frontage road in each direction. The width of the lane is 3.50 meteres, 2% slope, and the right of way is 60 meteres. The details of the pavement and the cross section of the highway at accident site is shown in Figure 15.

TARC investigated the crash site, its highway and environmental condition to find out if they have any significant effect on the accident. The wet surface could be one of the factors contributing an accident. According to the witness, during the crash, there was a raw drizzling rain and the road surface was wet (Figure 20). Wet roads have lower level of friction and skidding/loss of control can occur when the forces generated in acceleration, braking or cornering exceed the level of grip available. Similarly, another contributing factor could be the low curb height of the median due to pavement overlaying. The use of curb in high-speed roadways can be dangerous because of their potential to cause drivers to lose control and crash. The vertical curb have some stability to redirect errant vehicles since the impacting wheel is steered by the curb in a direction parallel to the travel way. If the impact velocity and angle are modest, this steering action is all that may be required to prevent the vehicle from leaving the roadway. If the speed and encroachment angle are higher, then the steering action of the curb alone is not sufficient to redirect the vehicle, leaving it from roadway or rollover. Also, the highway in this case has no shoulder between right edges of the road and curb (Figure 21). This can cause the tires of the vehicle has high chance to get over the curb, esp. if the height of the curb is too low. All these factors coupled together might have made a situation for the truck to cross over the median and collide.

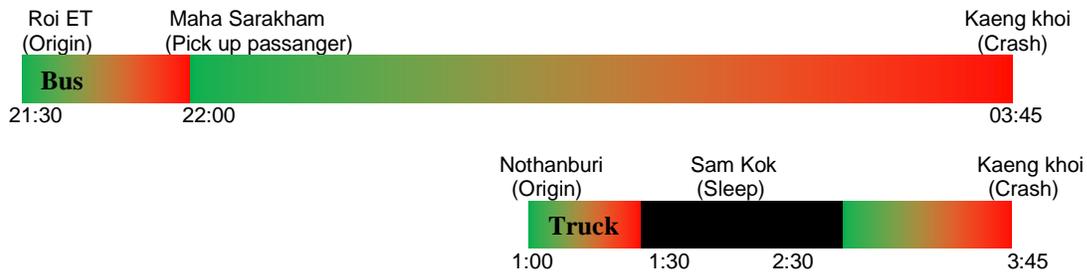
Figure 17 Bus and Truck Driving Hours before Crash

The truck driver, 29 years old male was an employee of TJJ Transport Ltd. He has been working in this company since one year, however he made his driver license in 2005 and has 5 or 6 years' driving experience in the former company he used to work. The medical report showed that the alcohol content in his blood was only 5 %, which is not significant for the accident. The truck driver summarized the event prior to the collision as - the truck started its journey from Rattana-thibeth road, Nothanburi at 1 am to kaeng Koi quarry, Saraburi in order to

collect the gravel. He said that he had an one hour sleep at Samkhok, Pathumthani and continued his journey to the quarry. While the Truck (V1) was moving in the inner lane of eastbound approach (uphill); he was feeling drowsy and sudenly the truck lost its control and deviate across median, approaching to opposite directional flow and colliding with the bus (V2) in westbound approach (downhill).

Similarly, there were two drivers in bus, named as driver 1 and driver 2 as shown in Figure 19. Driver 1, 43 years old male was driving the bus. As per the bus schedule, he started his trip from Roi Et and after picking up some passangers from Maha Sarakham, he resumed his journey to Mochit. Driver 2, 51 years old male was sleeping in the compartment. He had an experience of 10 years and was familiar to this route.
